final report
**WARRENSVILLE WEST
CEMETERY**
HISTORIC PRESERVATION MASTER PLAN

COMPLETED 03-14-2022

**SHAKER
HEIGHTS**

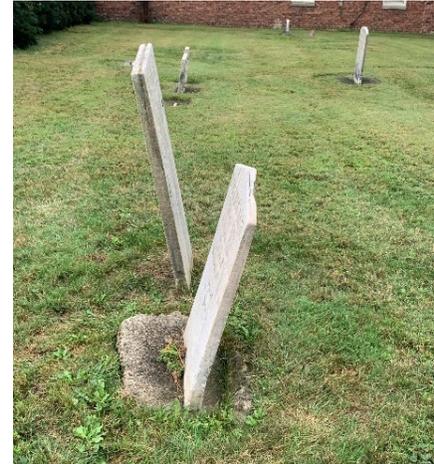
Markers in need of resetting

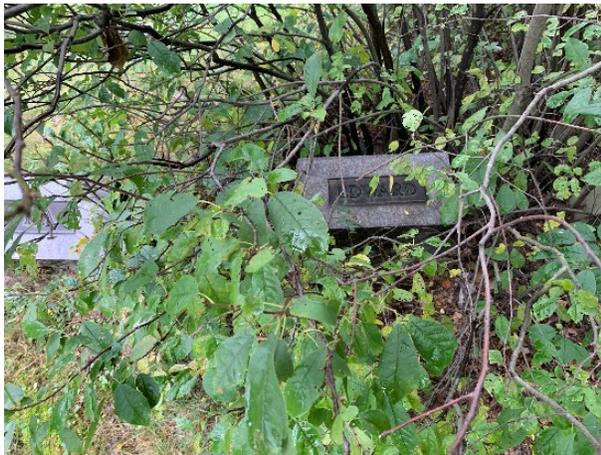
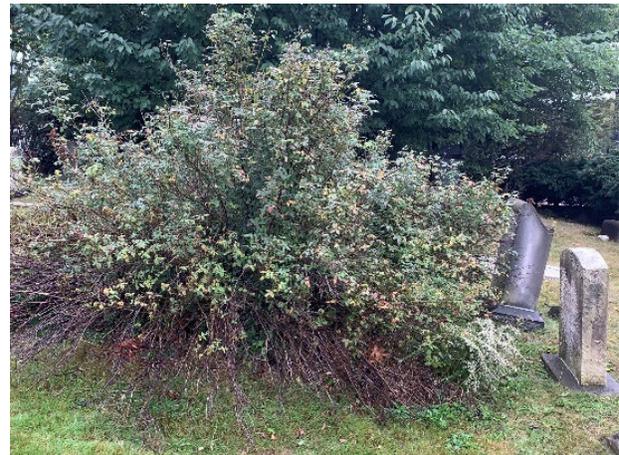
Markers concealed by vegetation

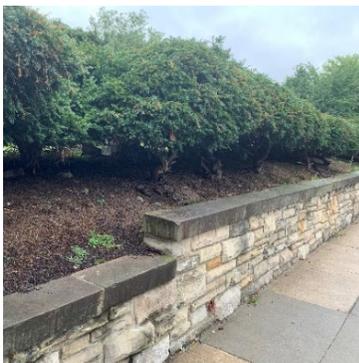
Retaining wall, west side (Lee Road)

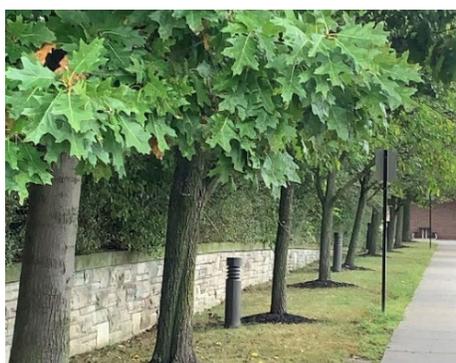
Retaining wall, south side

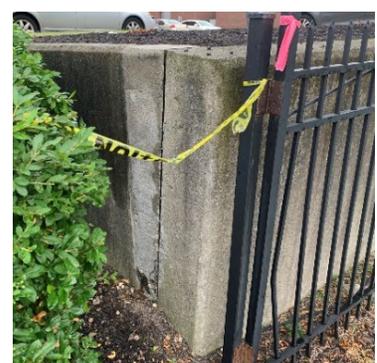
Retaining wall, east side

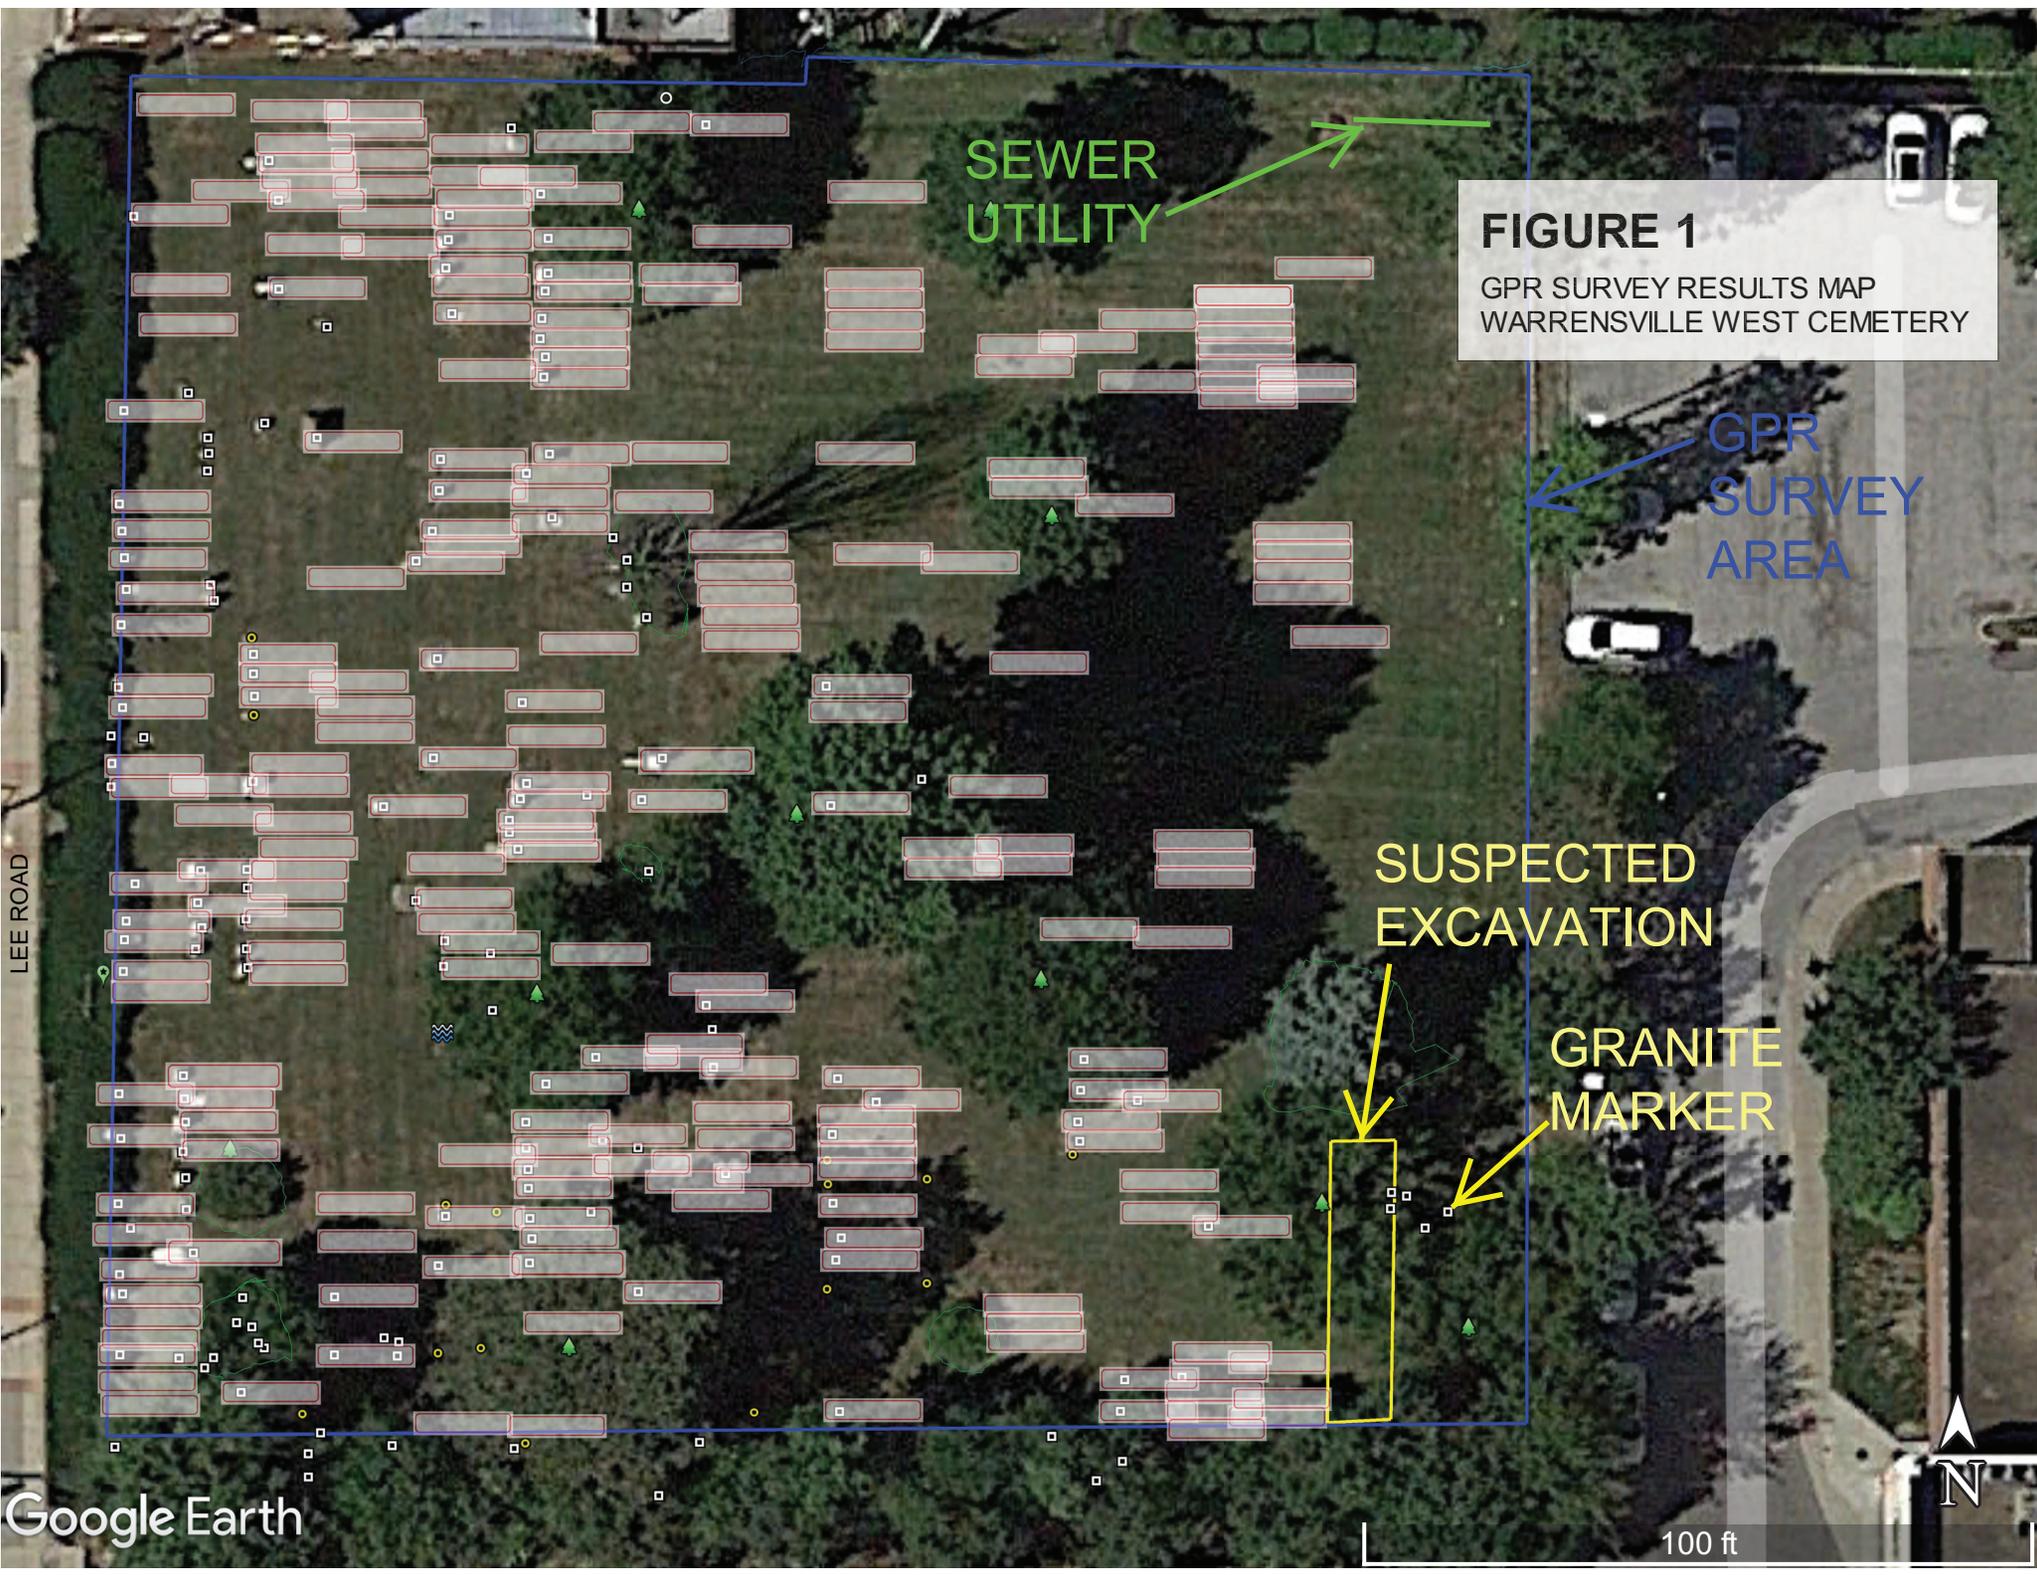
FIGURE 1

GPR is an effective means of characterizing the subsurface and the detection of buried anomalies and can provide a significant amount of detail about what is underground. GPR identification of burials at cemeteries typically involves the detection of the top of buried coffins or vaults, however over time, graves deteriorate and become difficult to detect. Additional GPR anomalies that are used in detection of burials are soil disturbances, including burial shafts and excavation areas. Other observable physical evidence is also considered along with the GPR data in the detection of burials, including surface disturbances and ground subsidence. However, GPR data can contain many additional unwanted components in the data, called noise, which originate from the use of the GPR, soil conditions, or additional subsurface materials (tree roots, rocks, and other forms excavation, not related to burials).

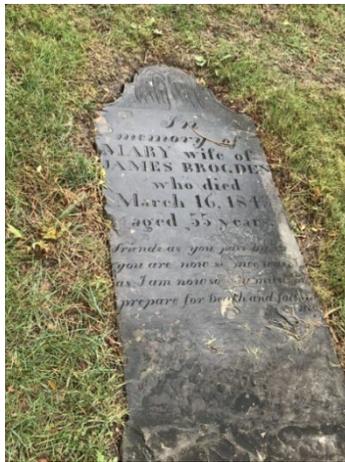
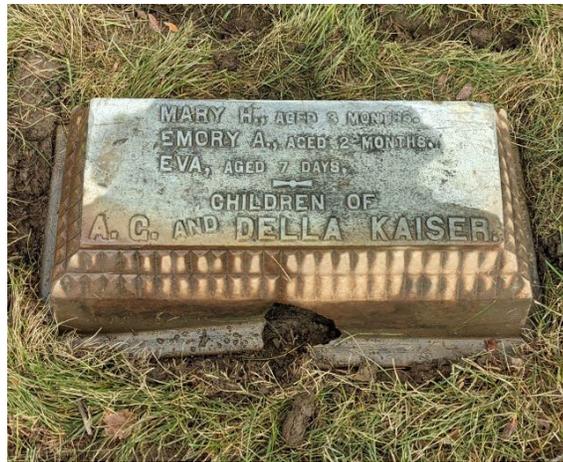
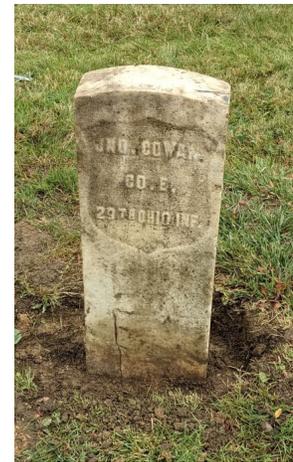
L-R, siltstone, zinc, marble

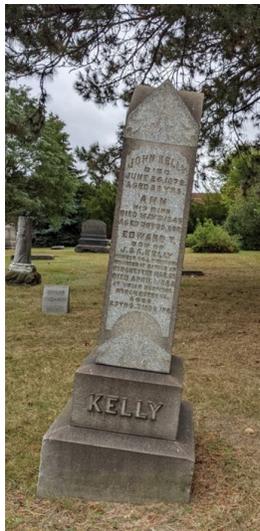
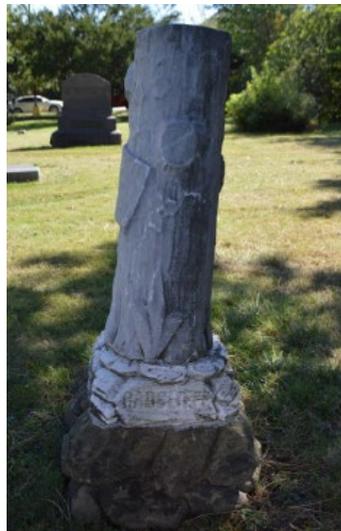
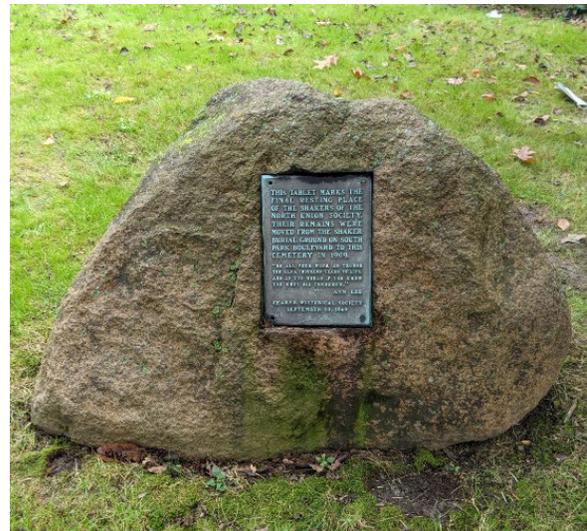
L-R, granite, marble, granite boulder

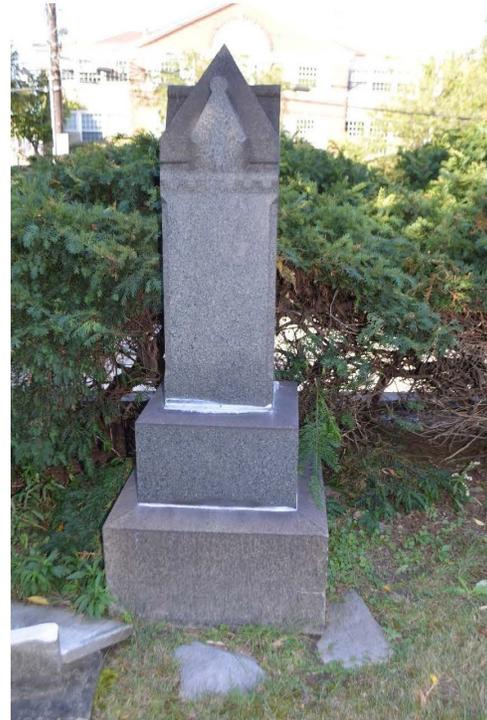
Conservation Form

Cemetery Location	Warrensville West Cemetery Lee Rd., Shaker Heights, Ohio
GPS#	20
Lot #	21
Name	Collister, Thomas & Ann
Date of Death	1891 & 1884
Material	granite
Marker Type	pedestal
Inscription	THOMAS COLLISTER/1807- 1891/ANN/HIS WIFE/1822-1884/JANE COLLISTER/1786-1862
 Stone Condition	 Ambient dirt, biological growth, leaning, set on rubble, caulk, impacted by bushes
 Recommendations	 Clean, treat biological growth, remove bushes, remove rubble & caulk, reset base plumb, reassemble with lime mortar

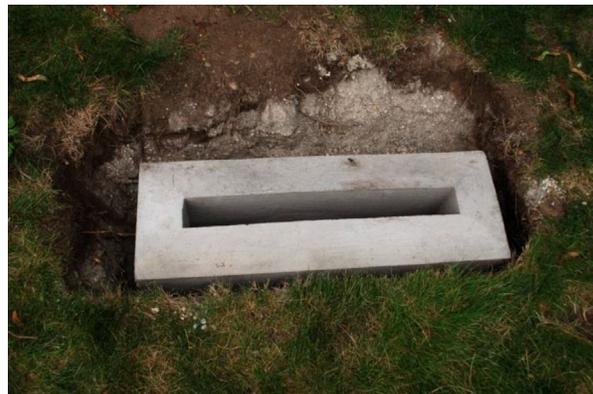
Cast concrete bases are typically made with a slot that is 1/2" wider and thicker than the stone and is recessed 3"-4". Depending on the size of the stone the base is usually 8"-12" deep, 8"-12" greater thickness and 6"-8" wider than the stone. This method is fine when resetting stones with a square bottom. If casting with a recessed slot, drainage holes must be provided.

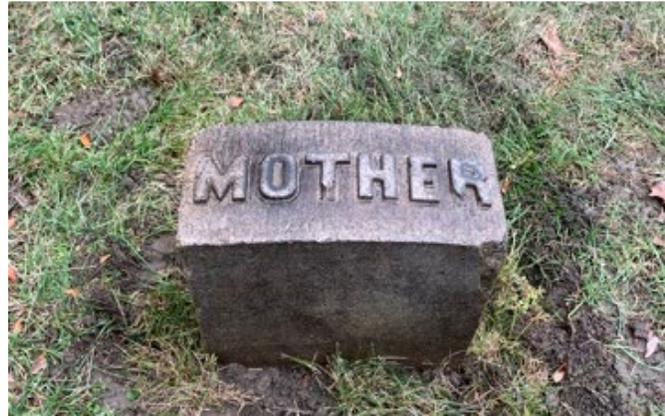
The Volunteers' Workshop resulted in the cleaning of fifteen stones and the resetting of eight stones. The head and footstones of Mary Brogden were cleaned and reset by Ta Mara Conde as part of the workshop demonstration. Ta Mara made use of a tripod to do the work. This type of work should only be performed by a trained specialist.

Reset Headstone

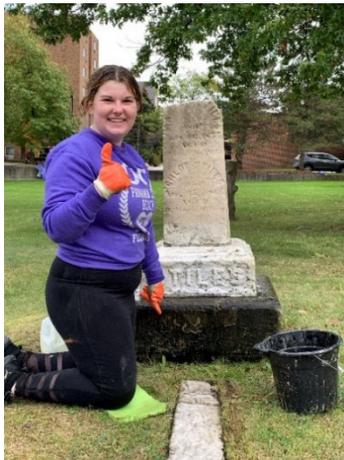
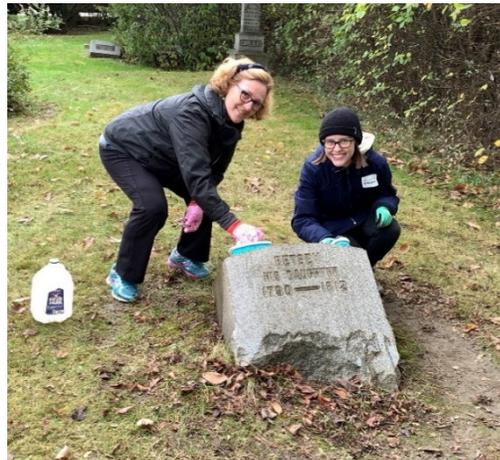
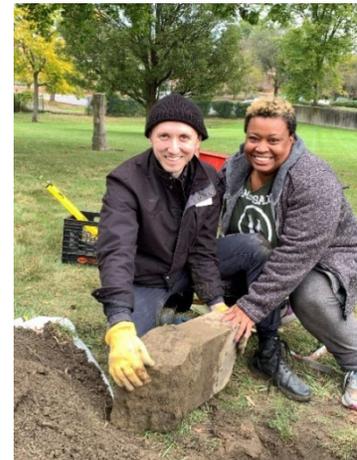
Volunteers, Cleaning and Resetting Markers

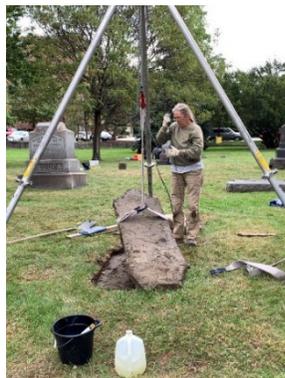
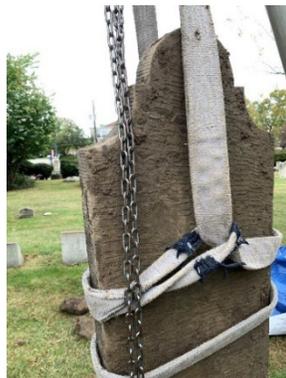
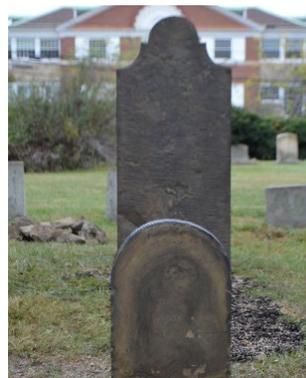
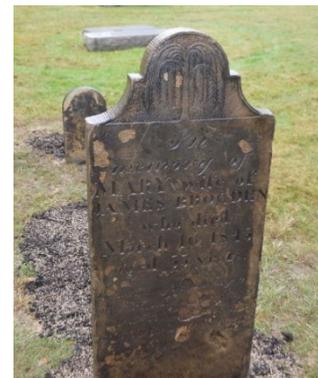
Cleaning and Resetting Mary Brogden Head and Foot Stones

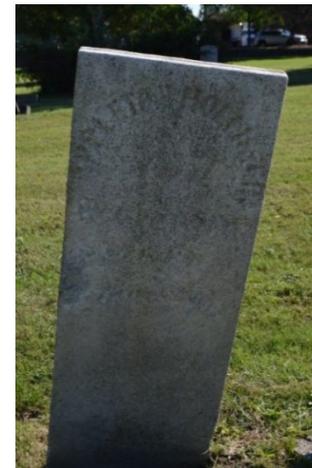
Graves may be marked with several different styles of monuments which present different issues. Early markers were a simple tablet shaped stone with one-third of the total stone length beneath ground, holding the stone erect. Over time many tablets may begin to lean or tilt to one side. A leaning stone is at risk and may lead to injury to the public or cemetery workers. Leaning stones are also an obstacle for the mowing equipment and are in danger of falling over or breaking.

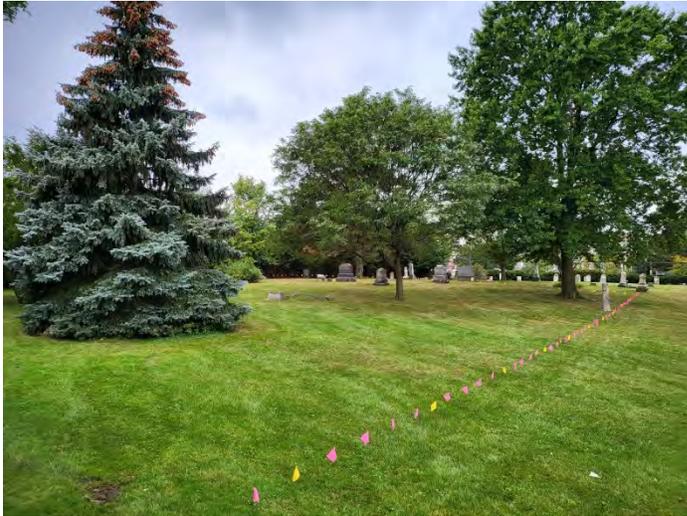
Figure 2 (left): View of the GPR survey grid flagging at the Warrensville West Cemetery, facing southwest.

Figure 3 (right): View of the GPR survey activities at the Warrensville West Cemetery, facing southeast.

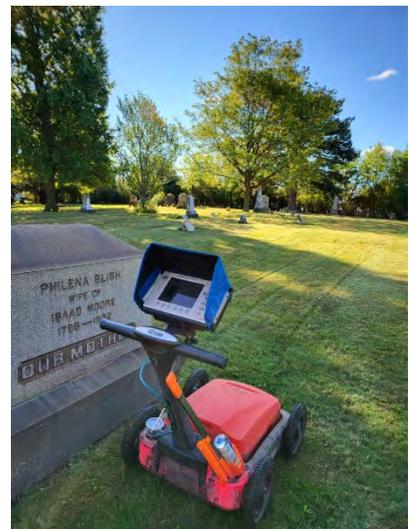
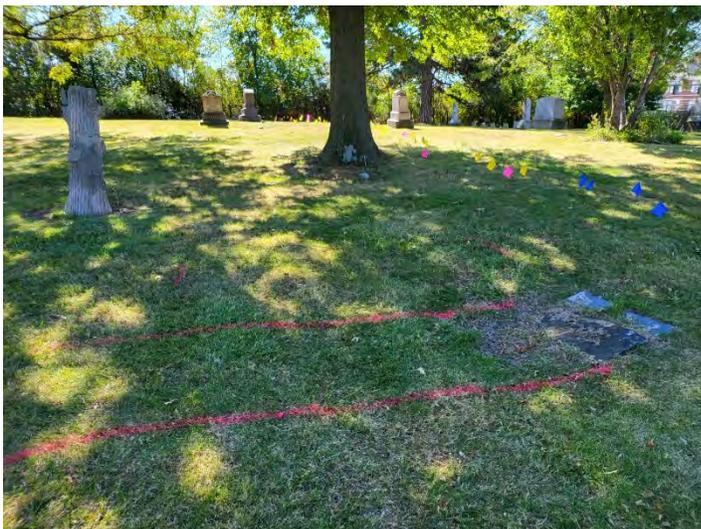
Figure 4 (left): View of burial marker and GPR anomaly field marking of suspected burial (marked in pink) at the Warrensville West Cemetery, facing south.

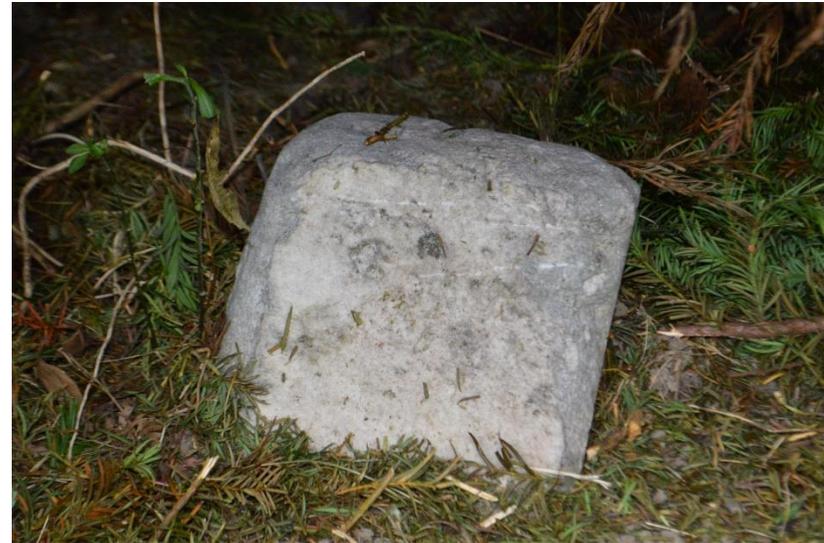
Stone Condition
 Ambient dirt, biological growth, leaning,
 impacted by bushes

Recommendations
 Clean, treat biological growth, remove
 bushes, reset plumb at correct height

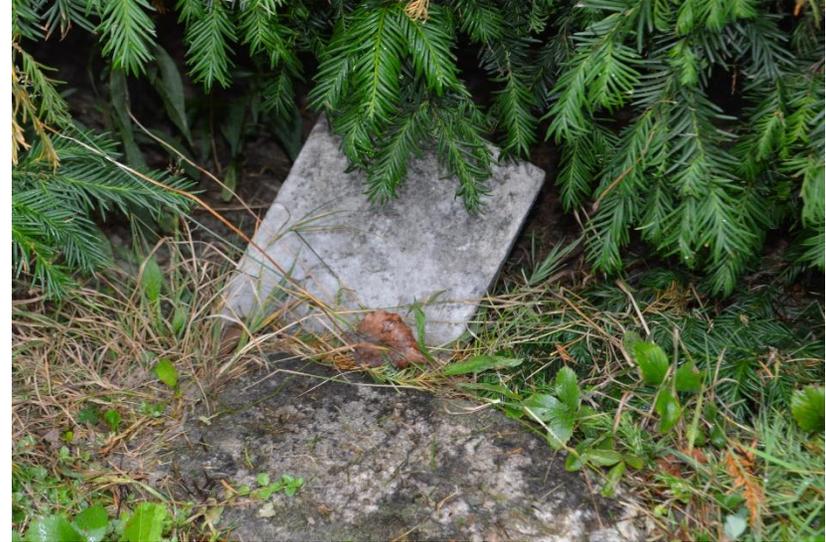
Stone Condition
 Ambient dirt, biological growth, leaning,
 impacted by bushes

Recommendations
 Clean, treat biological growth, remove
 bushes, reset plumb at correct height

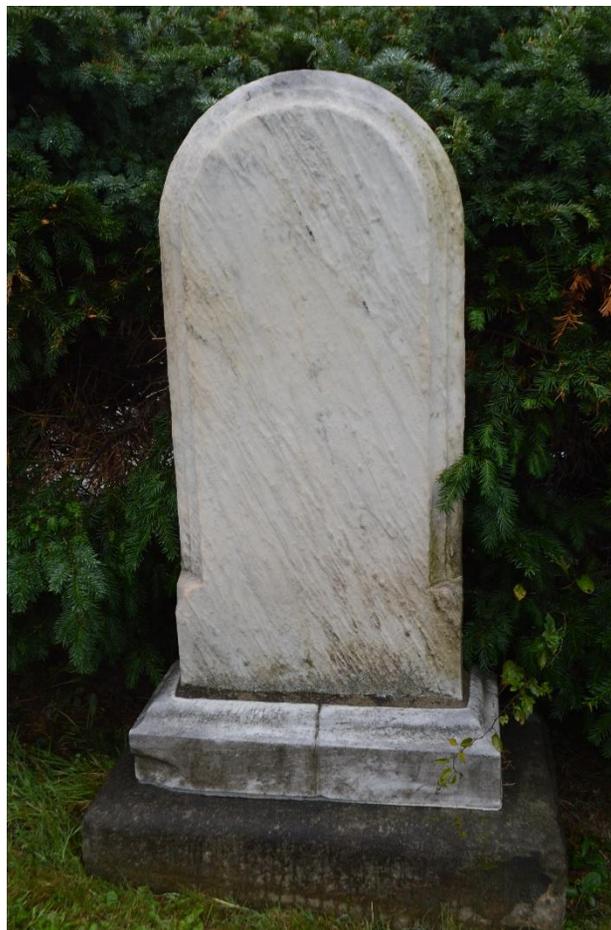
Cemetery	Warrensville West Cemetery
Location	Lee Rd., Shaker Heights, Ohio
GPS#	4
Lot #	4
Name	Kent, Harriet M.
Date of Death	
Material	marble
Marker Type	die with base
Inscription	HARRIET M./Wife of/GEORGE KENT/.../.../DEPARTED THIS LIFE/.../...
Stone Condition	Ambient dirt, biological growth, leaning, impacted by bushes, concrete
Recommendations	Clean, treat biological growth, remove bushes, reset base plumb at correct height, reset die with lime mortar

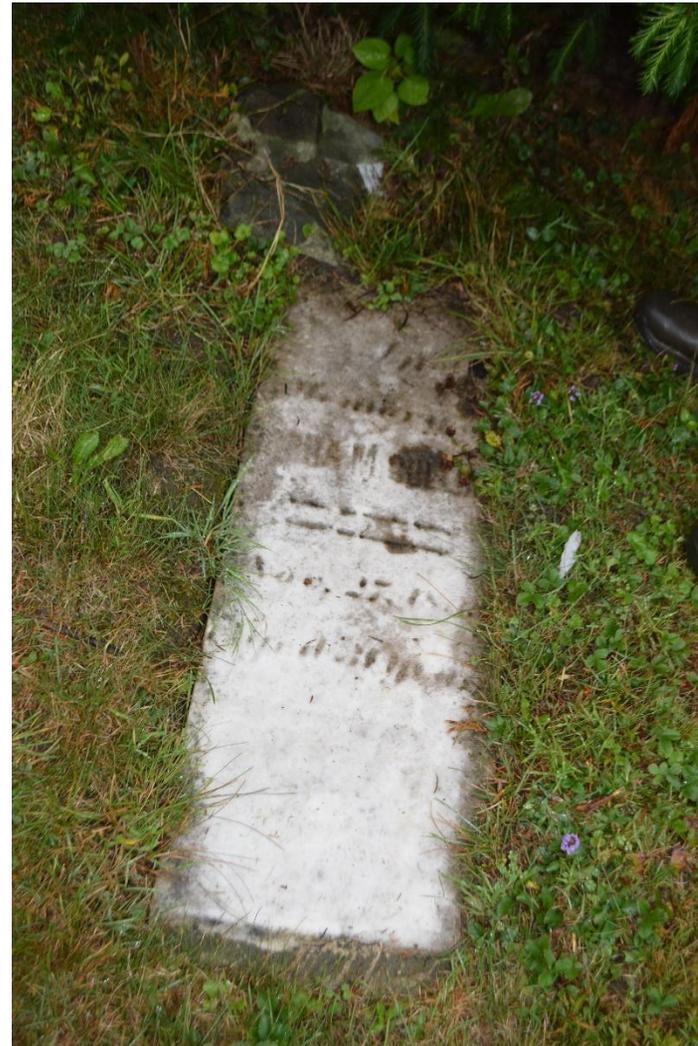
Cemetery	Warrensville West Cemetery
Location	Lee Rd., Shaker Heights, Ohio
GPS#	5
Lot #	5
Name	McCulloch, Orphah
Date of Death	Nov. 27, 1836
Material	marble
Marker Type	tablet with base
Inscription	In/Memory of/[Orphah] McCulloch/DIED/Nov. 27, 1836/Aged 30 years
Stone Condition	Ambient dirt, biological growth, fallen, missing base, impacted by bushes
Recommendations	Clean, treat biological growth, remove bushes, create below grade base, reset tablet into base with lime mortar

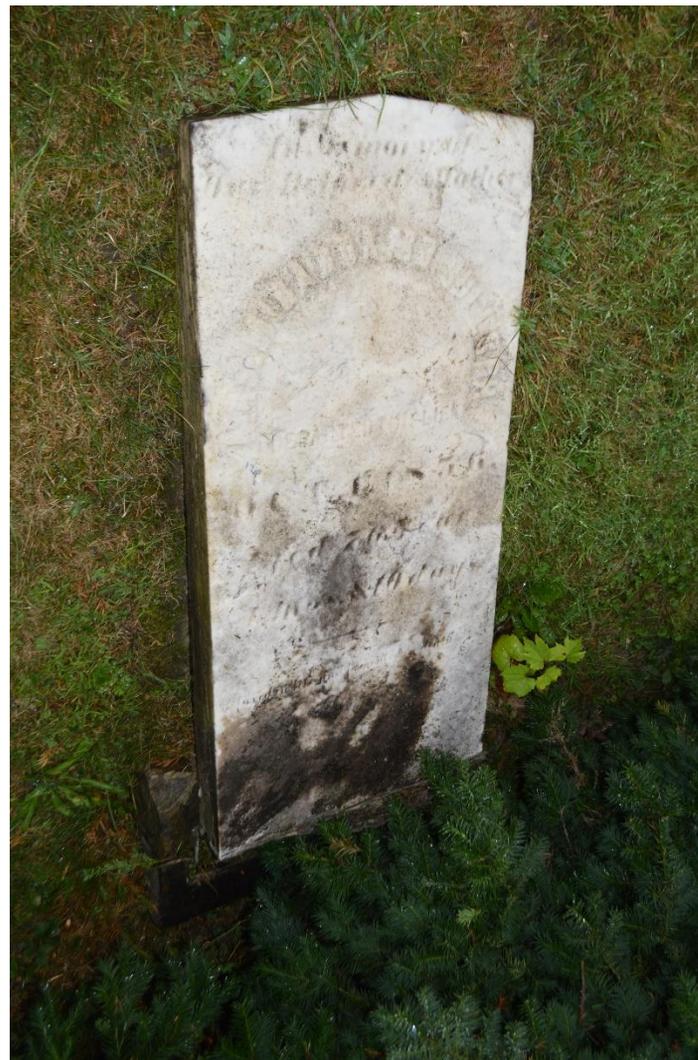
Cemetery	Warrensville West Cemetery
Location	Lee Rd., Shaker Heights, Ohio
GPS#	6
Lot #	6
Name	McCulloch, Miranda
Date of Death	Oct. 1, 1856
Material	marble
Marker Type	tablet with base
Inscription	In Memory of/Our Beloved Mother/MRS. MIRANDA McCULLOCH/DEPARTED THIS LIFE/Oct. 1, 1856/Aged 76 Years/4 Mns & 10 days
Stone Condition	Ambient dirt, biological growth, fallen, broken at base, impacted by bushes
Recommendations	Clean, treat biological growth, remove bushes, create below grade base, reset tablet into base with lime mortar

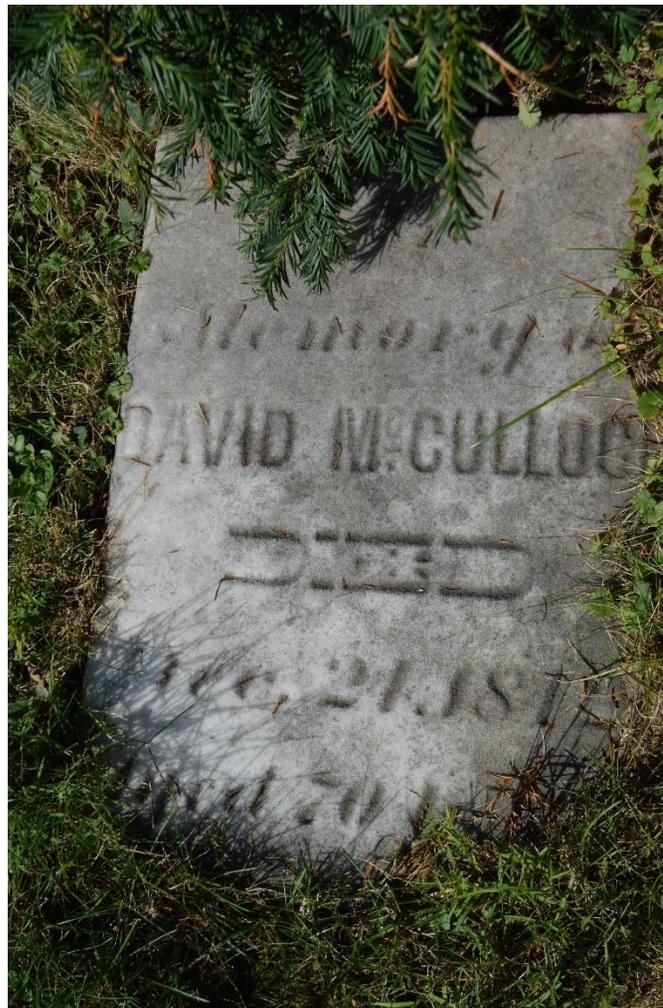
Stone Condition
Ambient dirt, biological growth, fallen,
broken at base, impacted by bushes

Recommendations
Clean, treat biological growth, remove
bushes, create below grade base, reset
tablet into base with lime mortar

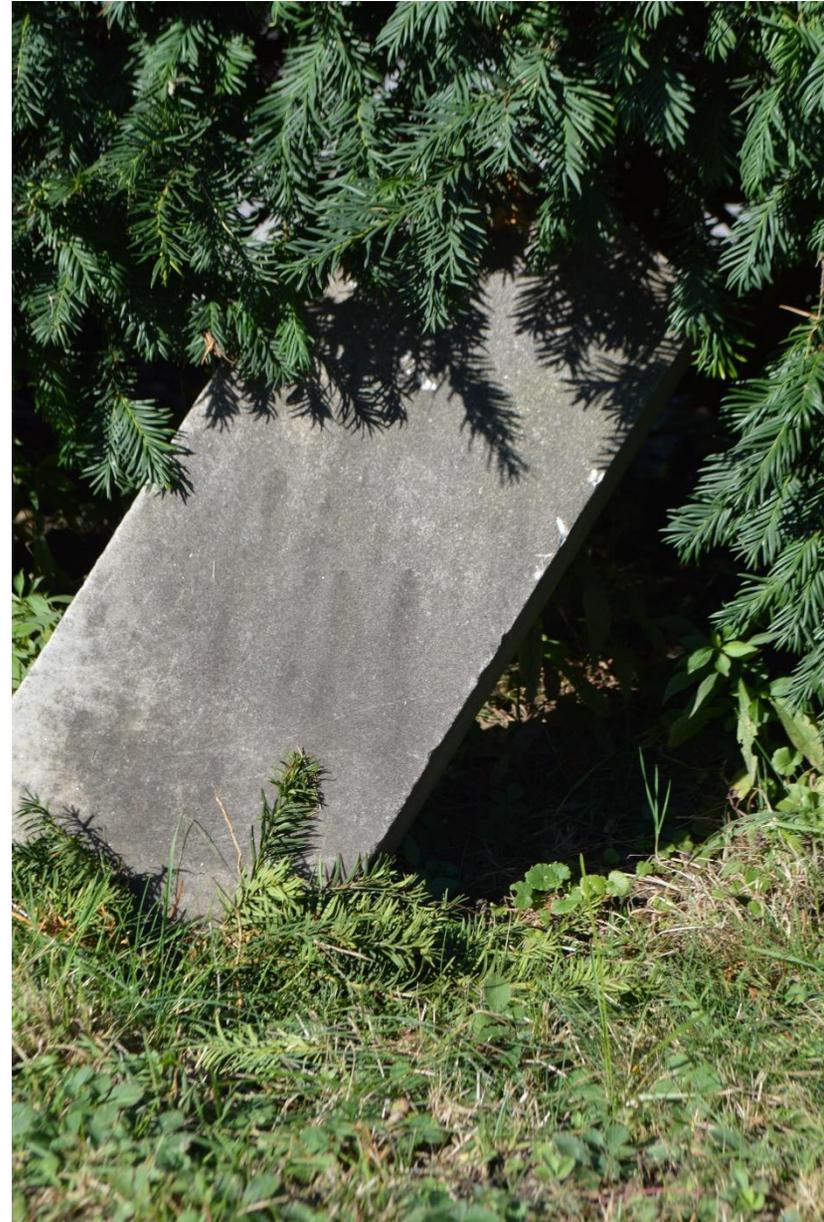
Cemetery	Warrensville West Cemetery
Location	Lee Rd., Shaker Heights, Ohio
GPS#	10
Lot #	10
Name	Kent, E. A.
Date of Death	
Material	marble
Marker Type	tablet (veteran)
Inscription	E. A. KENT/CO.A./124 TH OHIO INF.
Stone Condition	Ambient dirt, biological growth, leaning, tilted, impacted by bushes
Recommendations	Clean, treat biological growth, remove bushes, reset plumb at correct height

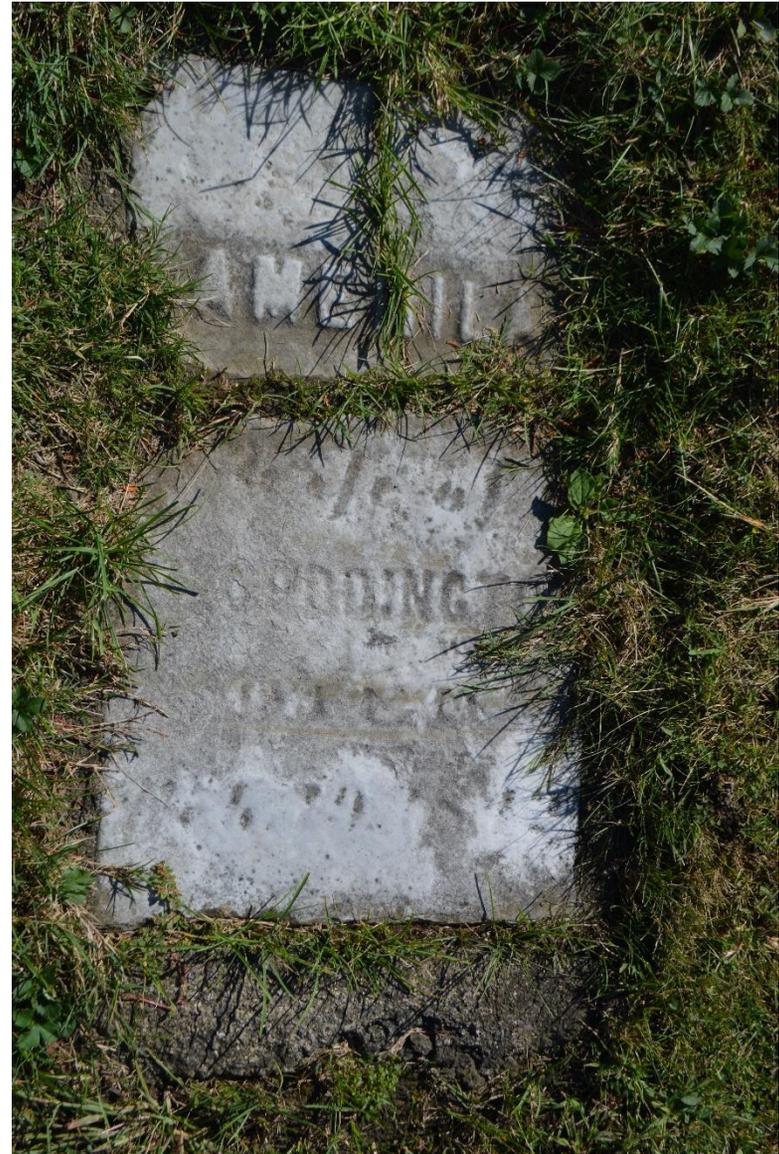
Cemetery	Warrensville West Cemetery
Location	Lee Rd., Shaker Heights, Ohio
GPS#	11
Lot #	11
Name	Coddington, Amerilla
Date of Death	Feb. 12, 1842
Material	marble
Marker Type	tablet with base
Inscription	AMERILA/Wife of/J.H. CODDINGTON/DIED/Feb. 12, 1842
Stone Condition	Ambient dirt, biological growth, fallen, 3 fragments, laid flat in concrete, impacted by bushes
Recommendations	Clean, treat biological growth, remove bushes, reset plumb at correct height to prevent flooding

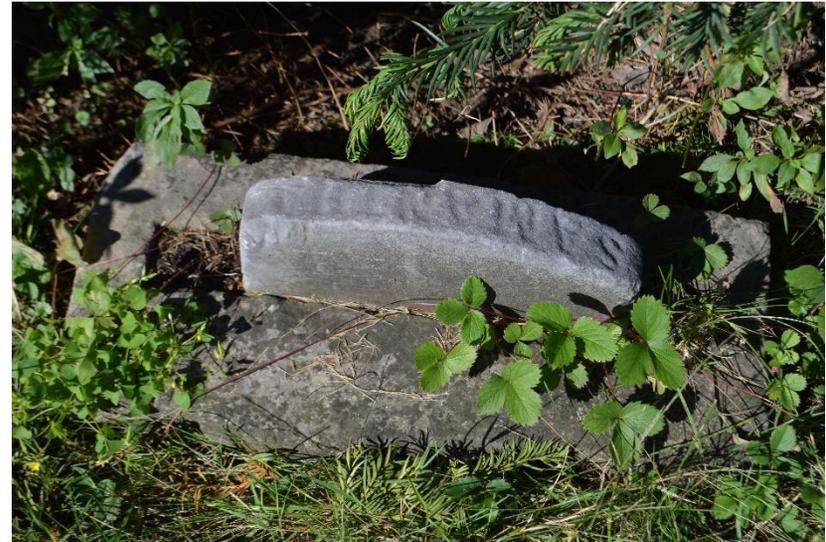
Cemetery	Warrensville West Cemetery
Location	Lee Rd., Shaker Heights, Ohio
GPS#	13
Lot #	13
Name	Ball, Samantha
Date of Death	
Material	marble
Marker Type	tablet with base
Inscription	SAMANTHA
Stone Condition	Ambient dirt, biological growth, loose in wrong base, sunken base, impacted by bushes
Recommendations	Clean, treat biological growth, remove bushes, locate correct base, reset plumb at correct height

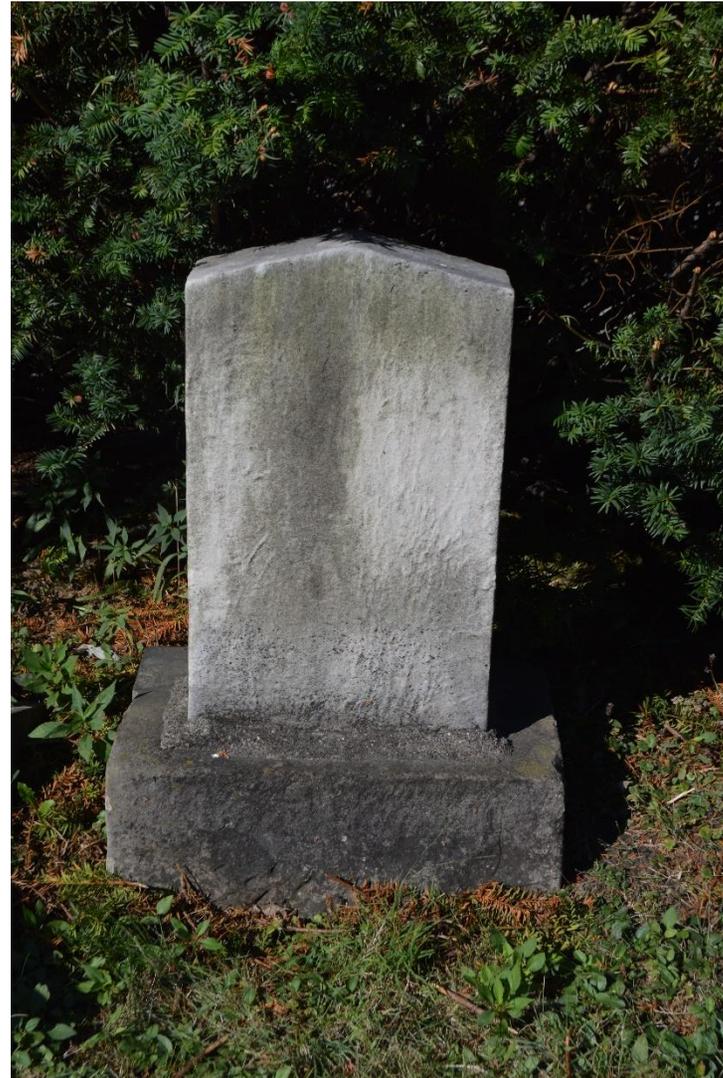
Stone Condition
Ambient dirt, biological growth, leaning,
concrete, impacted by bushes

Recommendations
Clean, treat biological growth, remove
bushes, remove concrete, reset base
plumb, reset die with lime mortar

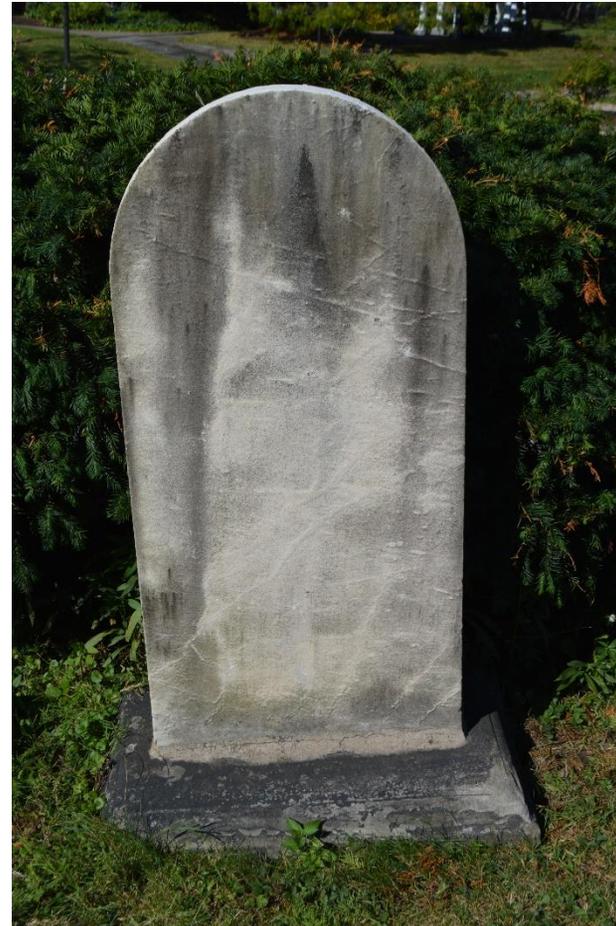
Stone Condition
Ambient dirt, biological growth, leaning,
concrete, impacted by bushes

Recommendations
Clean, treat biological growth, remove
bushes, remove concrete, reset base
plumb, reset tablet with lime mortar

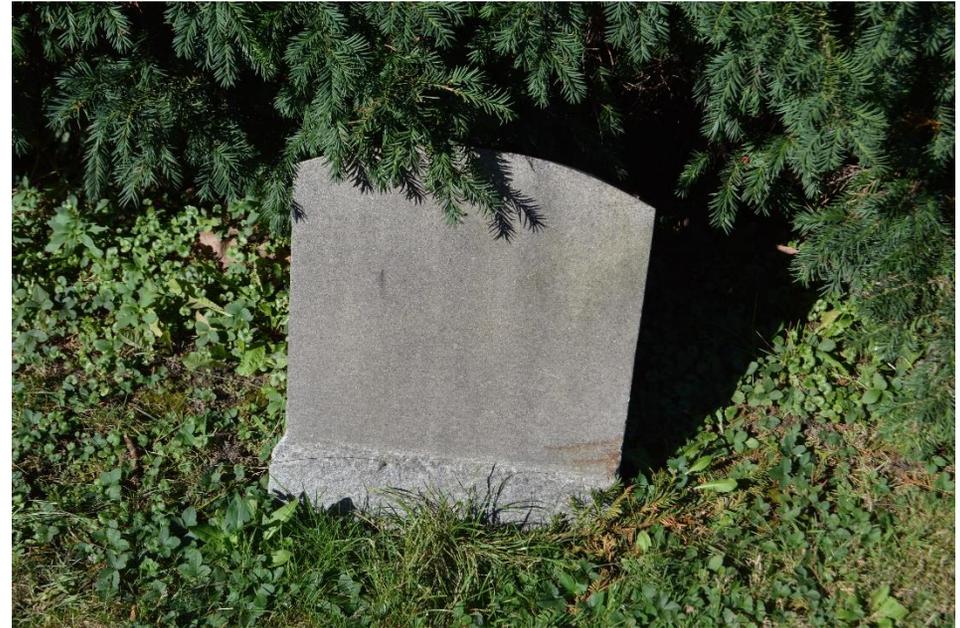
Cemetery	Warrensville West Cemetery
Location	Lee Rd., Shaker Heights, Ohio
GPS#	18
Lot #	19
Name	Sayle, Rev. John & Catherine
Date of Death	1827 & 1858
Material	granite
Marker Type	tablet
Inscription	REV. JOHN SAYLE/1766- 1827/CATHERINE/HIS WIFE/1770- 1858
Stone Condition	Ambient dirt, biological growth, leaning, impacted by bushes
Recommendations	Clean, treat biological growth, remove bushes, reset plumb at correct height

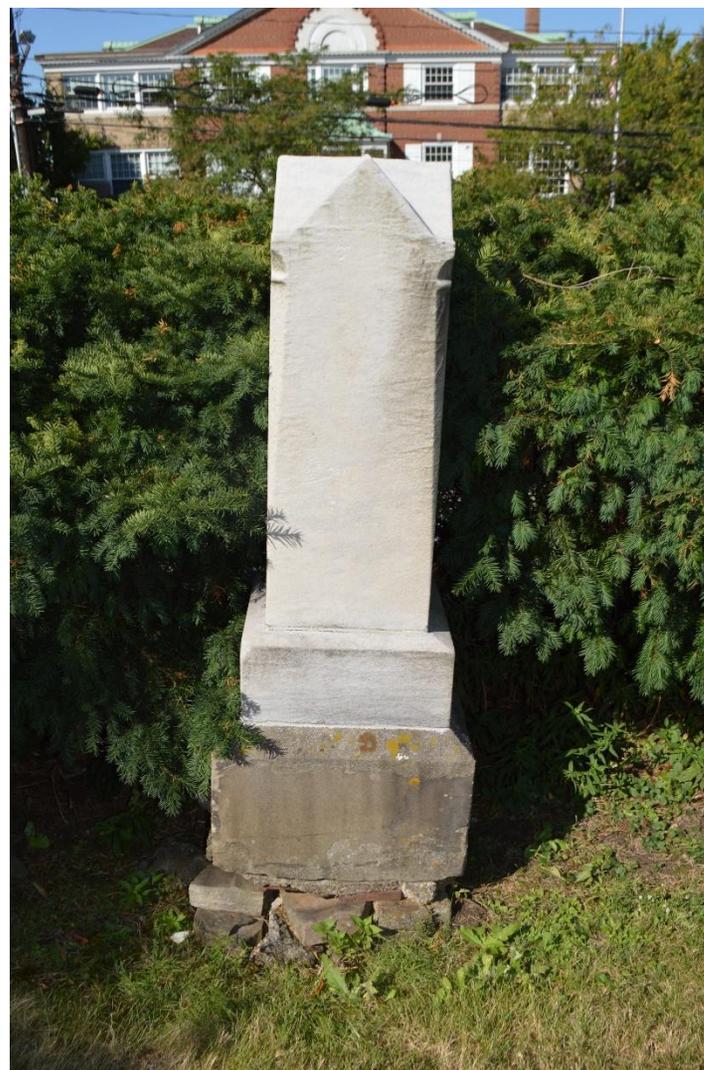
Cemetery	Warrensville West Cemetery
Location	Lee Rd., Shaker Heights, Ohio
GPS#	19
Lot #	20
Name	Callow, William & Isabella
Date of Death	May 15, 1881 & March 29, 1891
Material	marble
Marker Type	pedestal
Inscription	WILLIAM CALLOW/died/May 15, 1881/Aged/71 Years/ISABELLA/HIS WIFE/DIED MAR. 29, 1891/AGED 79 YEARS
Stone Condition	Ambient dirt, biological growth, leaning, set on rubble, caulk, missing mortar, impacted by bushes
Recommendations	Clean, treat biological growth, remove bushes, remove rubble & caulk, reset base plumb, reassemble with lime mortar

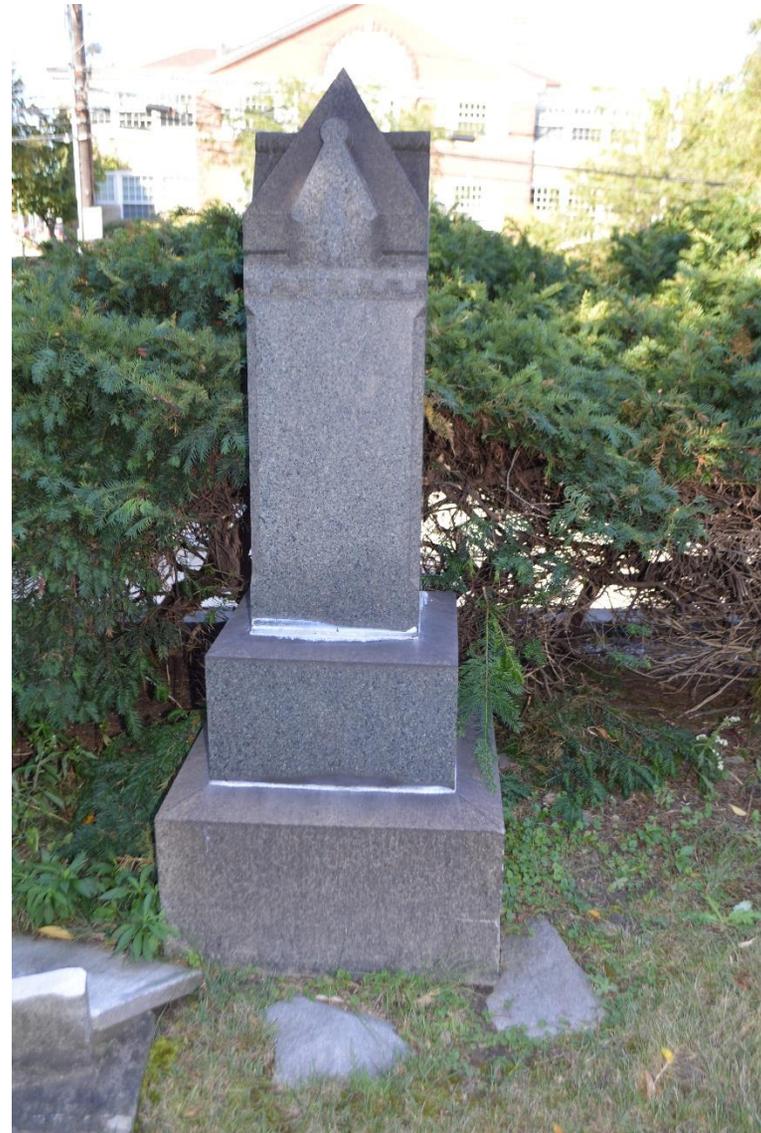
Cemetery	Warrensville West Cemetery
Location	Lee Rd., Shaker Heights, Ohio
GPS#	20
Lot #	21
Name	Collister, Thomas & Ann
Date of Death	1891 & 1884
Material	granite
Marker Type	pedestal
Inscription	THOMAS COLLISTER/1807- 1891/ANN/HIS WIFE/1822-1884/JANE COLLISTER/1786-1862
Stone Condition	Ambient dirt, biological growth, leaning, set on rubble, caulk, impacted by bushes
Recommendations	Clean, treat biological growth, remove bushes, remove rubble & caulk, reset base plumb, reassemble with lime mortar

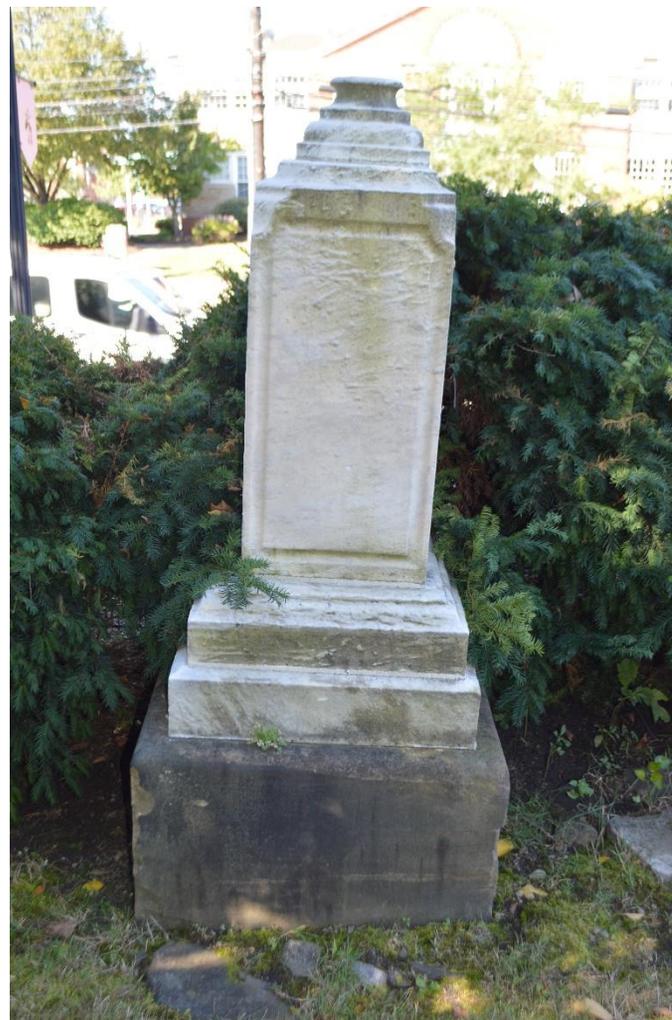
Cemetery	Warrensville West Cemetery
Location	Lee Rd., Shaker Heights, Ohio
GPS#	23
Lot #	23
Name	Kewish, William & Ann
Date of Death	Oct. (21, 1849) & Oct. 21, 1835
Material	marble
Marker Type	pedestal
Inscription	WM. F. KEWISH/DIED/Oct. (21, 1849)/AGED/41 Years & 6 Ms./ANN KEWISH/DIED/Oct. 21, 1835/Aged 35 years//JANE KEWISH/DIED/Aug. 20, 1872/Aged 76 Years/JOHN J. KEWISH/DIED/Feb. 3, 1889/Aged 56 Yrs.
Stone Condition	Ambient dirt, biological growth, leaning, set on rubble, caulk, missing urn, impacted by bushes
Recommendations	Clean, treat biological growth, remove bushes, remove rubble & caulk, reset base plumb, reassemble with lime mortar

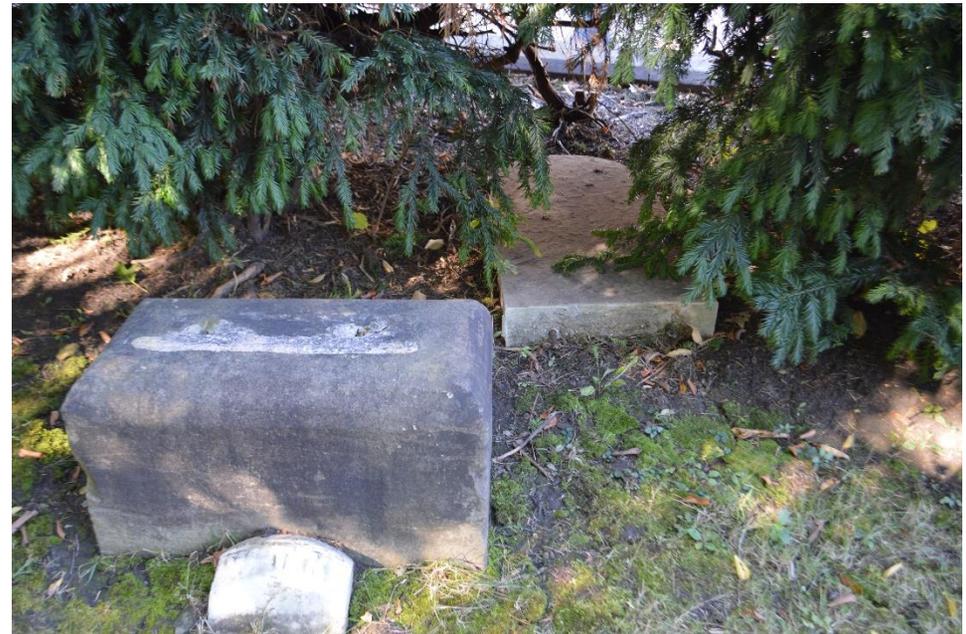
Cemetery	Warrensville West Cemetery
Location	Lee Rd., Shaker Heights, Ohio
GPS#	24
Lot #	24
Name	Caine, William
Date of Death	Dec. 11, 1866
Material	marble
Marker Type	die with base
Inscription	WILLIAM CAINE/DIED DEC. 11, 1866/AGED 60 YRS. -MS. 20 D
Stone Condition	Ambient dirt, biological growth, fallen, pins, base leaning, impacted by bushes
Recommendations	Clean, treat biological growth, remove bushes, remove pins, reset base plumb, reset die with lime mortar

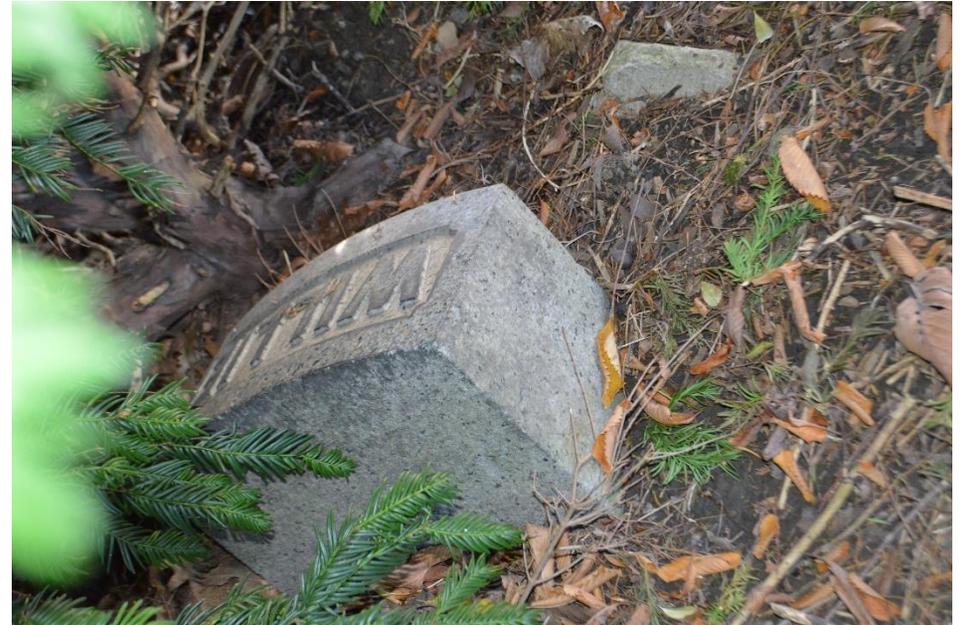
Cemetery	Warrensville West Cemetery
Location	Lee Rd., Shaker Heights, Ohio
GPS#	25
Lot #	25
Name	Duff, Willie
Date of Death	
Material	granite
Marker Type	marker
Inscription	WILLIE/
Stone Condition	Ambient dirt, biological growth, leaning, sunken, impacted by bushes
Recommendations	Clean, treat biological growth, remove bushes, reset plumb at correct height
