final report
**WARRENSVILLE WEST
CEMETERY**
HISTORIC PRESERVATION MASTER PLAN

COMPLETED 03-14-2022

**SHAKER
HEIGHTS**

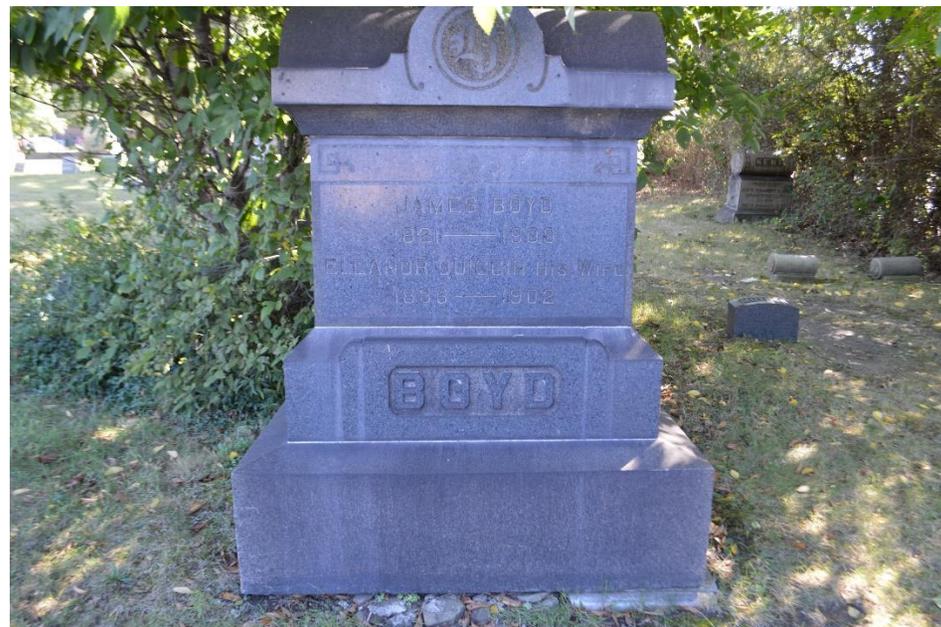
Cemetery	Warrensville West Cemetery
Location	Lee Rd., Shaker Heights, Ohio
GPS#	26
Lot #	43
Name	Boyd, James & Eleanor
Date of Death	1900 & 1902
Material	granite
Marker Type	die with base
Inscription	JAMES BOYD/1821-1900/ELEANOR QUIGGIN HIS WIFE/1836- 1902/CATHERINE CORLETT BOYD/1819-1859/ANN MYLREA BOYD/1822-1862
Stone Condition	Ambient dirt, biological growth, leaning, set on rubble, caulk
Recommendations	Clean, treat biological growth, remove bushes, remove rubble & caulk, reset plumb at correct height

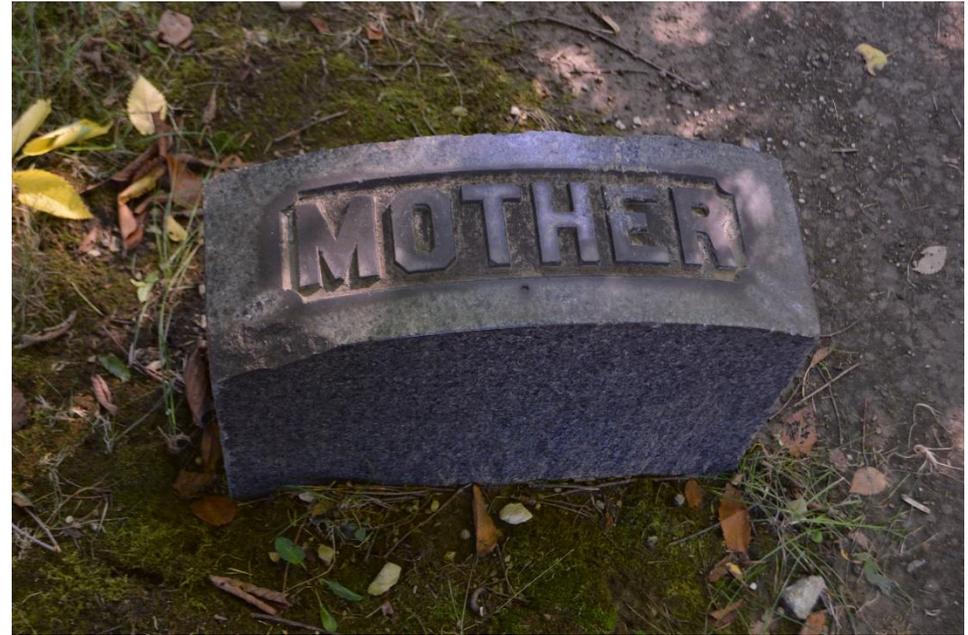
Cemetery	Warrensville West Cemetery
Location	Lee Rd., Shaker Heights, Ohio
GPS#	26A
Lot #	62
Name	Boyd, Mother
Date of Death	
Material	granite
Marker Type	marker
Inscription	MOTHER
Stone Condition	Ambient dirt, biological growth, leaning, impacted by bush/trees
Recommendations	Clean, treat biological growth, trim or remove bushes, reset plumb at correct height

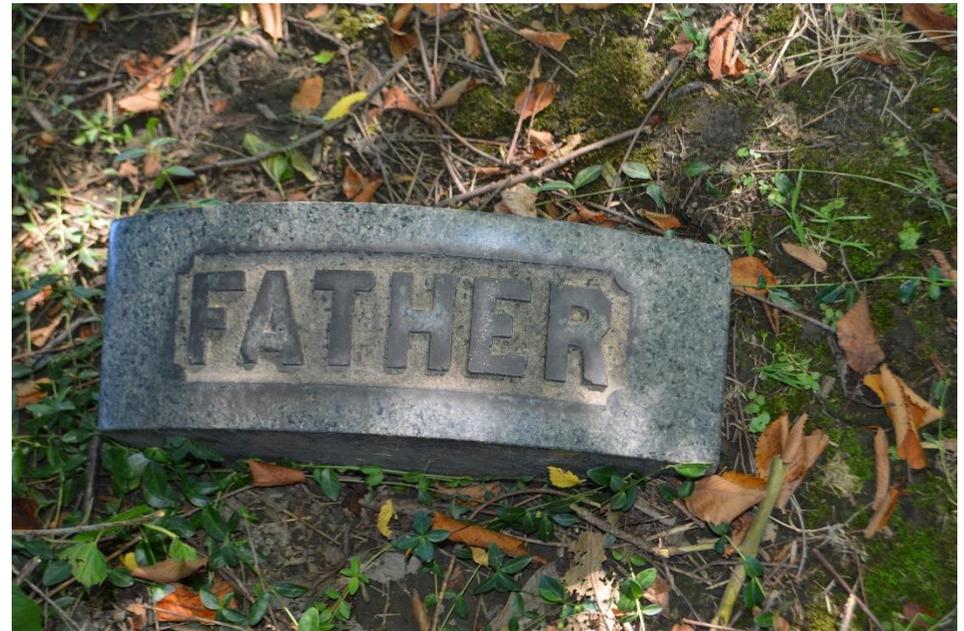
Cemetery	Warrensville West Cemetery
Location	Lee Rd., Shaker Heights, Ohio
GPS#	26B
Lot #	63
Name	Boyd, Father
Date of Death	
Material	granite
Marker Type	marker
Inscription	FATHER
Stone Condition	Ambient dirt, biological growth, leaning, impacted by bush/trees
Recommendations	Clean, treat biological growth, trim or remove bushes, reset plumb at correct height

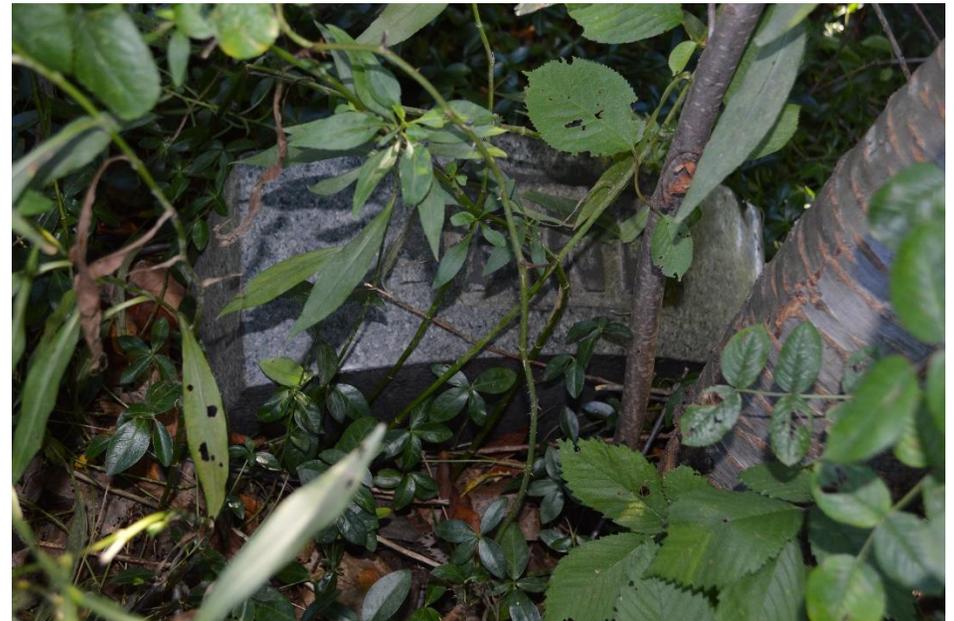
Cemetery	Warrensville West Cemetery
Location	Lee Rd., Shaker Heights, Ohio
GPS#	26C
Lot #	59
Name	Boyd, Ann
Date of Death	
Material	granite
Marker Type	marker
Inscription	ANN
Stone Condition	Ambient dirt, biological growth, leaning, impacted by bush/trees
Recommendations	Clean, treat biological growth, trim or remove bushes, reset plumb at correct height

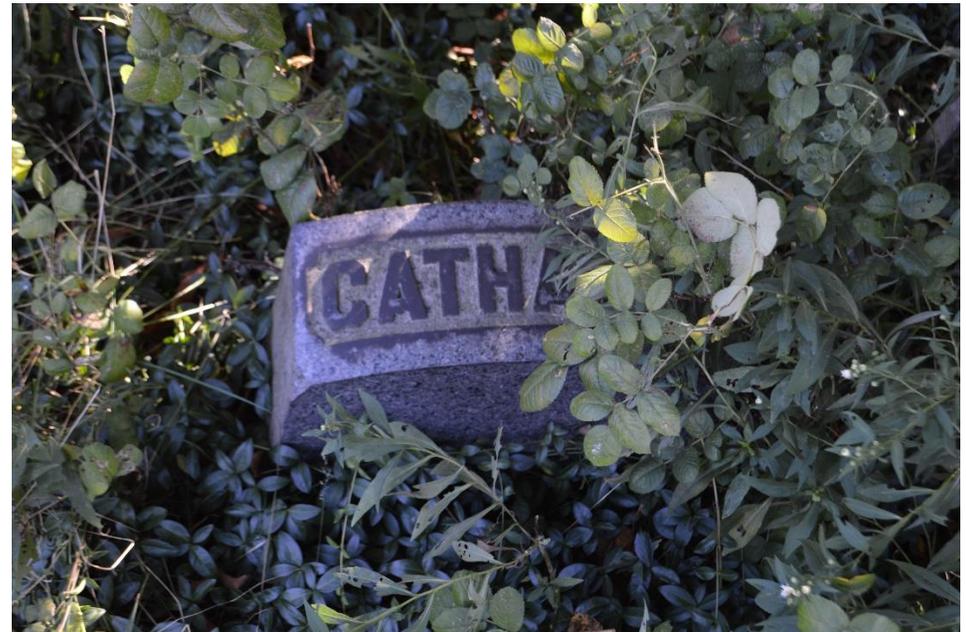
Cemetery	Warrensville West Cemetery
Location	Lee Rd., Shaker Heights, Ohio
GPS#	26D
Lot #	58
Name	Boyd, Catherine
Date of Death	
Material	granite
Marker Type	marker
Inscription	CATHERINE
Stone Condition	Ambient dirt, biological growth, leaning, impacted by bush/trees
Recommendations	Clean, treat biological growth, trim or remove bushes, reset plumb at correct height

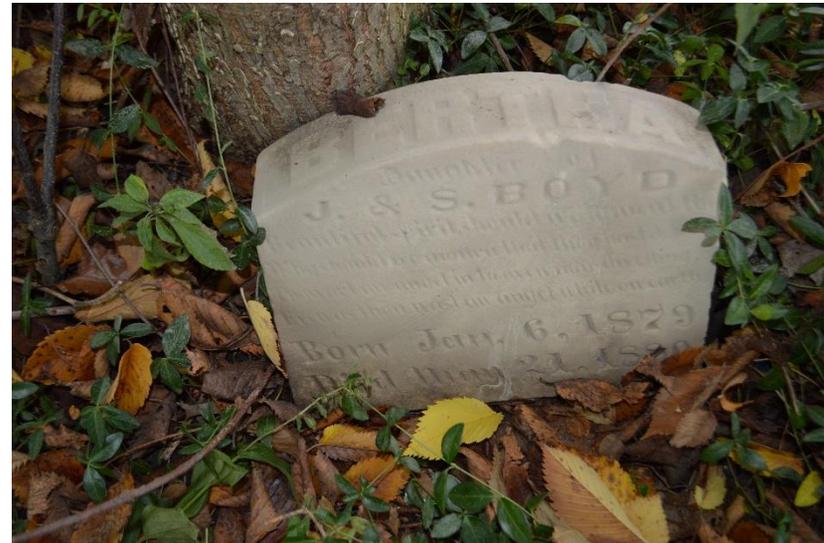
Cemetery	Warrensville West Cemetery
Location	Lee Rd., Shaker Heights, Ohio
GPS#	26E
Lot #	
Name	Boyd, Bertha
Date of Death	
Material	marble
Marker Type	die with base
Inscription	BERTHA/daughter of/J. &S. BOYD//verse//Born Jan. 6, 1879/Died May 21, 1880
Stone Condition	Ambient dirt, biological growth, fallen, pins, missing base, impacted by trees
Recommendations	Clean, treat biological growth, trim or remove bushes, remove pins, locate & reset base plumb, reset die with lime mortar

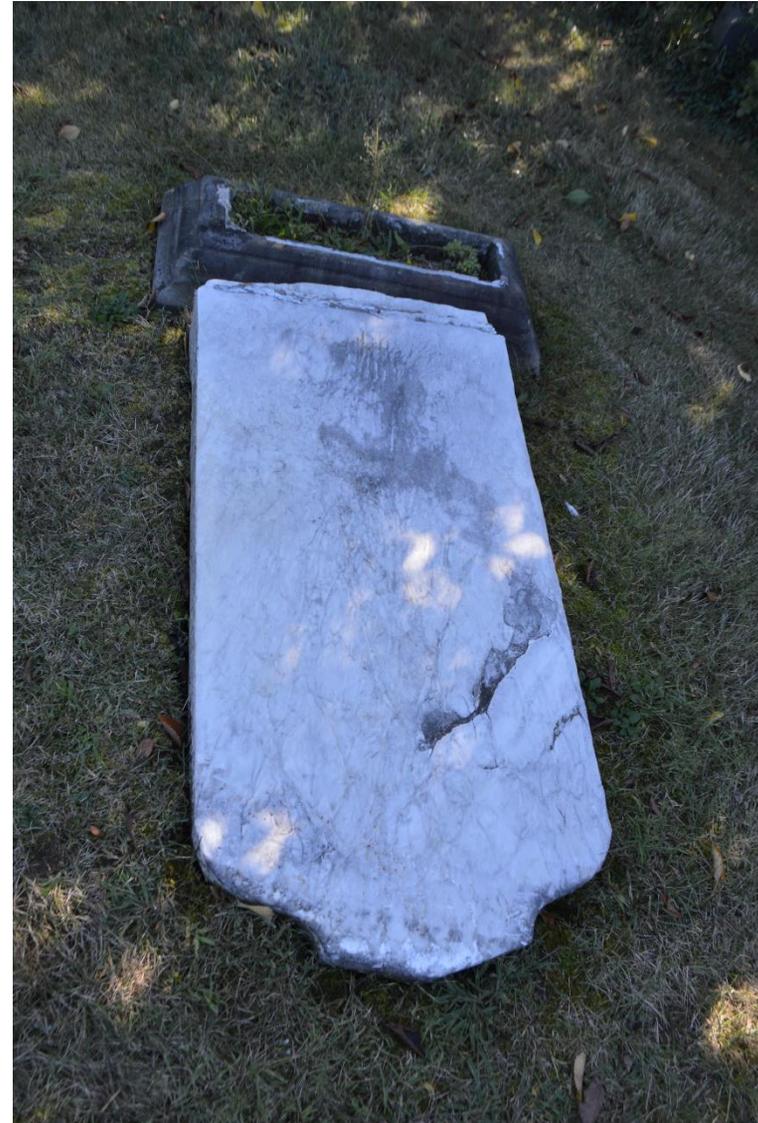
Cemetery	Warrensville West Cemetery
Location	Lee Rd., Shaker Heights, Ohio
GPS#	2
Lot #	42
Name	Unknown
Date of Death	
Material	marble
Marker Type	tablet with base
Inscription	Unreadable
Stone Condition	Ambient dirt, biological growth, fallen, concrete, surface cracks
Recommendations	Clean, treat biological growth, reset base plumb, remove concrete, reset tablet with lime mortar, fill cracks

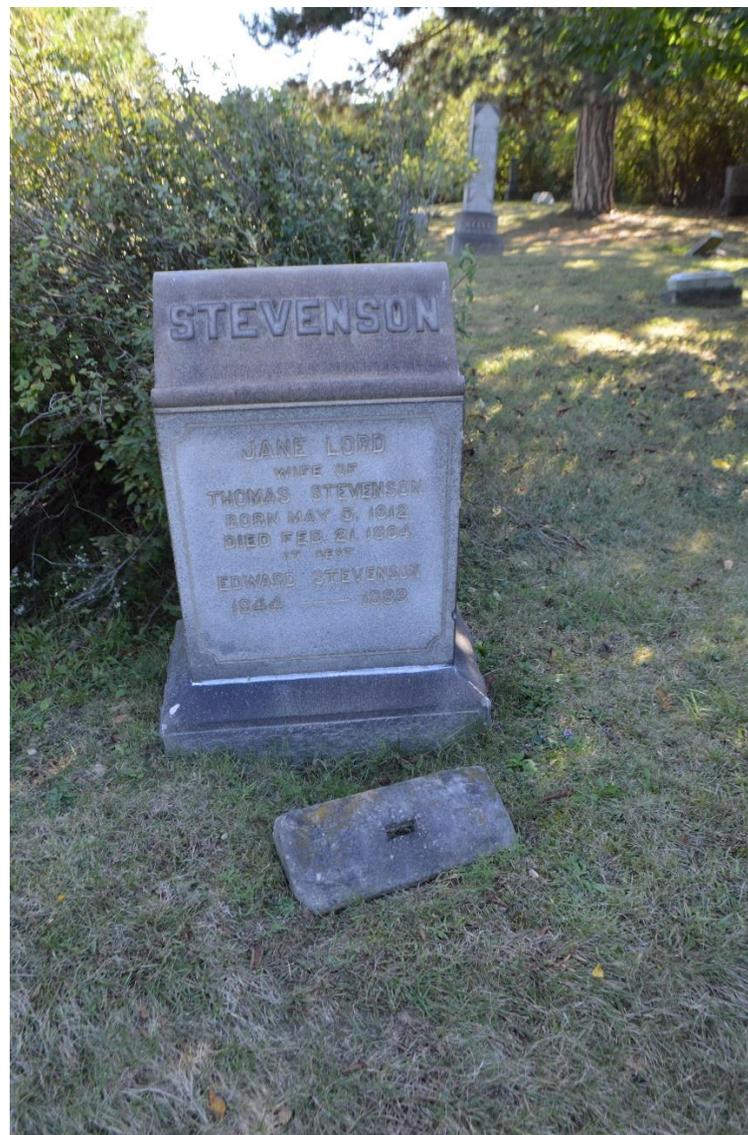
Cemetery	Warrensville West Cemetery
Location	Lee Rd., Shaker Heights, Ohio
GPS#	28
Lot #	41
Name	Stevenson, Jane Lord
Date of Death	Feb. 21, 1884
Material	granite
Marker Type	die with base
Inscription	STEVENSON/JANE LORD/WIFE OF/THOMAS STEVENSON/BORN MAY 5, 1812/DIED FEB. 21, 1884/AT REST/EDWARD STEVENSON/1844- 1883
Stone Condition	Ambient dirt, biological growth, leaning, caulk, impacted by bushes
Recommendations	Clean, treat biological growth, remove or trim bush, reset base plumb, remove caulk, reset die with lime mortar

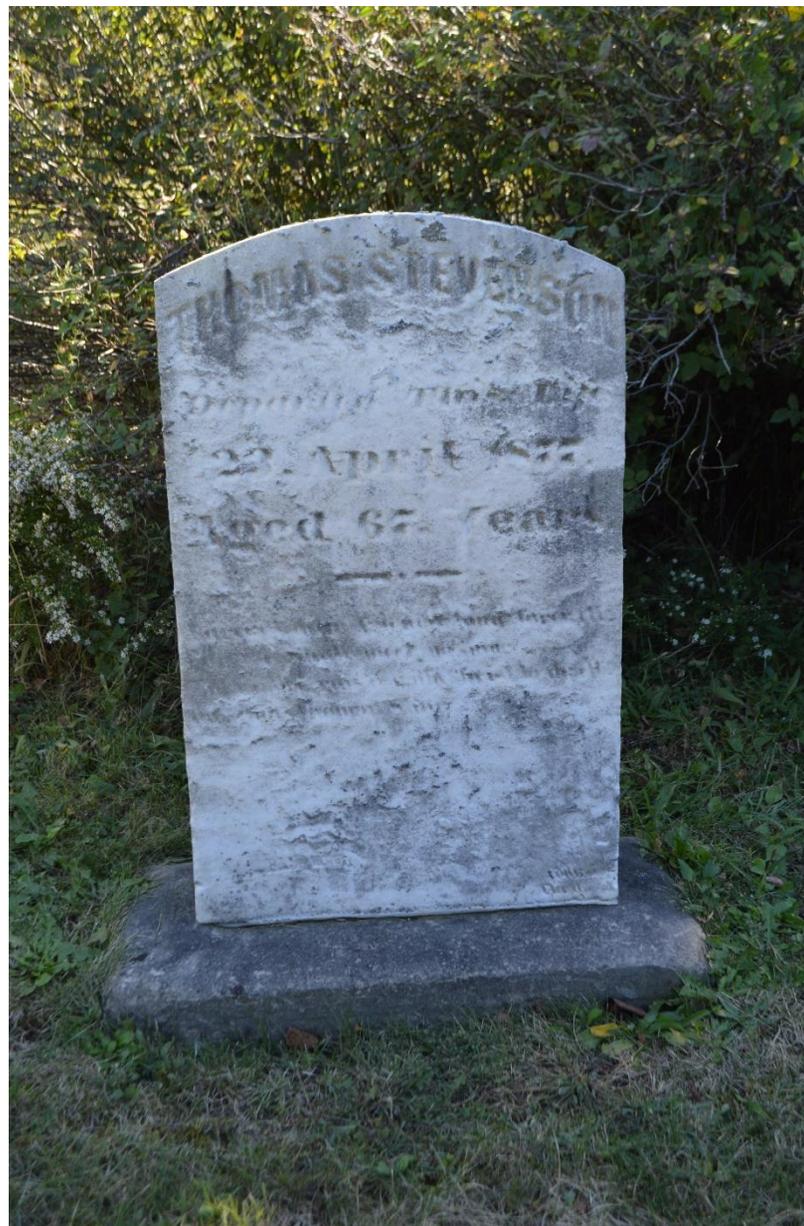
Cemetery	Warrensville West Cemetery
Location	Lee Rd., Shaker Heights, Ohio
GPS#	29
Lot #	40
Name	Stevenson, Thomas
Date of Death	April 23, 1877
Material	marble
Marker Type	tablet with base
Inscription	THOMAS STEVENSON/Departed This Life/23, April 1877/Aged 67 Years//verse//
Stone Condition	Ambient dirt, biological growth, leaning, loose in base, caulk, concrete
Recommendations	Clean, treat biological growth, reset base plumb, remove caulk, reset die with lime mortar

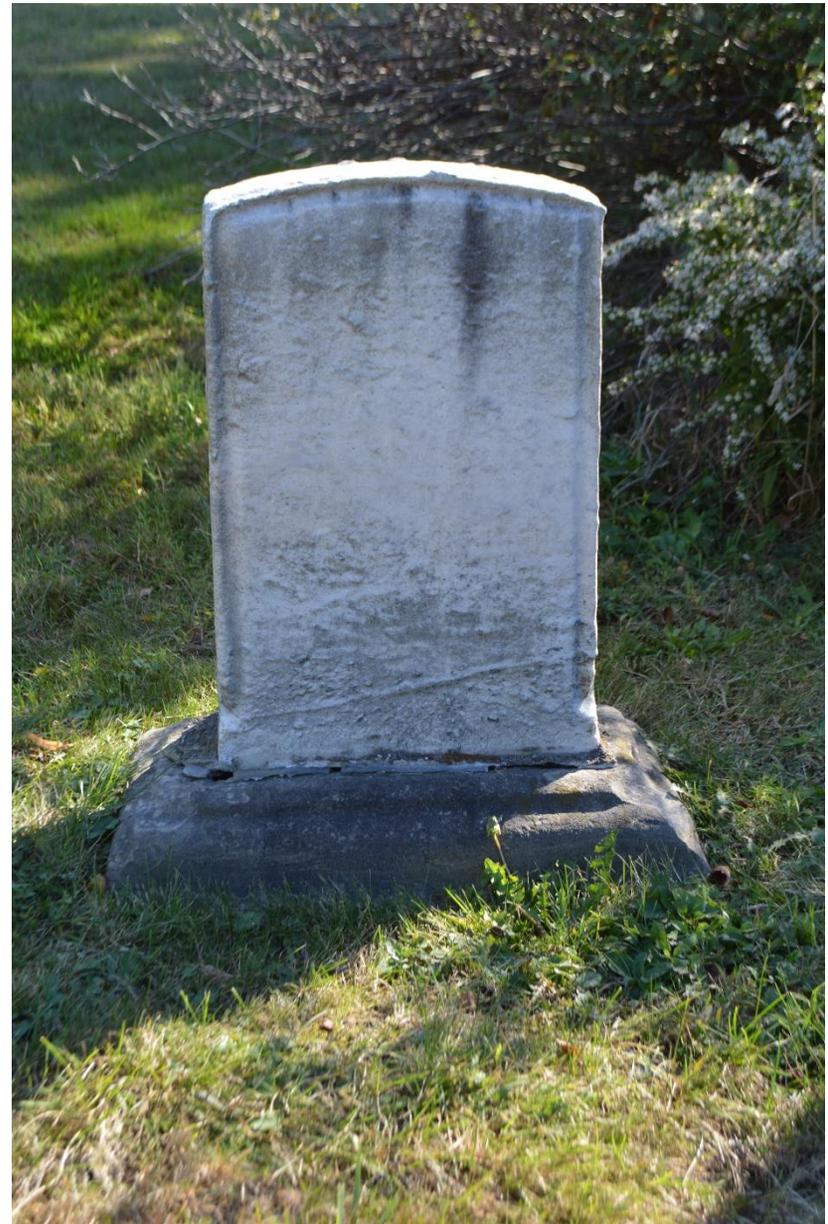
Cemetery	Warrensville West Cemetery
Location	Lee Rd., Shaker Heights, Ohio
GPS#	30
Lot #	39
Name	Stevenson, Unknown
Date of Death	
Material	marble
Marker Type	tablet with base
Inscription	Unreadable
Stone Condition	Ambient dirt, biological growth, leaning, loose in base, caulk, concrete
Recommendations	Clean, treat biological growth, reset base plumb, remove caulk, reset die with lime mortar

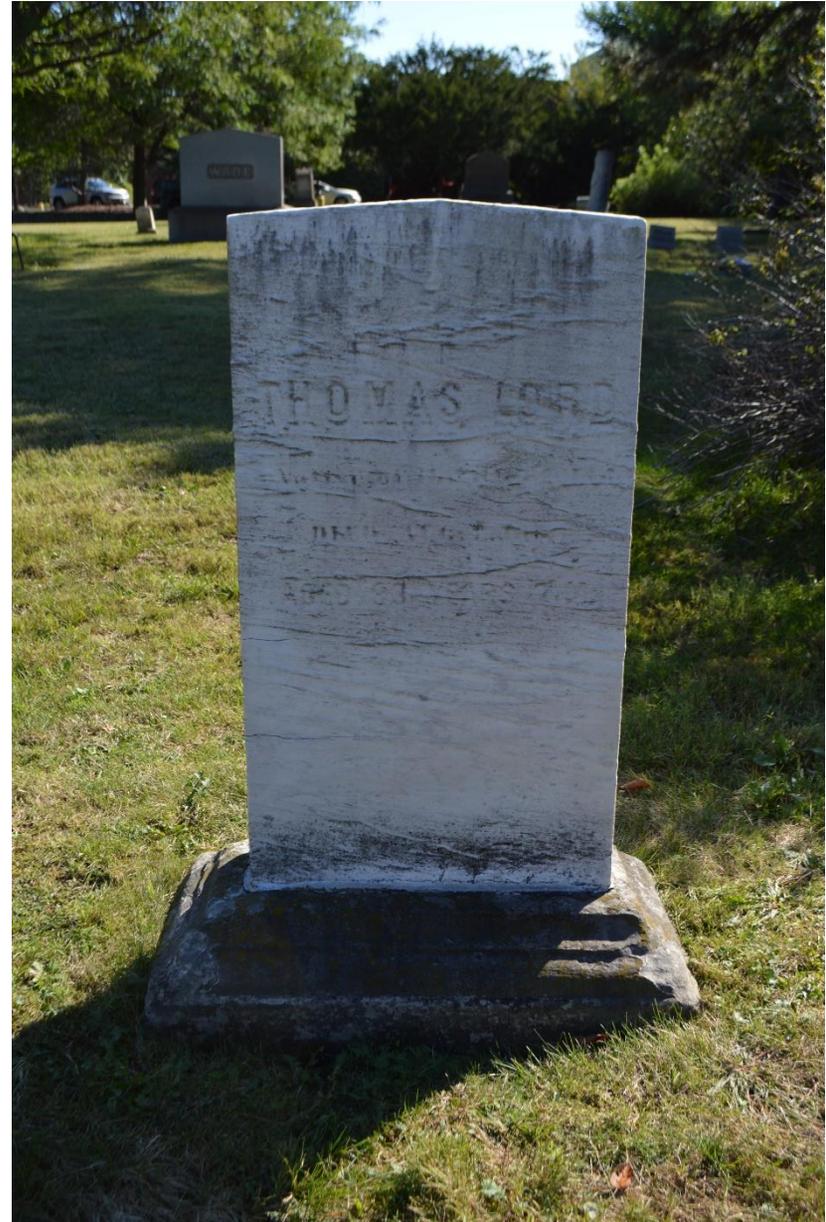
Cemetery	Warrensville West Cemetery
Location	Lee Rd., Shaker Heights, Ohio
GPS#	31
Lot #	38
Name	Lord, Thomas
Date of Death	Aug. 7, 1864
Material	marble
Marker Type	tablet with base
Inscription	Unreadable
Stone Condition	Ambient dirt, biological growth, leaning, caulk, chipped base
Recommendations	Clean, treat biological growth, reset base plumb, remove caulk, reset die with lime mortar

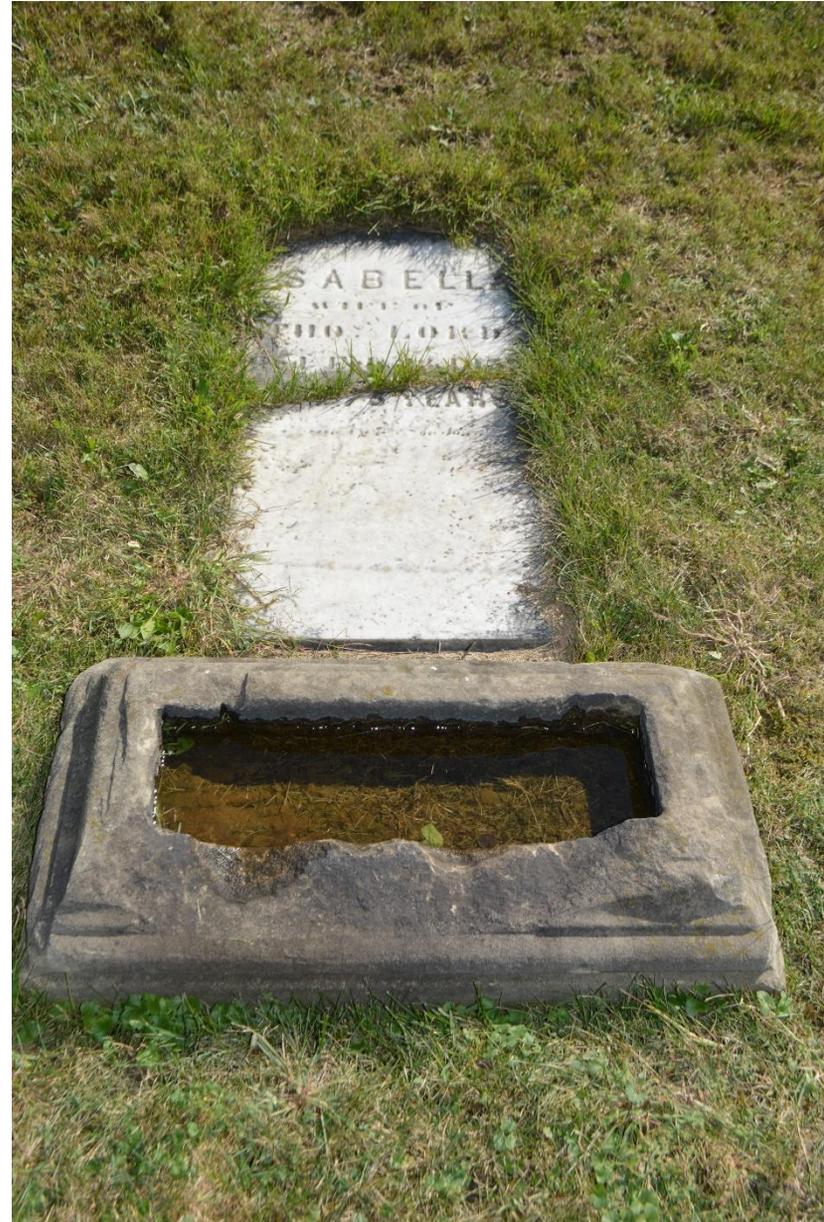
Cemetery	Warrensville West Cemetery
Location	Lee Rd., Shaker Heights, Ohio
GPS#	32
Lot #	37
Name	Lord, Isabella
Date of Death	Feb. 23, 1853
Material	marble
Marker Type	tablet with base
Inscription	ISABELLA/WIFE OF/THO. LORD/Died Feb. 23, 1853/75 YEARS
Stone Condition	Ambient dirt, biological growth, fallen, broken, 2 fragments, base broken
Recommendations	Clean, treat biological growth, reattach base fragments with restoration mortar, reset plumb, reattach fragments

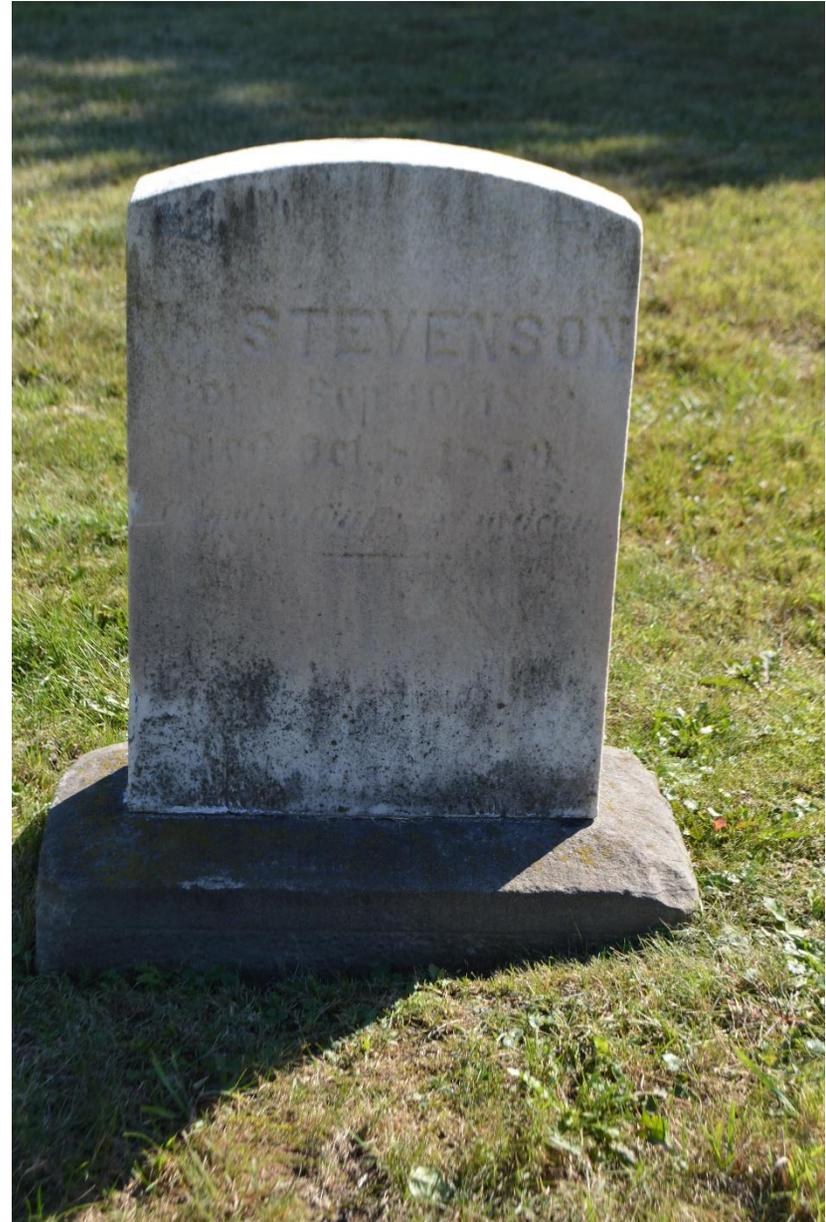
Cemetery	Warrensville West Cemetery
Location	Lee Rd., Shaker Heights, Ohio
GPS#	33
Lot #	36
Name	Stevenson, William
Date of Death	Oct. 8, 1879
Material	marble
Marker Type	die with base
Inscription	W. STEVENSON/Born Sep. 20, 1828/Died Oct. 8, 1879
Stone Condition	Ambient dirt, biological growth, leaning, caulk, sunken base
Recommendations	Clean, treat biological growth, remove caulk, reset base plumb, reset tablet with lime mortar

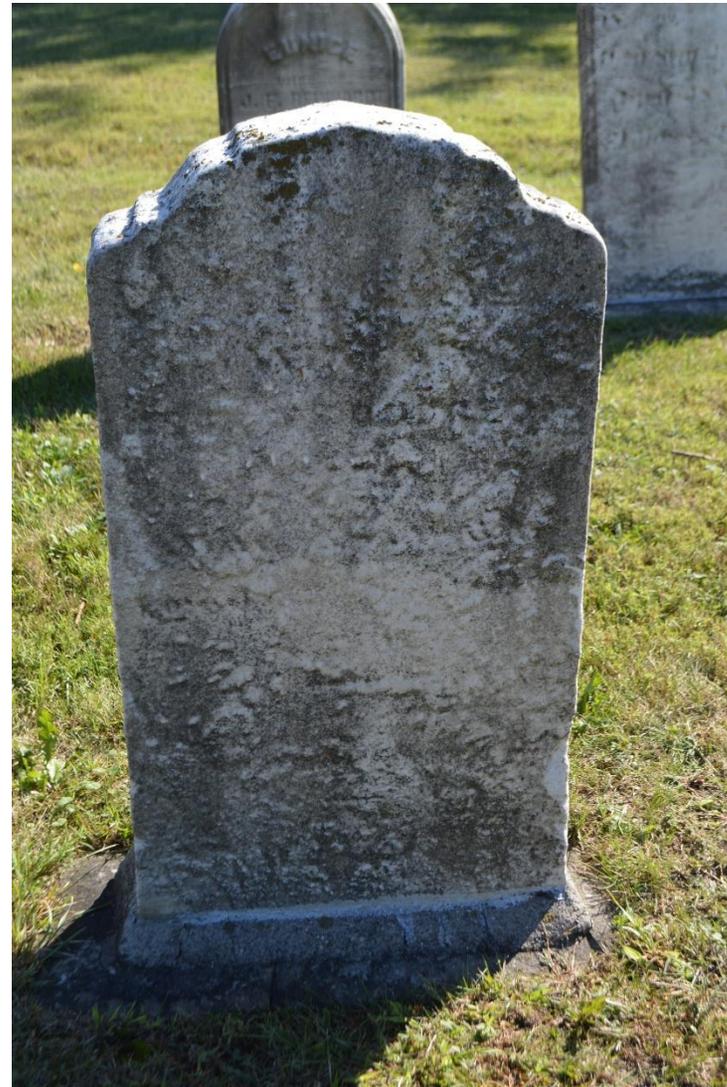
Cemetery	Warrensville West Cemetery
Location	Lee Rd., Shaker Heights, Ohio
GPS#	34
Lot #	35
Name	Dudgeon, Isabella Caley
Date of Death	May 18, 1864
Material	marble
Marker Type	die with base
Inscription	ISABELLA CALEY/WIFE OF/GEORGE DUDGEON/DIED/May 18, 1864/Aged 33 Yrs.
Stone Condition	Ambient dirt, biological growth, leaning, caulk, concrete, mower damage
Recommendations	Clean, treat biological growth, remove caulk & concrete, reset base plumb, reset tablet with lime mortar

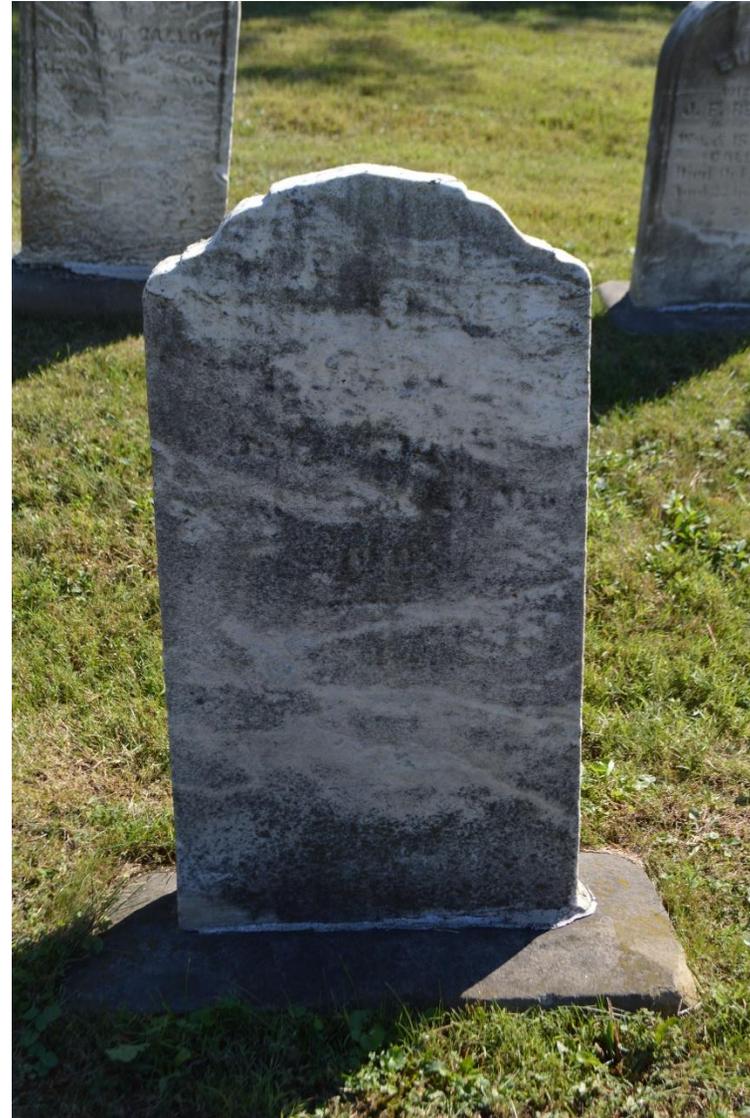
Cemetery	Warrensville West Cemetery
Location	Lee Rd., Shaker Heights, Ohio
GPS#	35
Lot #	34
Name	Caley, Thomas
Date of Death	July 6, 1867
Material	marble
Marker Type	tablet with base
Inscription	THOMAS CALEY/DIED/July 6, 1867/Aged 66 Yrs. 3 Ms.
Stone Condition	Ambient dirt, biological growth, leaning, sunken base, caulk, concrete
Recommendations	Clean, treat biological growth, remove caulk & concrete, reset base plumb, reset tablet with lime mortar

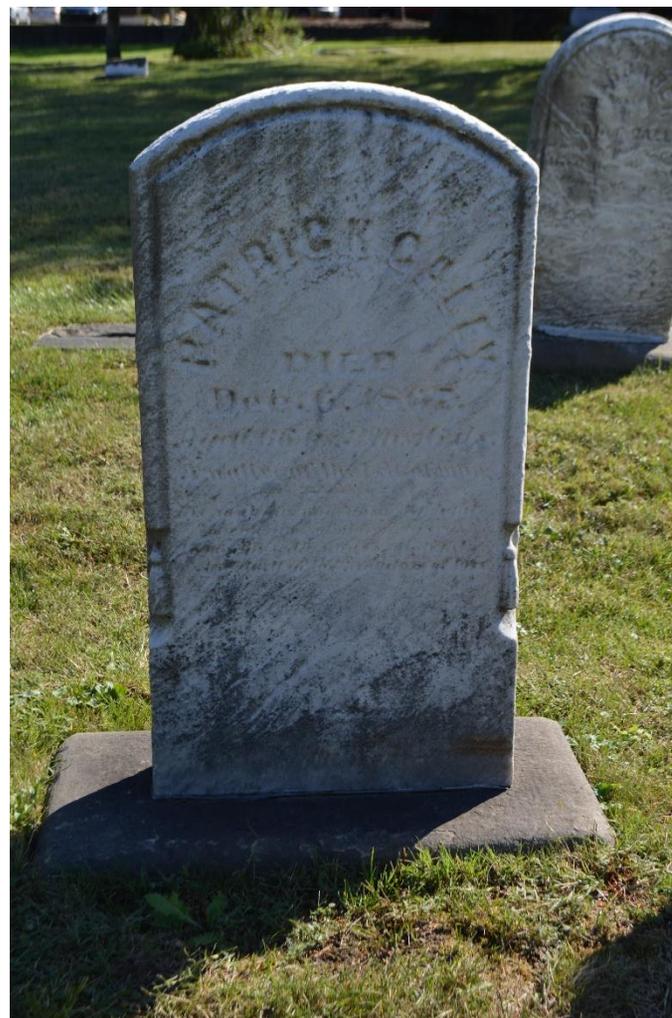
Cemetery	Warrensville West Cemetery
Location	Lee Rd., Shaker Heights, Ohio
GPS#	36
Lot #	33
Name	Caley, Patrick
Date of Death	Dec. 6, 1867
Material	marble
Marker Type	tablet with base
Inscription	PATRICK CALEY/DIED/Dec. 6, 1867/Aged 66 Yrs. 3 Ms.//verse//
Stone Condition	Ambient dirt, biological growth, leaning, sunken base, caulk, concrete
Recommendations	Clean, treat biological growth, remove caulk & concrete, reset base plumb, reset tablet with lime mortar

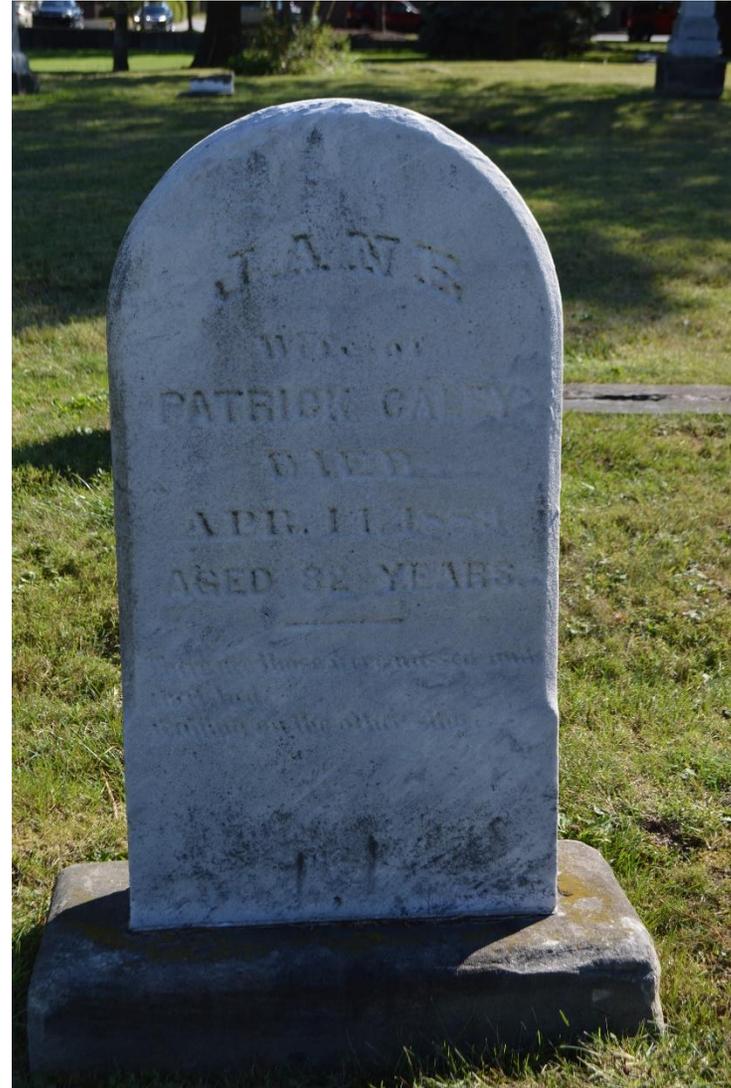
Cemetery Location	Warrensville West Cemetery Lee Rd., Shaker Heights, Ohio
GPS#	37
Lot #	32
Name	Caley, Jane
Date of Death	April 14, 1883
Material	marble
Marker Type	tablet with base
Inscription	JANE CALEY/Wife of/PATRICK CALEY/DIED/APR. 14, 1883/Aged 82 YEARS//verse//
Stone Condition	Ambient dirt, biological growth, caulk, missing mortar
Recommendations	Clean, treat biological growth, remove caulk, re-point tablet with lime mortar

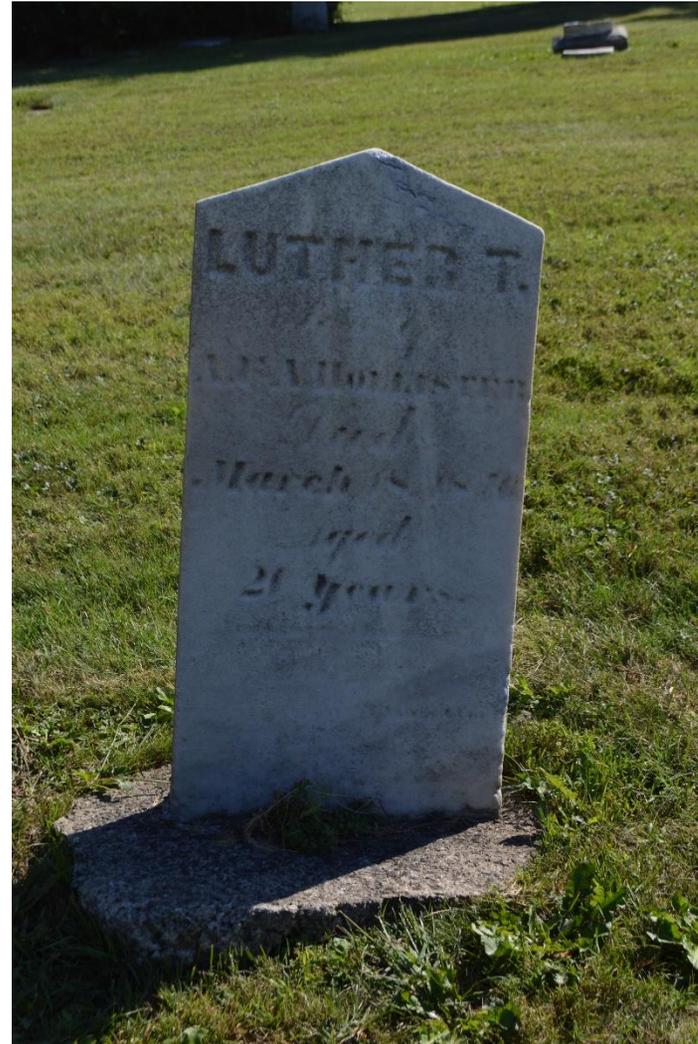
Cemetery	Warrensville West Cemetery
Location	Lee Rd., Shaker Heights, Ohio
GPS#	38
Lot #	31
Name	Hollister, Luther T.
Date of Death	March 18, 1840
Material	marble
Marker Type	tablet
Inscription	LUTHER T./son of/A & A Hollister/Died/March 18, 1840/Aged/21 Years
Stone Condition	Ambient dirt, biological growth, leaning, concrete
Recommendations	Clean, treat biological growth, remove concrete, reset tablet plumb at correct height

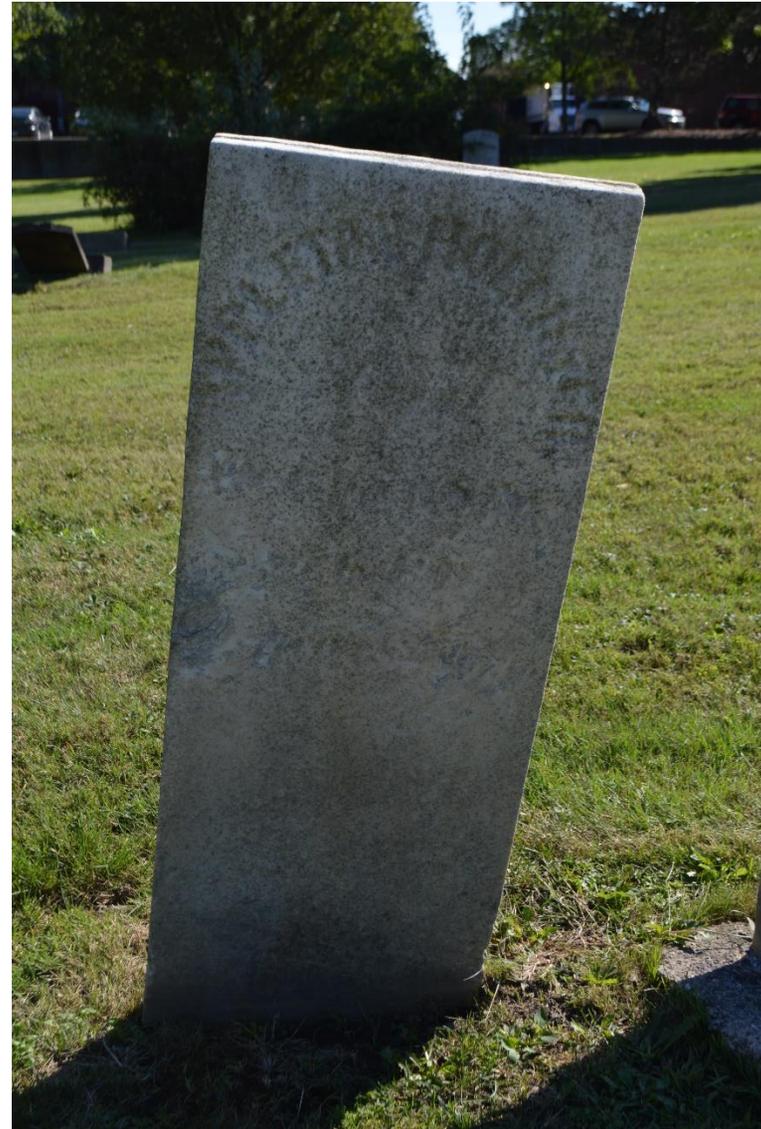
Cemetery	Warrensville West Cemetery
Location	Lee Rd., Shaker Heights, Ohio
GPS#	39
Lot #	30
Name	Hollister, Appleton
Date of Death	Dec. 15, 1831
Material	marble
Marker Type	tablet
Inscription	APPLETON HOLLISTER/Died/Dec.15,1831/AGED/ 69 Years 2 M
Stone Condition	Ambient dirt, biological growth, leaning, tilted
Recommendations	Clean, treat biological growth, reset tablet plumb at correct height

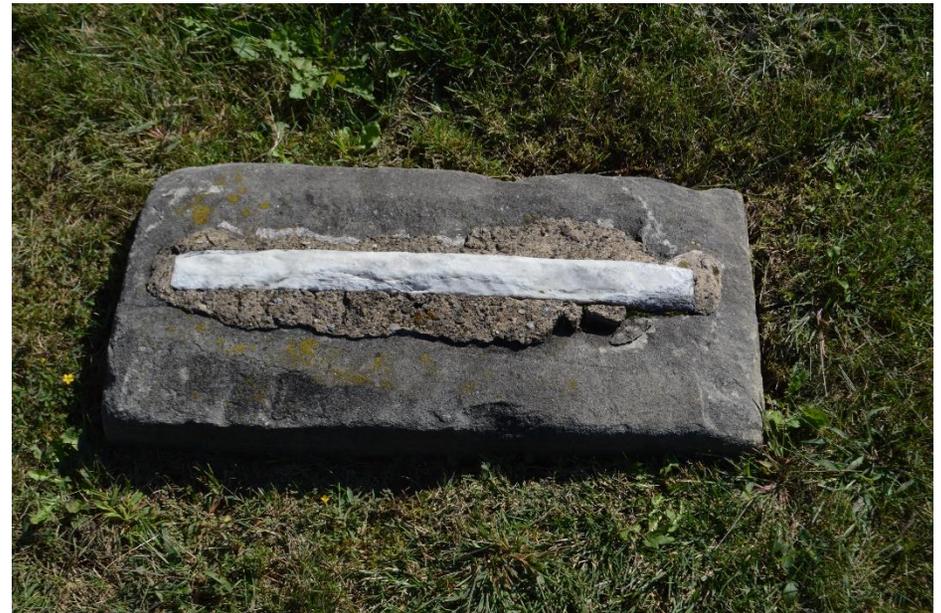
Concrete with fragment encased, missing
stone

Locate stone

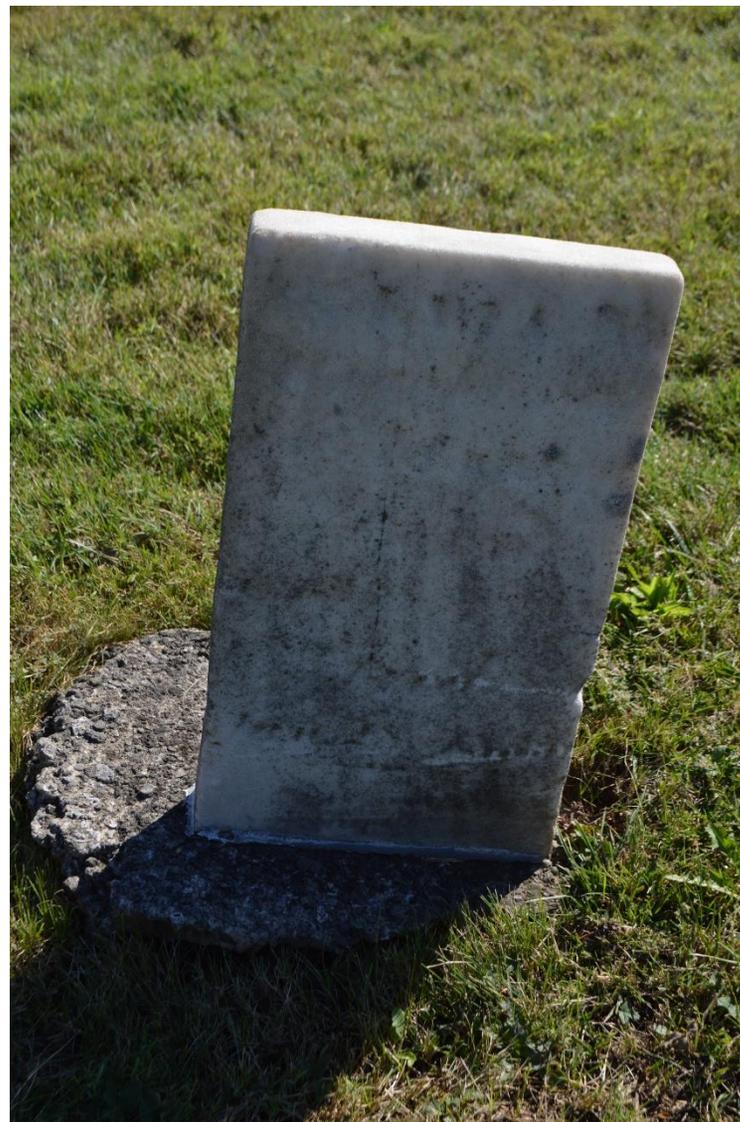
Cemetery	Warrensville West Cemetery
Location	Lee Rd., Shaker Heights, Ohio
GPS#	42
Lot #	27
Name	Conkey, Laura
Date of Death	Oct. 29, 1834
Material	marble
Marker Type	tablet
Inscription	LAURA/Daughter of/Jacob & Ama/ Conkey/Born Aug. 12, 1827/Died/Oct. 29, 1834
Stone Condition	Ambient dirt, biological growth, leaning, sunken base, caulk, concrete
Recommendations	Clean, treat biological growth, remove concrete, reset tablet plumb at correct height

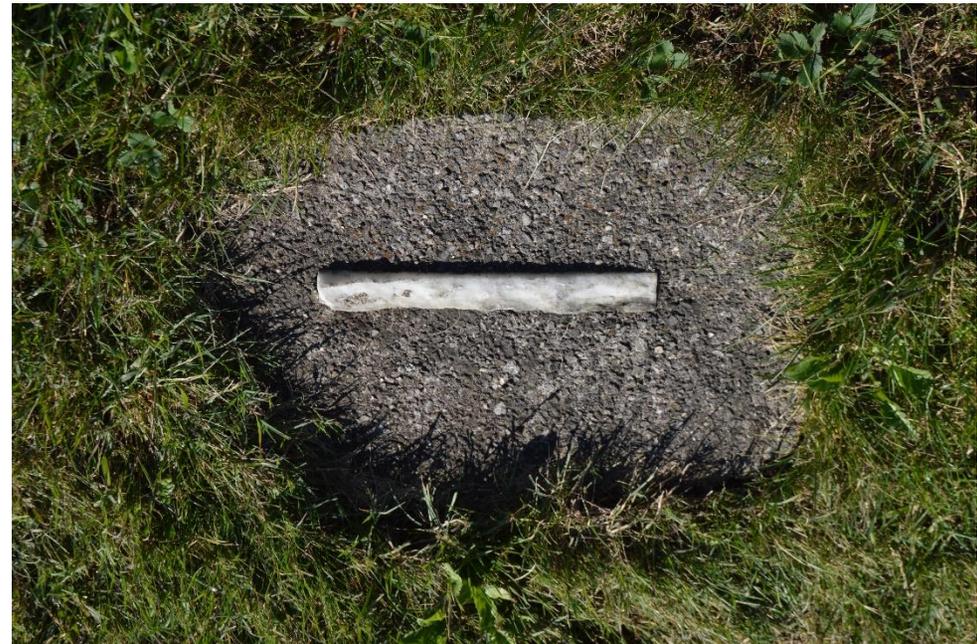
Stone Condition
Concrete with stone fragment, missing
stone

Recommendations
Locate Stone

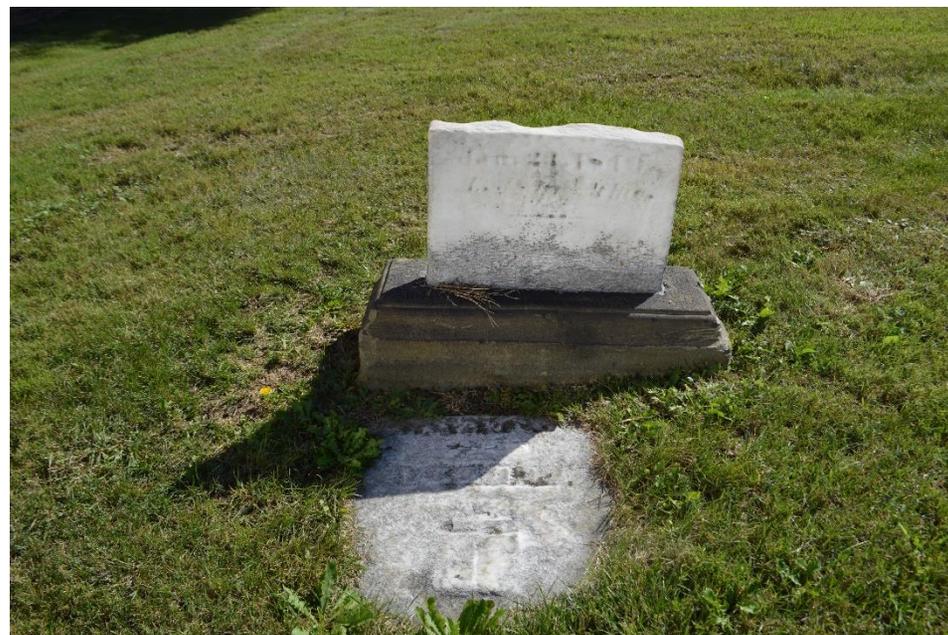
Cemetery	Warrensville West Cemetery
Location	Lee Rd., Shaker Heights, Ohio
GPS#	44
Lot #	44
Name	Beach, Electa
Date of Death	Jan. 21, 1841
Material	marble
Marker Type	tablet with base
Inscription	ELECTA/WIFE OF/S.P.BEACH/DIED/Jan. 21, 1841
Stone Condition	Ambient dirt, biological growth, fallen, broken, 2 fragments, caulk, sugaring of fragment
Recommendations	Clean, treat biological growth, remove caulk, reset tablet plumb at correct height, reattach fragment

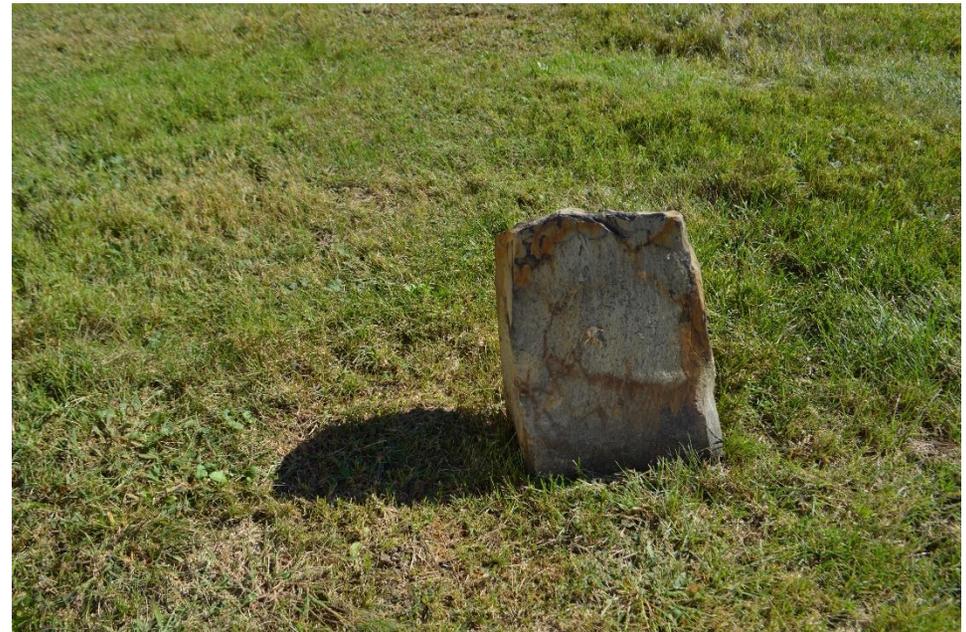
Stone Condition
Ambient dirt, biological growth, leaning,
surface cracks

Recommendations
Clean, treat biological growth, reset
tablet plumb at correct height, fill cracks

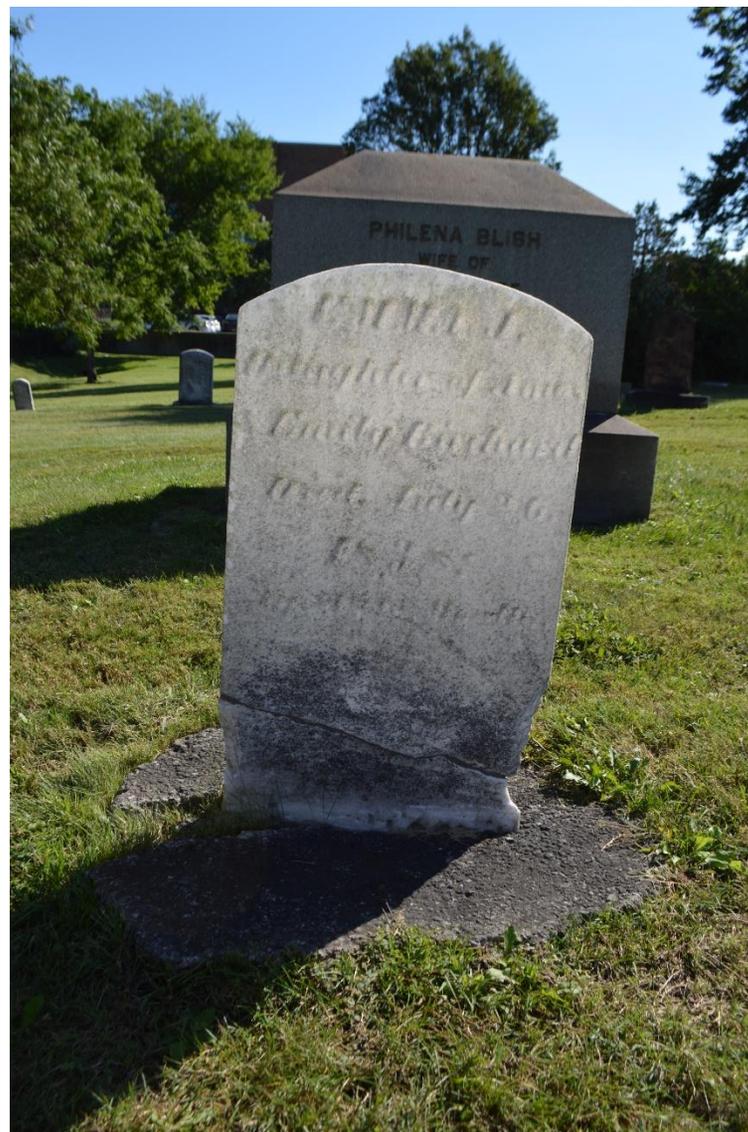
Cemetery	Warrensville West Cemetery
Location	Lee Rd., Shaker Heights, Ohio
GPS#	47
Lot #	47
Name	Burchard, Emma J.
Date of Death	July 26, 1838
Material	marble
Marker Type	tablet
Inscription	EMMA J./Daughter of Amos/& Emily Burchard/Died July 26/1838/Aged 6 month
Stone Condition	Ambient dirt, biological growth, leaning, broken - old repair, concrete
Recommendations	Clean, treat biological growth, remove concrete, reset tablet plumb at correct height, fill cracks

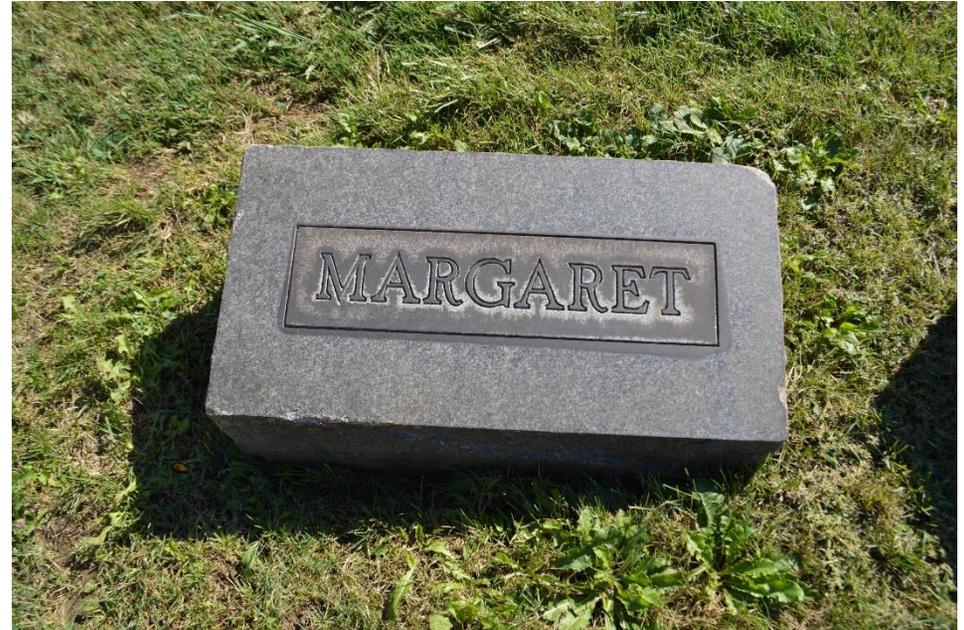
Cemetery	Warrensville West Cemetery
Location	Lee Rd., Shaker Heights, Ohio
GPS#	48A
Lot #	49
Name	Corlett, Margaret
Date of Death	
Material	granite
Marker Type	marker
Inscription	MARGARET
Stone Condition	Ambient dirt, biological growth, sunken corner
Recommendations	Clean, treat biological growth, reset tablet plumb at correct height
