final report
**WARRENSVILLE WEST
CEMETERY**
HISTORIC PRESERVATION MASTER PLAN

COMPLETED 03-14-2022

**SHAKER
HEIGHTS**

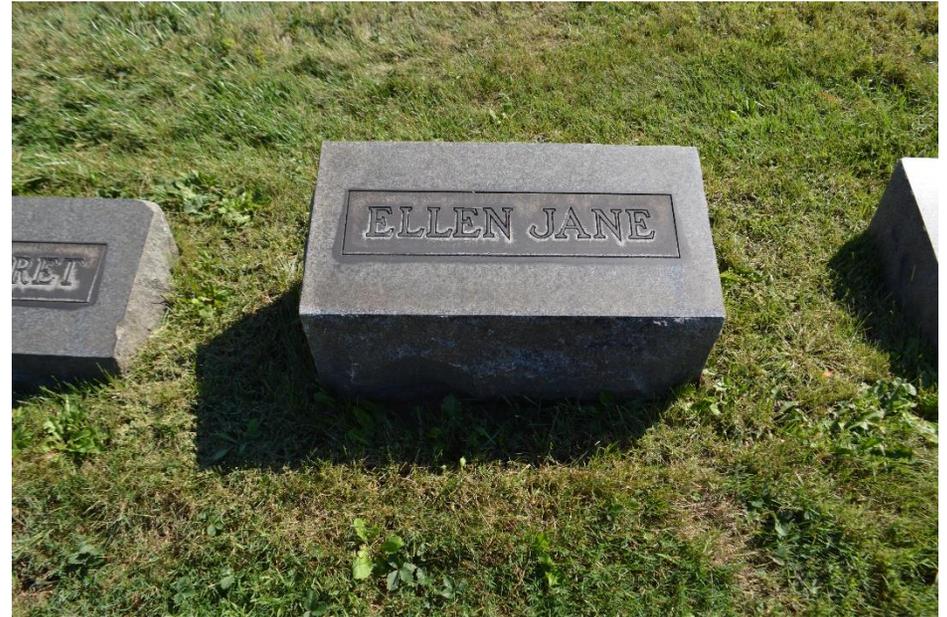
Cemetery	Warrensville West Cemetery
Location	Lee Rd., Shaker Heights, Ohio
GPS#	48B
Lot #	50
Name	Corlett, Ellen Jane
Date of Death	
Material	granite
Marker Type	marker
Inscription	ELLEN JANE
Stone Condition	Ambient dirt, biological growth, good condition
Recommendations	Clean, treat biological growth

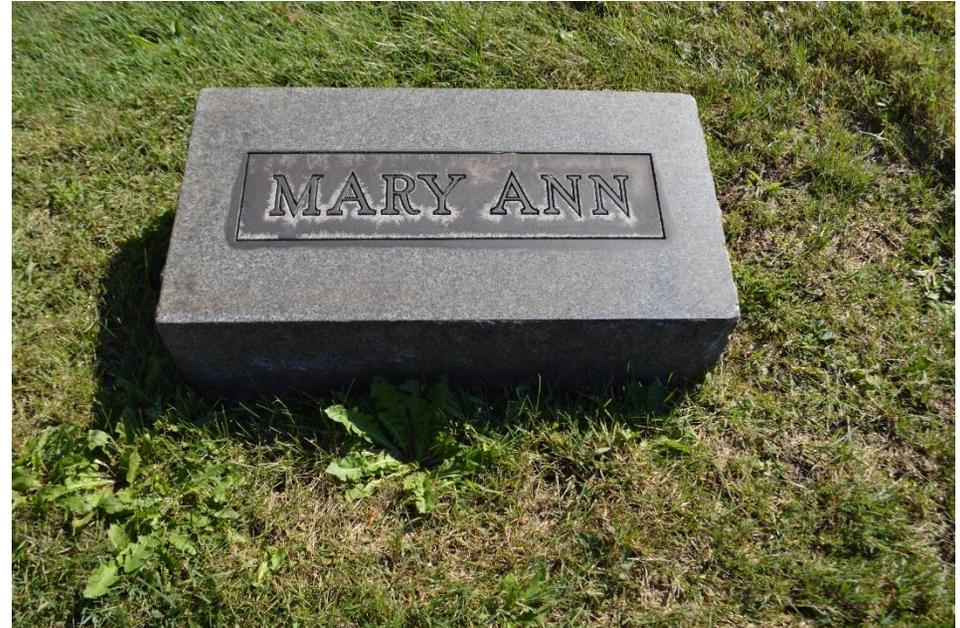
Cemetery	Warrensville West Cemetery
Location	Lee Rd., Shaker Heights, Ohio
GPS#	48C
Lot #	51
Name	Corlett, Mary Ann
Date of Death	
Material	granite
Marker Type	marker
Inscription	MARY ANN
Stone Condition	Ambient dirt, biological growth, good condition
Recommendations	Clean, treat biological growth

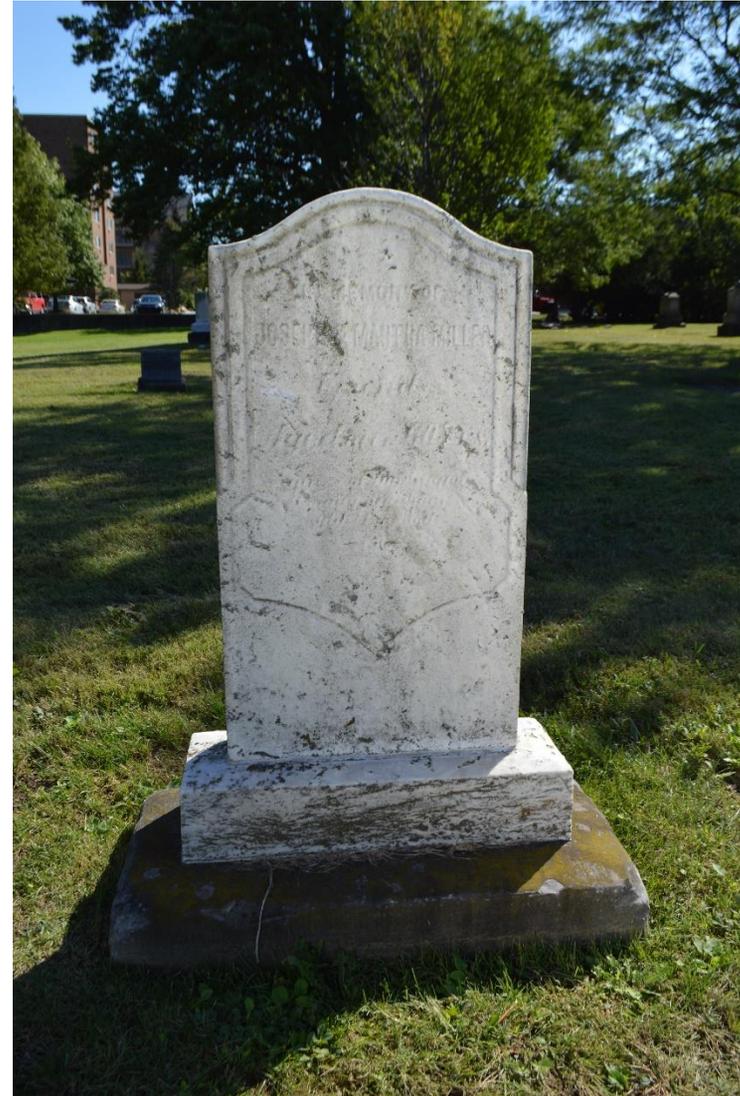
Cemetery	Warrensville West Cemetery
Location	Lee Rd., Shaker Heights, Ohio
GPS#	49
Lot #	52
Name	Miller, Joseph & Martha
Date of Death	
Material	marble
Marker Type	die with base
Inscription	IN MEMORY OF/JOSEPH & MARTHA MILLER/Friends/Aged over 60 Yrs.
Stone Condition	Ambient dirt, biological growth, caulk residue
Recommendations	Clean, treat biological growth, remove caulk

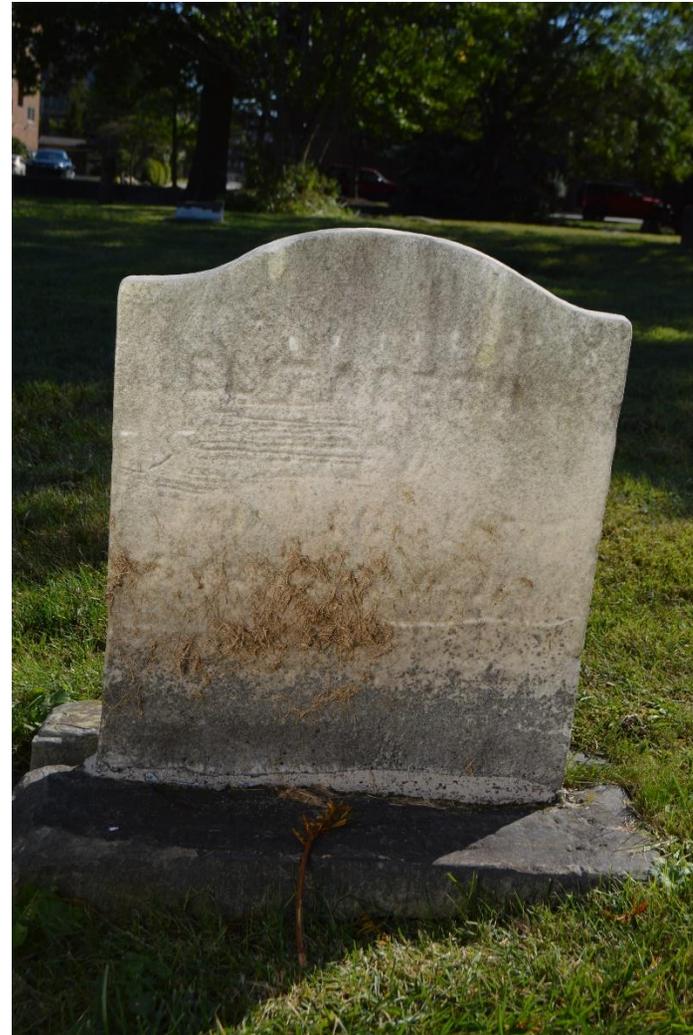
Cemetery	Warrensville West Cemetery
Location	Lee Rd., Shaker Heights, Ohio
GPS#	50
Lot #	53
Name	Elizabeth
Date of Death	
Material	marble
Marker Type	tablet with base
Inscription	ELIZABETH
Stone Condition	Ambient dirt, biological growth, leaning & loose, broken base, concrete
Recommendations	Clean, treat biological growth, remove concrete, reset base plumb, reset tablet with lime mortar

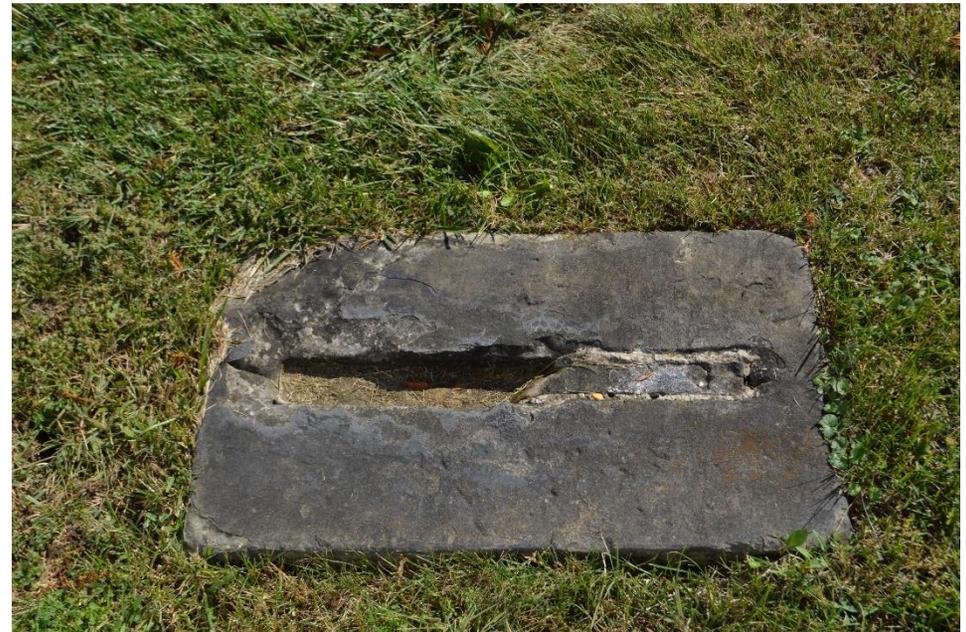
Cemetery	Warrensville West Cemetery
Location	Lee Rd., Shaker Heights, Ohio
GPS#	51
Lot #	54
Name	Callow, William
Date of Death	
Material	marble
Marker Type	tablet with base
Inscription	
Stone Condition	Base with stone fragment, missing stone
Recommendations	Locate stone

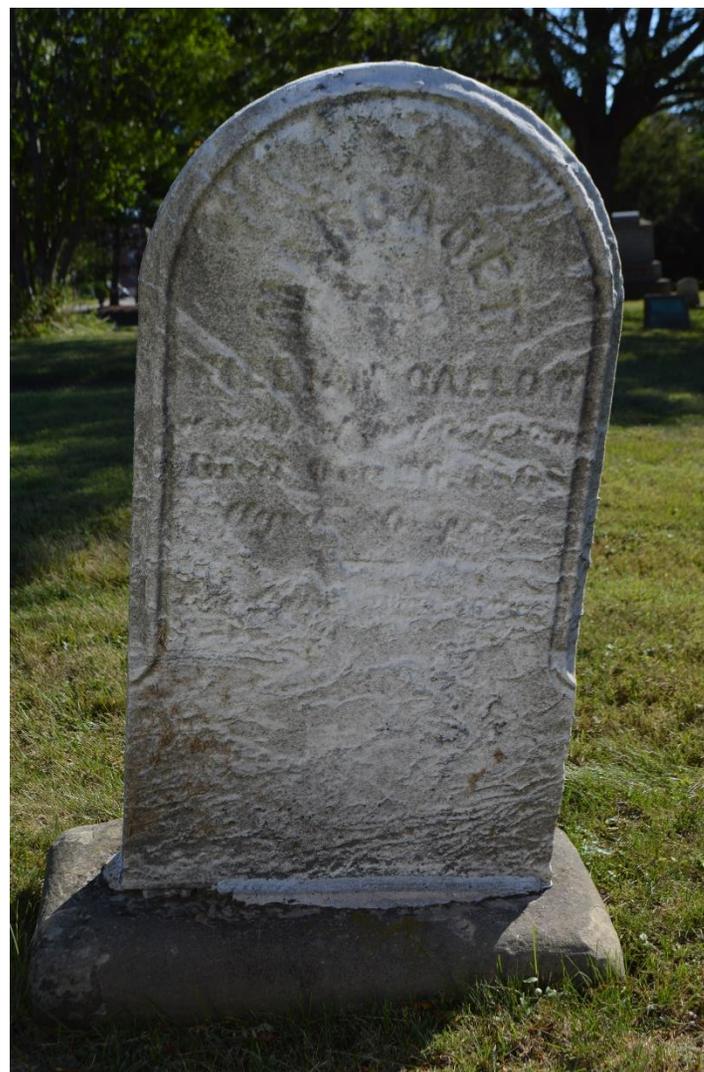
Cemetery	Warrensville West Cemetery
Location	Lee Rd., Shaker Heights, Ohio
GPS#	52
Lot #	55
Name	Callow, Margaret
Date of Death	Oct. 26, 1868
Material	marble
Marker Type	tablet with base
Inscription	MARGARET/WIFE/OF/WILLIAM CALLOW/of the Isle of Man/Died Oct. 26,1868/Aged 86 Yrs.
Stone Condition	Ambient dirt, biological growth, leaning, sunken base, caulk, concrete
Recommendations	Clean, treat biological growth, remove caulk & concrete, reset base plumb, reset tablet with lime mortar

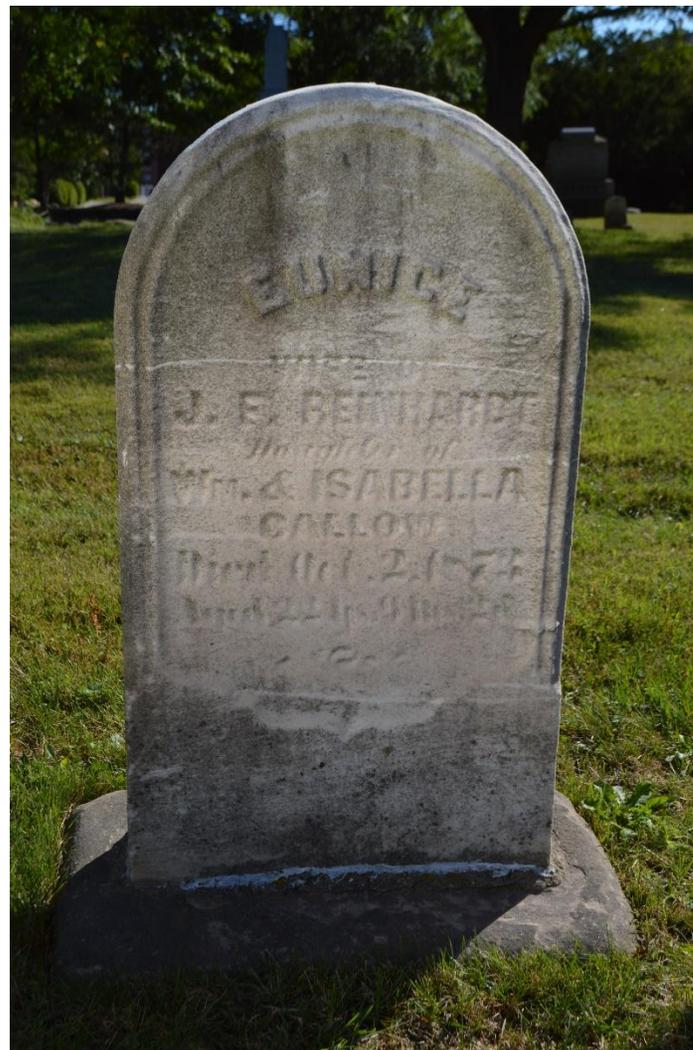
Cemetery	Warrensville West Cemetery
Location	Lee Rd., Shaker Heights, Ohio
GPS#	53
Lot #	56
Name	Reinhart, Eunice Callow
Date of Death	Oct. 2, 1873
Material	marble
Marker Type	tablet with base
Inscription	EUNICE/WIFE OF/J.F. REINHART/daughter of/WM. & ISABELLA/CALLOW/Died Oct. 2, 1873/Aged 22 Yrs. 9 Ms. 2 d.
Stone Condition	Ambient dirt, biological growth, leaning, sunken base, caulk, concrete
Recommendations	Clean, treat biological growth, remove caulk & concrete, reset base plumb, reset tablet with lime mortar

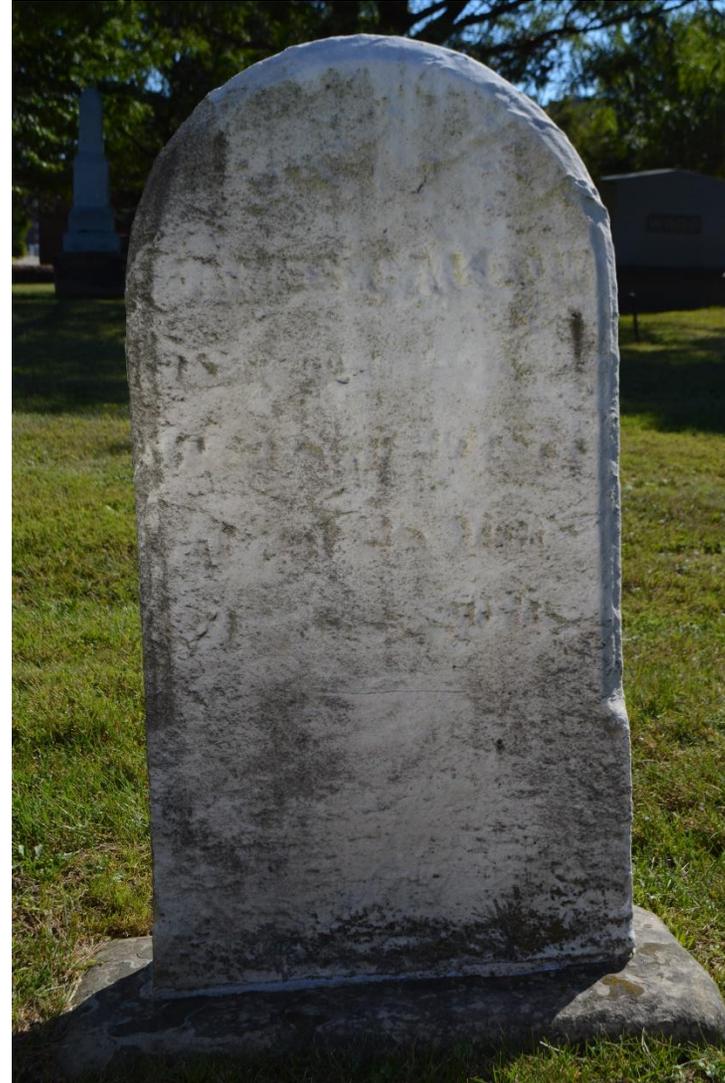
Cemetery	Warrensville West Cemetery
Location	Lee Rd., Shaker Heights, Ohio
GPS#	54
Lot #	57
Name	Callow, James
Date of Death	Sept. 29, 1877
Material	marble
Marker Type	tablet with base
Inscription	JAMES CALLOW/Died Sept. 29, 1877/Aged 28 Years
Stone Condition	Ambient dirt, biological growth, leaning, sunken base, caulk, concrete
Recommendations	Clean, treat biological growth, remove caulk & concrete, reset base plumb, reset tablet with lime mortar

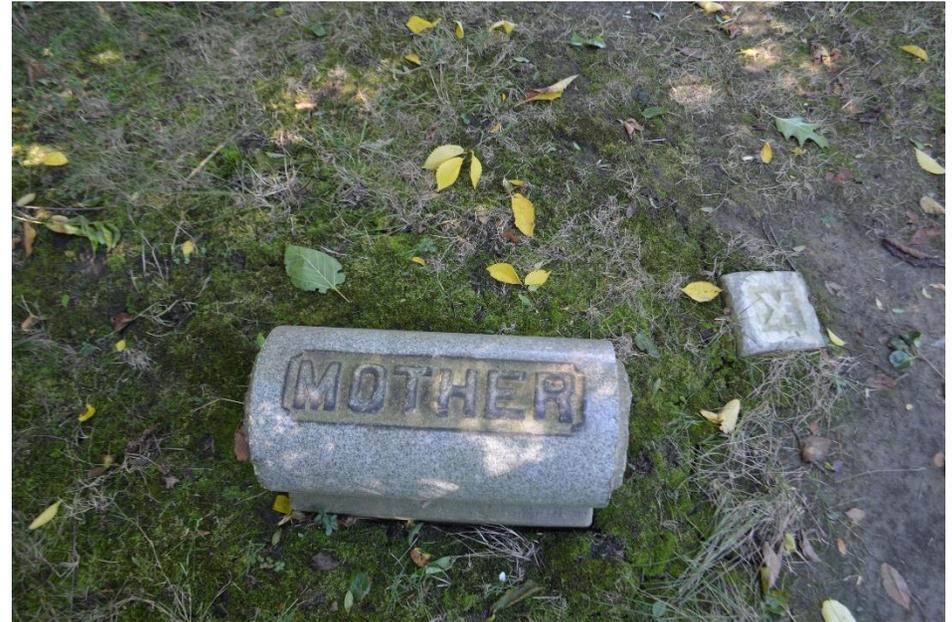
Cemetery	Warrensville West Cemetery
Location	Lee Rd., Shaker Heights, Ohio
GPS#	56A
Lot #	67
Name	Mother
Date of Death	
Material	granite
Marker Type	cylinder
Inscription	MOTHER
Stone Condition	Ambient dirt, biological growth, leaning, impacted by bushes
Recommendations	Clean, treat biological growth, remove or trim trees, reset base plumb, remove caulk, reset die with lime mortar

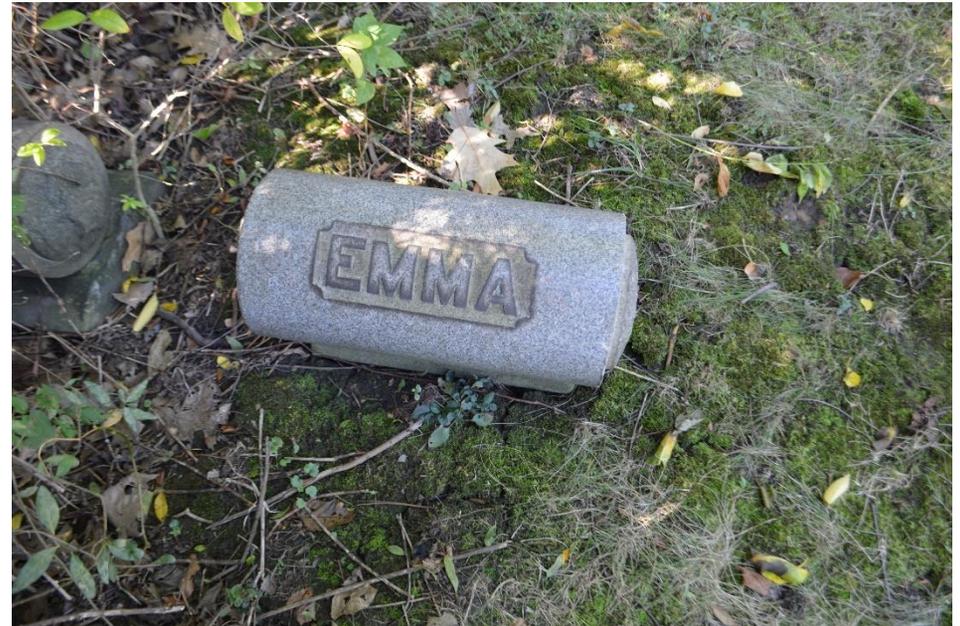
Cemetery	Warrensville West Cemetery
Location	Lee Rd., Shaker Heights, Ohio
GPS#	56B
Lot #	68
Name	Emma
Date of Death	
Material	granite
Marker Type	cylinder
Inscription	EMMA
Stone Condition	Ambient dirt, biological growth, leaning, impacted by bushes
Recommendations	Clean, treat biological growth, remove or trim trees, reset base plumb, remove caulk, reset die with lime mortar

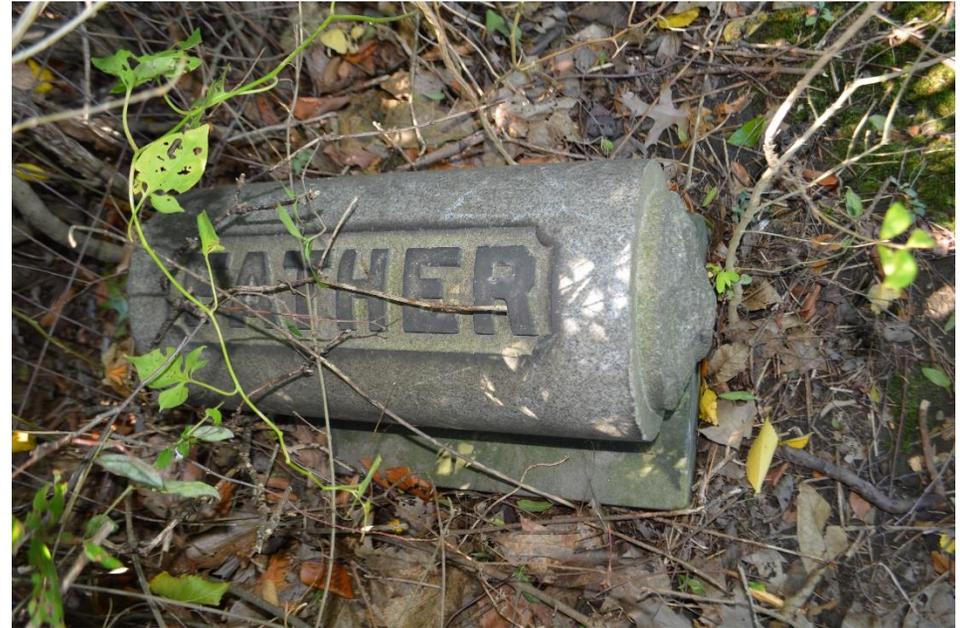
Cemetery	Warrensville West Cemetery
Location	Lee Rd., Shaker Heights, Ohio
GPS#	56C
Lot #	69
Name	Father
Date of Death	
Material	granite
Marker Type	cylinder
Inscription	FATHER
Stone Condition	Ambient dirt, biological growth, leaning, impacted by bushes
Recommendations	Clean, treat biological growth, remove or trim trees, reset base plumb, remove caulk, reset die with lime mortar

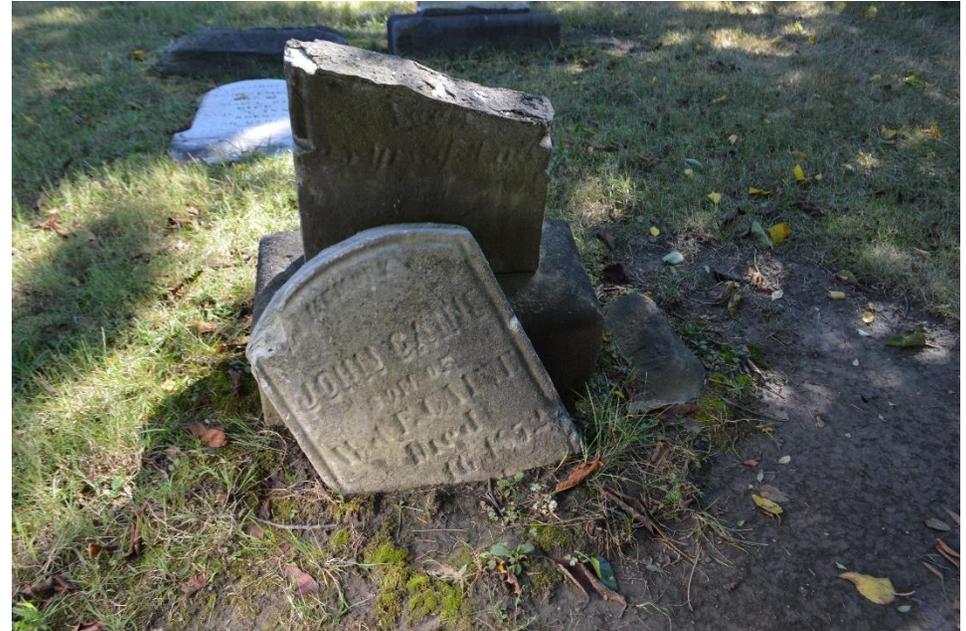
Ambient dirt, biological growth, fallen,
broken, 2 fragments, concrete residue,
failed repair

Clean, treat biological growth, reset base
plumb, remove concrete, reset die with
lime mortar, reattach fragments

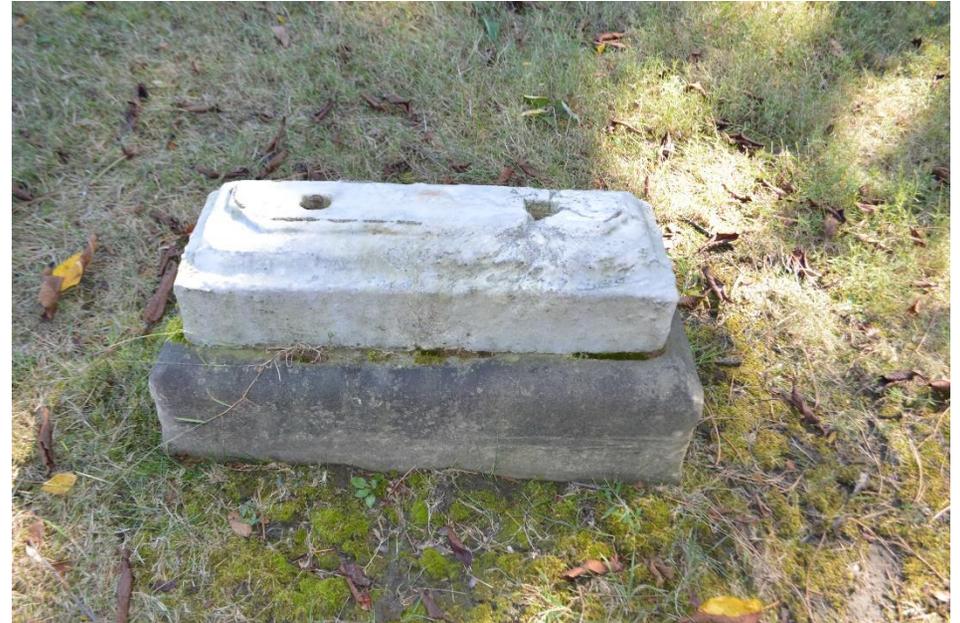
Stone Condition
Missing die, cracks in plinth

Recommendations
Locate stone

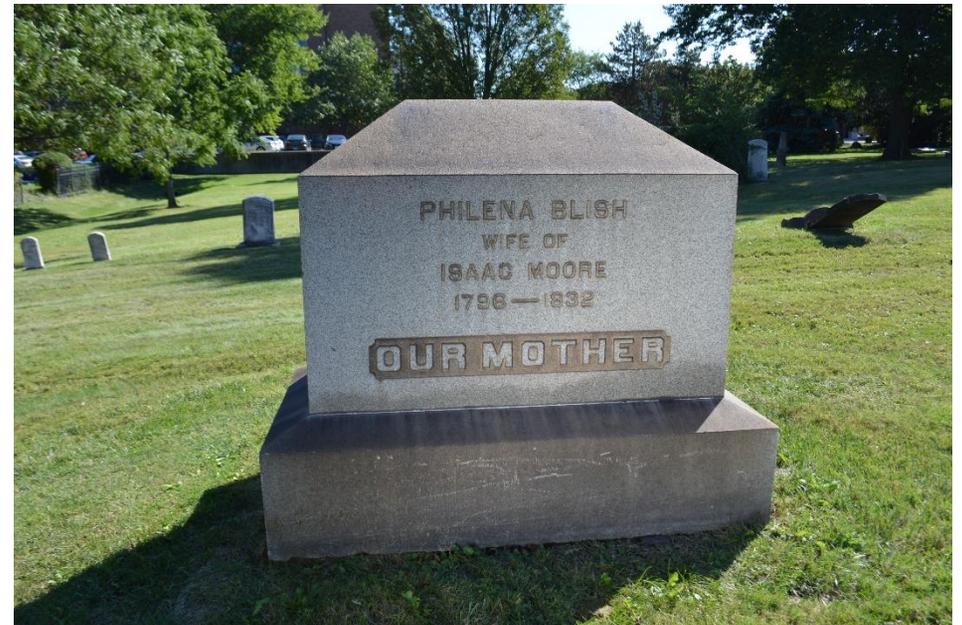
Stone Condition
Ambient dirt, biological growth, good
condition

Recommendations
Clean, treat biological growth

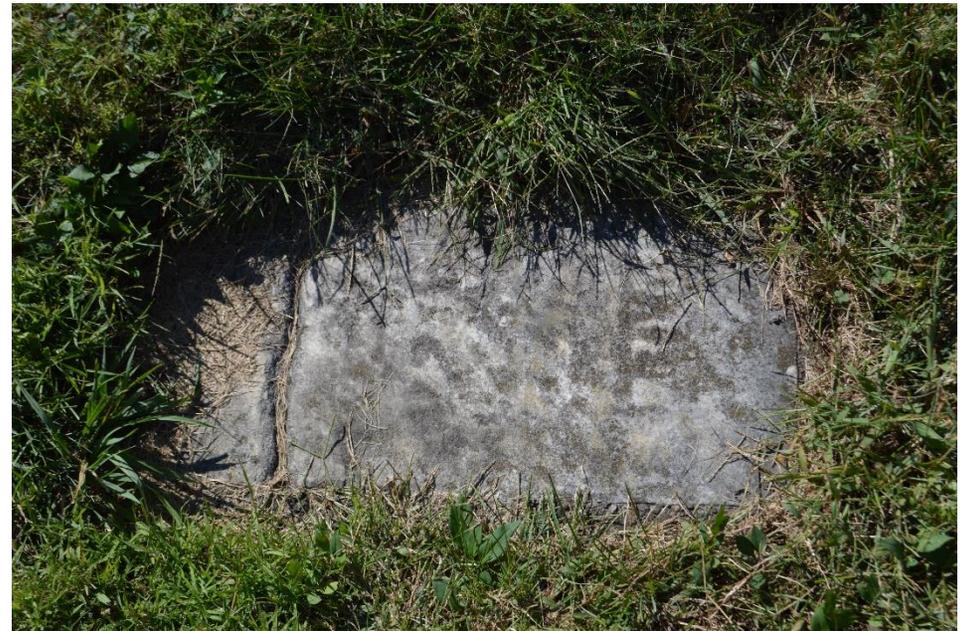
Stone Condition Ambient dirt, biological growth, set flat
into concrete

Recommendations Clean, treat biological growth, reset
tablet at correct height to prevent
flooding

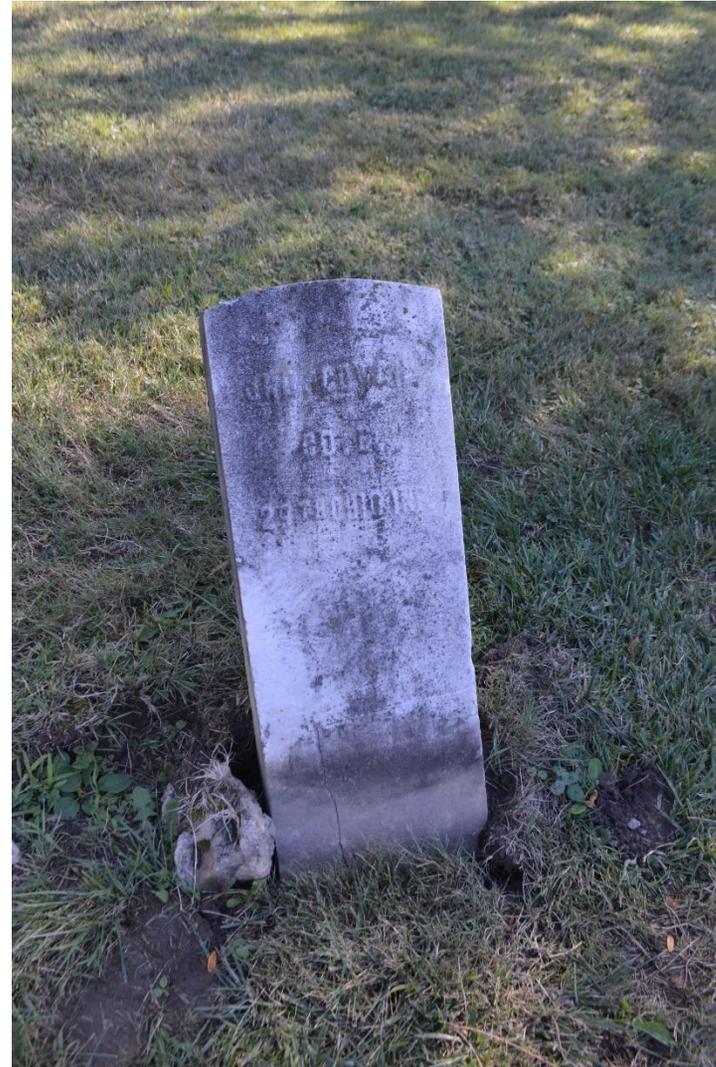
Ambient dirt, biological growth, leaning, concrete rubble, surface cracks

Clean, treat biological growth, remove rubble, reset plumb at correct height

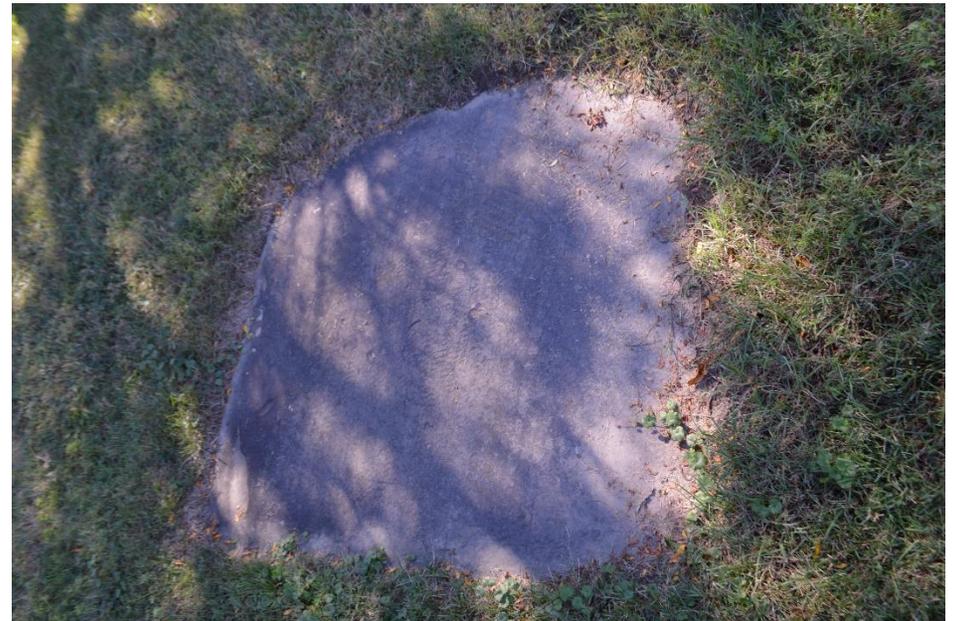
Missing die/monument

Locate stone

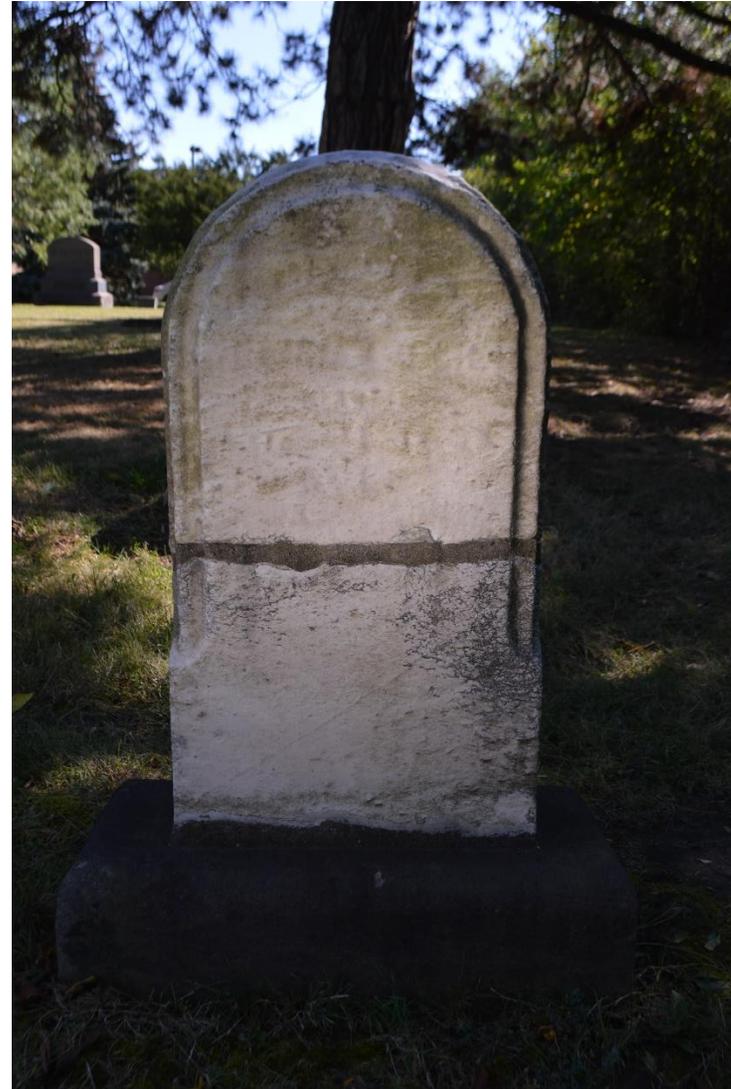
Ambient dirt, biological growth,
concrete, old repair, sugaring, caulk

Clean, treat biological growth, remove
concrete & caulk, reset base plumb, reset
die with lime mortar

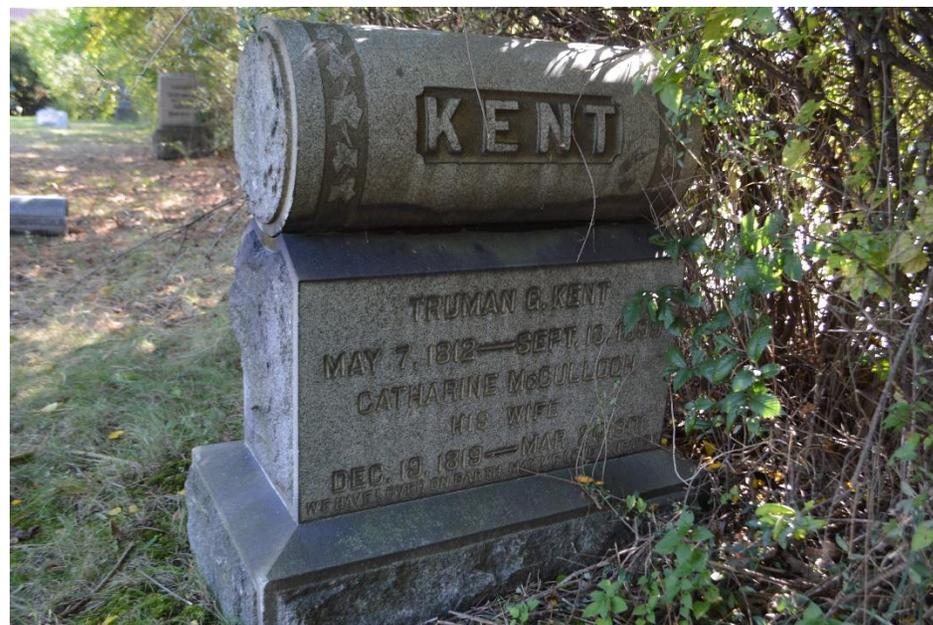
Cemetery	Warrensville West Cemetery
Location	Lee Rd., Shaker Heights, Ohio
GPS#	65
Lot #	73
Name	Kent, Truman & Catherine
Date of Death	Sept. 13, 1899 & March 21, 1901
Material	granite
Marker Type	die with base
Inscription	KENT/TRUMAN G. KENT/MAY 7, 1812 – SEPT. 13, 1899/CATHARINE McCULLOCH/HIS WIFE/DEC. 19, 1819 – MAR. 21, 1901/WE HAVE LOVED ON EARTH MAY WE LOVE IN HEAVEN//EMMA J. KENT/1845- 1910
Stone Condition	Ambient dirt, biological growth, leaning, tilted, impacted by bushes
Recommendations	Clean, treat biological growth, remove bushes, reset base plumb, reset die with lime mortar

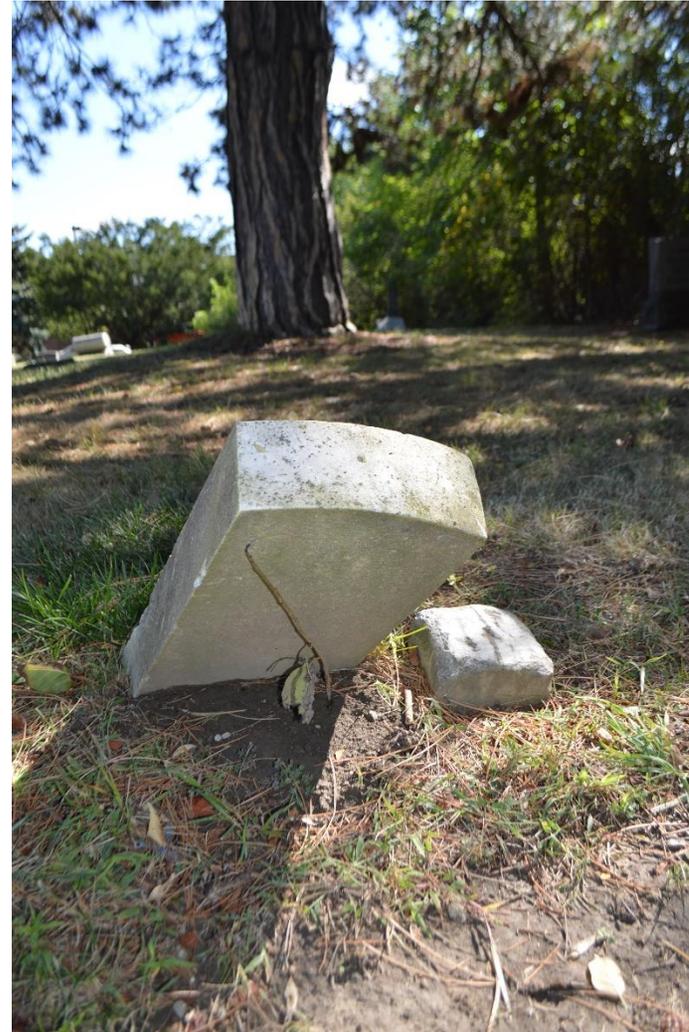
Cemetery	Warrensville West Cemetery
Location	Lee Rd., Shaker Heights, Ohio
GPS#	66
Lot #	88
Name	Kelley, E.T.
Date of Death	
Material	marble
Marker Type	veteran tablet
Inscription	CORP'L/E.T. KELLEY/CO.A./7TH OHIO INF.
Stone Condition	Ambient dirt, biological growth, leaning, sunken
Recommendations	Clean, treat biological growth, reset plumb at correct height

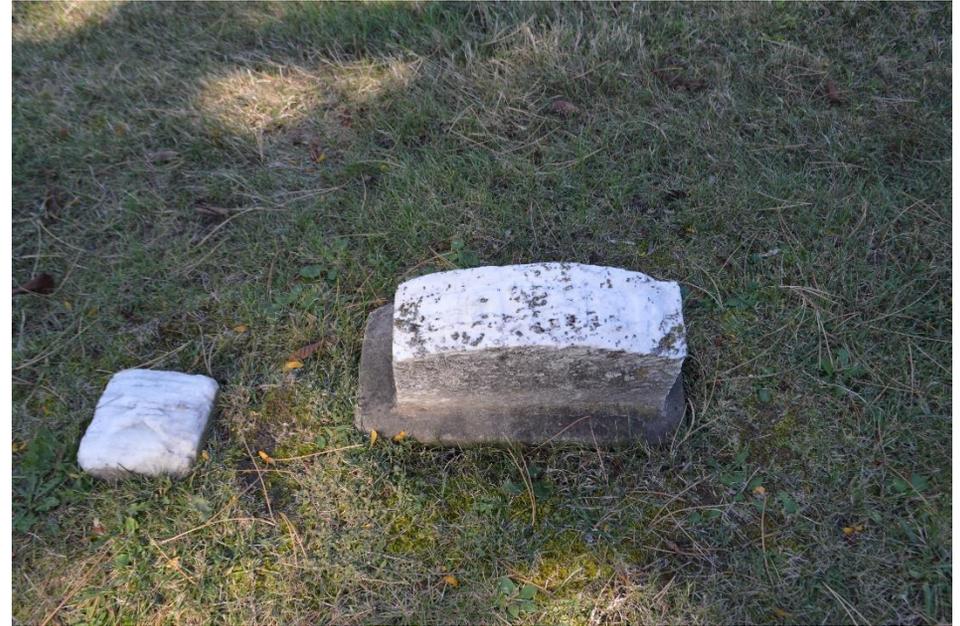
Cemetery	Warrensville West Cemetery
Location	Lee Rd., Shaker Heights, Ohio
GPS#	67A
Lot #	86
Name	Mother
Date of Death	
Material	marble
Marker Type	die with base
Inscription	MOTHER
Stone Condition	Ambient dirt, biological growth, leaning, sunken, concrete
Recommendations	Clean, treat biological growth, remove concrete, reset die with lime mortar

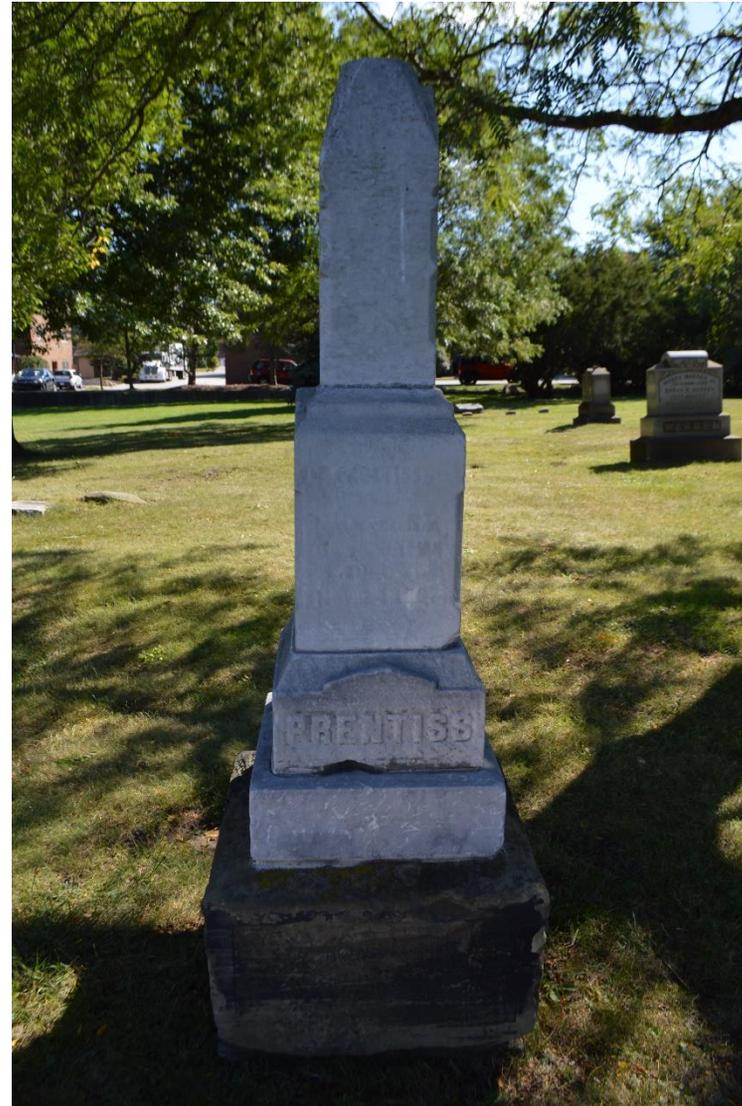
Cemetery	Warrensville West Cemetery
Location	Lee Rd., Shaker Heights, Ohio
GPS#	68
Lot #	98
Name	Prentiss, L.R. & Abigail
Date of Death	July 20, 1897
Material	marble
Marker Type	obelisk
Inscription	PRENTISS/L.R. PRENTISS/BORN ACKWORTH, NH/JULY 20, 1803/DIED/NOV. 24, 1897//ABIGAIL
Stone Condition	Ambient dirt, biological growth, leaning, missing mortar
Recommendations	Clean, treat biological growth, reset base plumb, reassemble with lime mortar

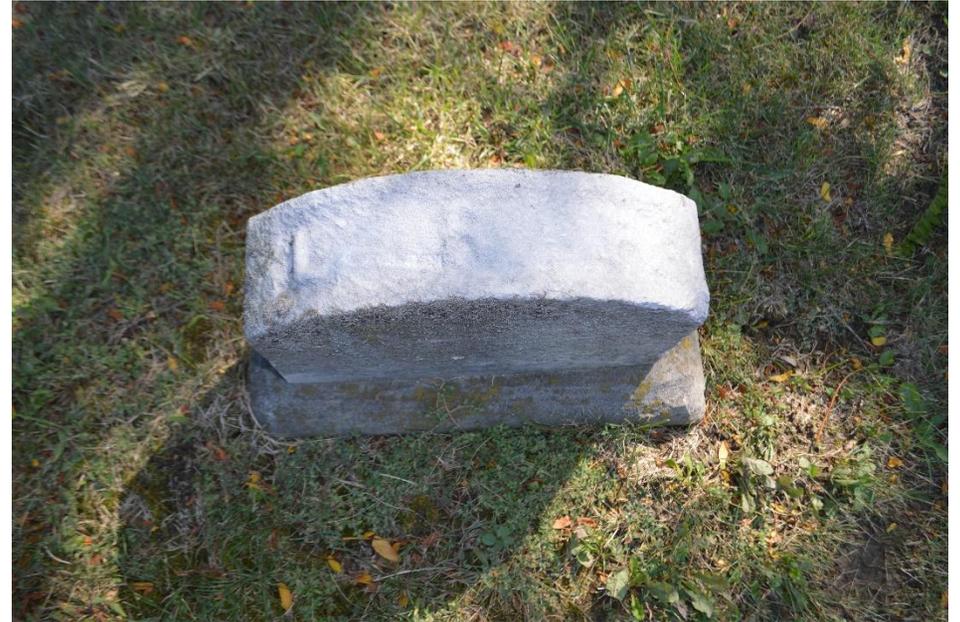
Cemetery	Warrensville West Cemetery
Location	Lee Rd., Shaker Heights, Ohio
GPS#	68A
Lot #	85
Name	Prentiss, L.R.
Date of Death	
Material	marble
Marker Type	die with base
Inscription	L.R.P.
Stone Condition	Ambient dirt, biological growth, leaning, tilted, pins, missing mortar
Recommendations	Clean, treat biological growth, remove concrete, reset die with lime mortar

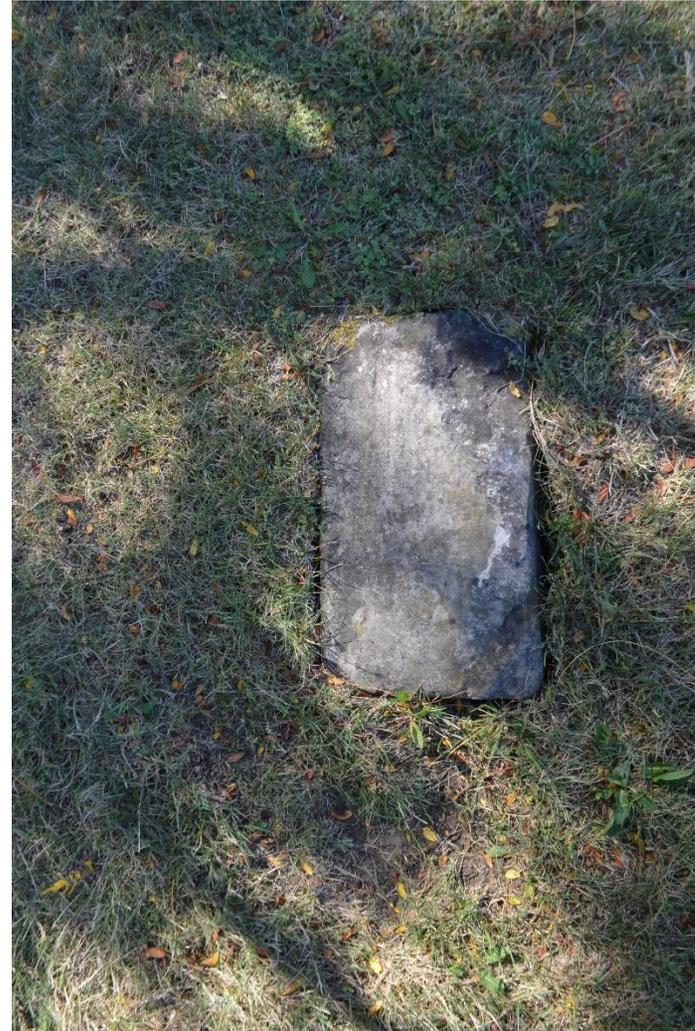
Stone Condition
Ambient dirt, biological growth, fallen base, stone may be under grass

Recommendations
Clean, treat biological growth, reset base plumb, reset die with lime mortar

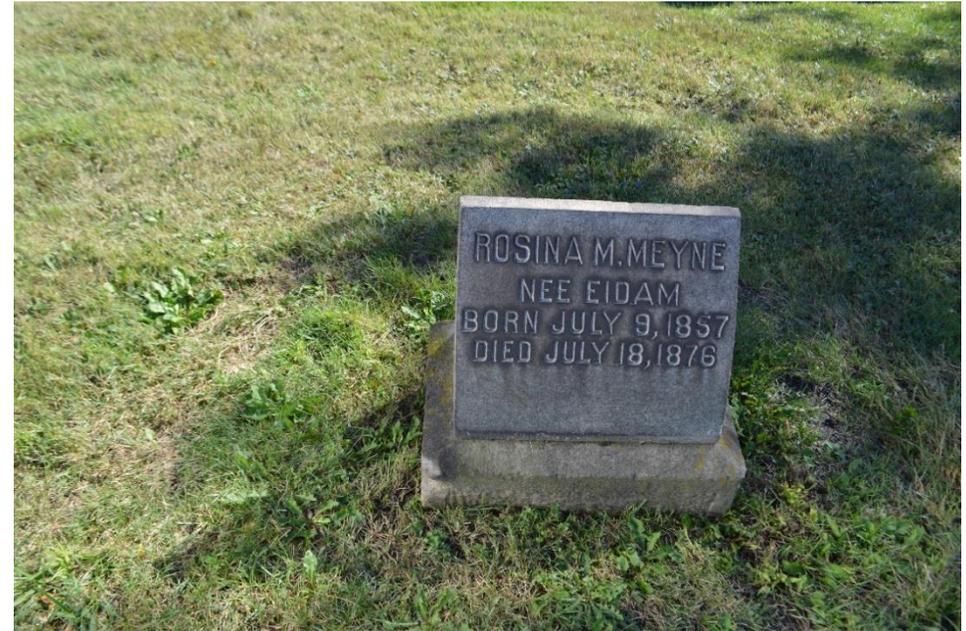
Cemetery	Warrensville West Cemetery
Location	Lee Rd., Shaker Heights, Ohio
GPS#	69
Lot #	83
Name	Meyne, Rosina M
Date of Death	July 18, 1876
Material	granite
Marker Type	die with base
Inscription	ROSINA M. MEYNE/NEE EIDAM/BORN JULY 9, 1857/DIED JULY 18. 1876
Stone Condition	Ambient dirt, biological growth, leaning, sunken base
Recommendations	Clean, treat biological growth, reset base plumb, reset die with lime mortar

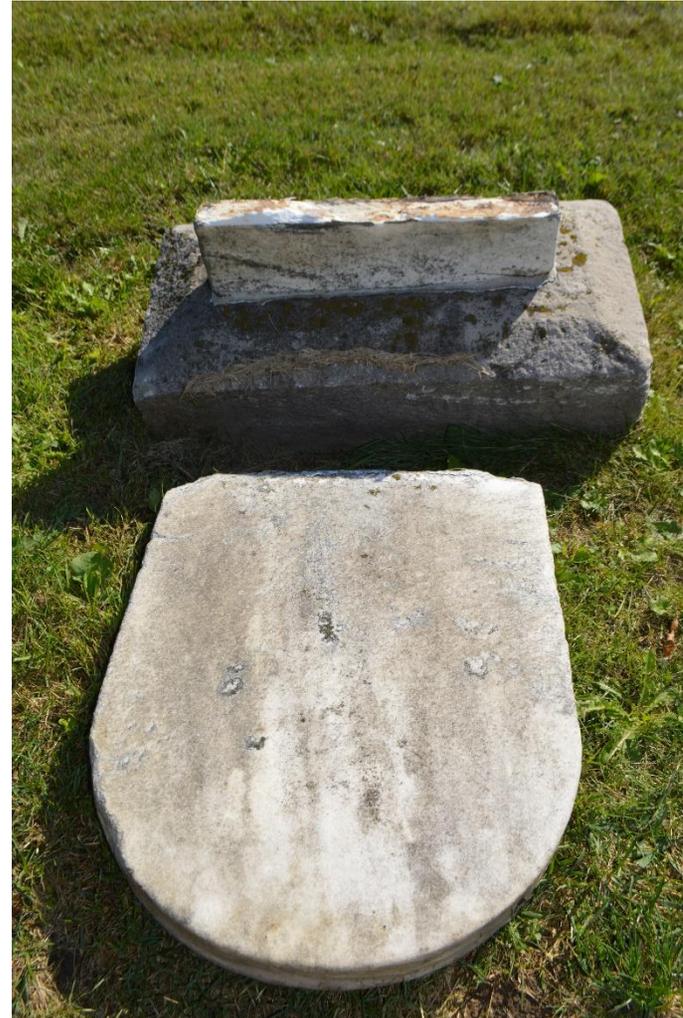
Ambient dirt, biological growth, fallen, 2 fragments, concrete, caulk, failed epoxy repair

Clean, treat biological growth, remove concrete & epoxy residue, reset base plumb, reattach fragments

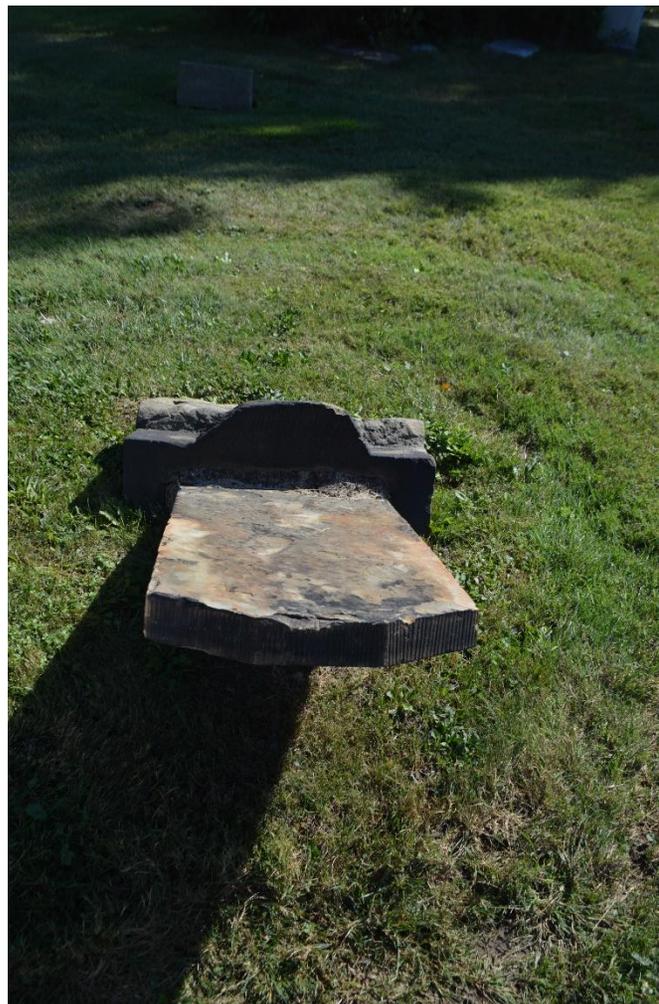
Cemetery	Warrensville West Cemetery
Location	Lee Rd., Shaker Heights, Ohio
GPS#	72
Lot #	80
Name	Adams, Lydia
Date of Death	June 2, 1827
Material	siltstone
Marker Type	tablet with base
Inscription	In/memory of/Lydia Adams/who died/June 2 nd 1827/aged 69/years
Stone Condition	Ambient dirt, biological growth, leaning more than 50°
Recommendations	Clean, treat biological growth, reset base plumb, reset tablet with lime mortar

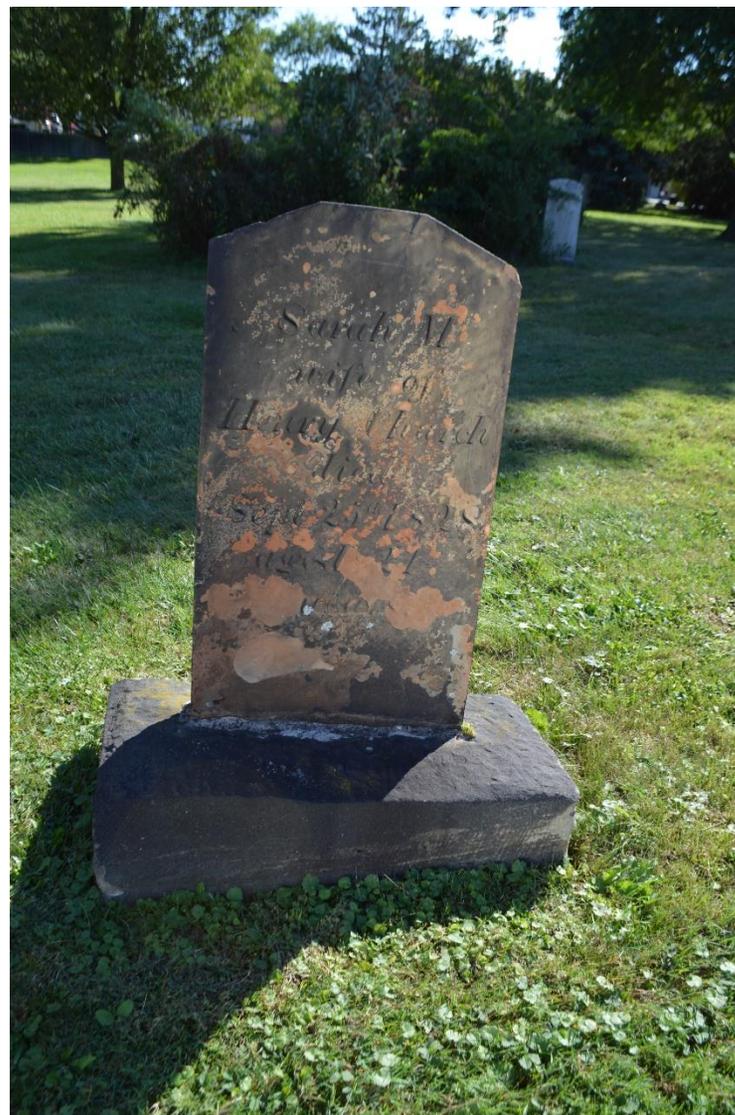
Cemetery	Warrensville West Cemetery
Location	Lee Rd., Shaker Heights, Ohio
GPS#	73
Lot #	79
Name	Church, Sarah M.
Date of Death	Sept. 25, 1828
Material	siltstone
Marker Type	tablet with base
Inscription	Sarah M./wife of/Henry Church/died/Sept. 25 th , 1828/aged 24/years
Stone Condition	Ambient dirt, biological growth, leaning, tilted, delaminating
Recommendations	Clean, treat biological growth, reset base & tablet plumb

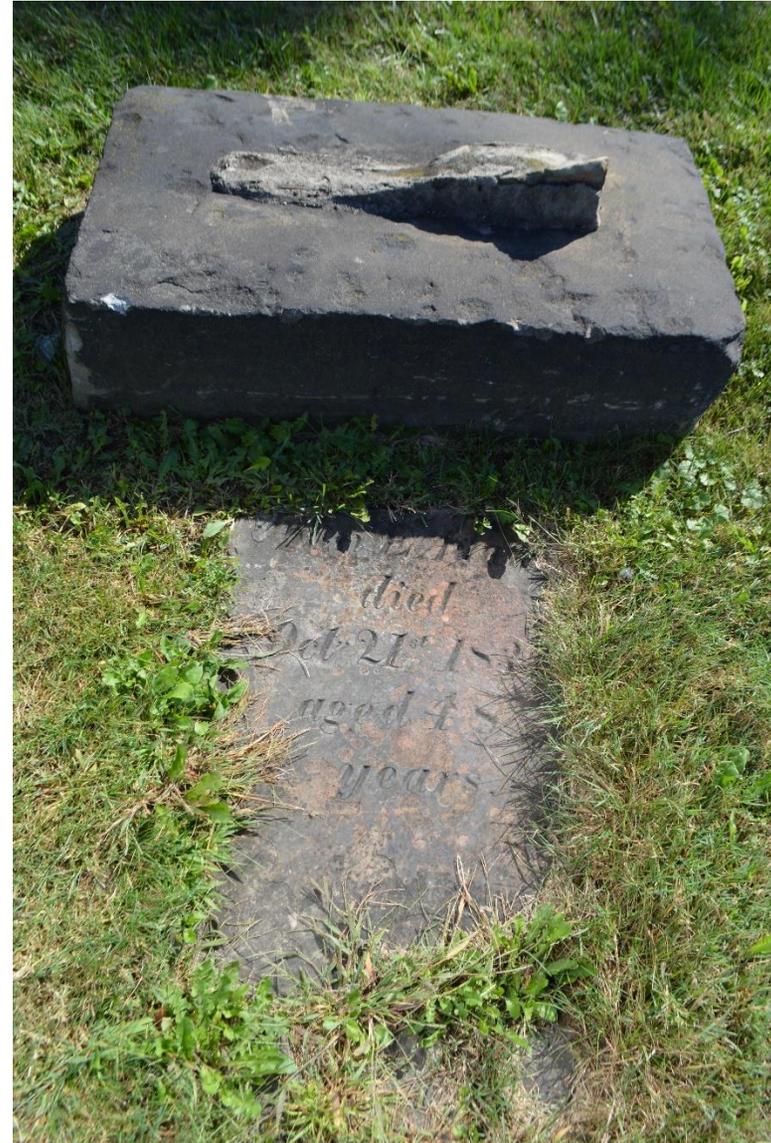
Cemetery	Warrensville West Cemetery
Location	Lee Rd., Shaker Heights, Ohio
GPS#	74
Lot #	78
Name	Adams, John
Date of Death	Oct. 21, 1835
Material	siltstone
Marker Type	tablet with base
Inscription	John E. Adams/died/Oct.21 st 1835/aged 48/Years/Sarah M./wife of
Stone Condition	Ambient dirt, biological growth, fallen, 2 fragments
Recommendations	Clean, treat biological growth, reset base plumb, reattach fragments

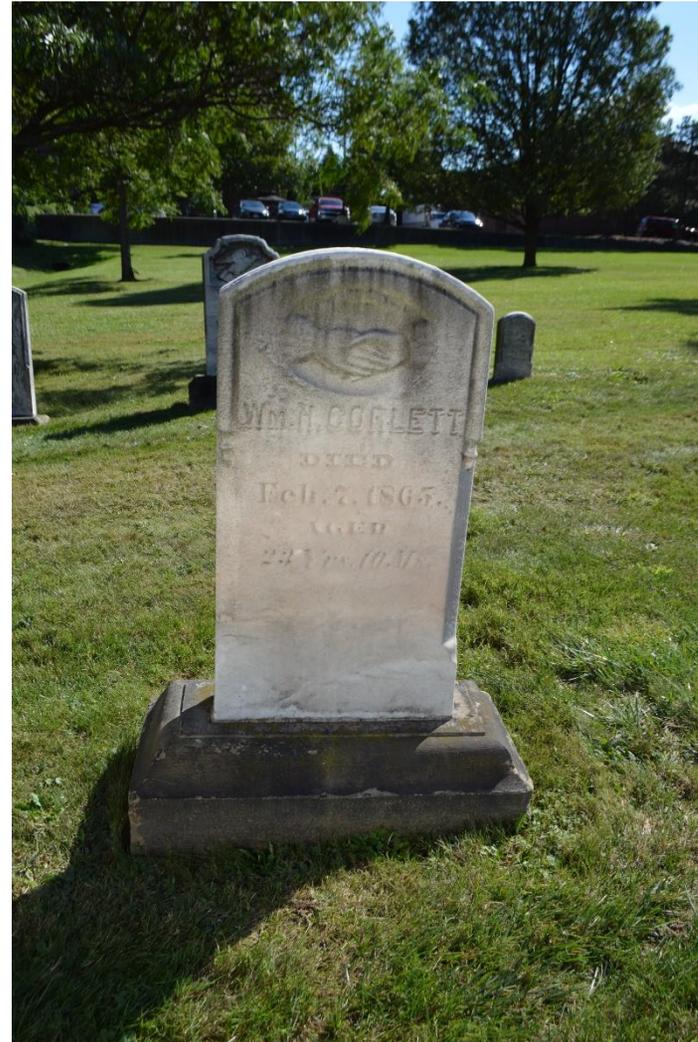
Cemetery	Warrensville West Cemetery
Location	Lee Rd., Shaker Heights, Ohio
GPS#	76
Lot #	76
Name	Corlett, William
Date of Death	Feb. 7, 1865
Material	marble
Marker Type	die with base
Inscription	Wm H. CORLETT/DIED/Feb.7,1865/AGED/23 Yrs. 10 Ms.
Stone Condition	Ambient dirt, biological growth, tilted
Recommendations	Clean, treat biological growth, reset base & tablet plumb
