final report
**WARRENSVILLE WEST
CEMETERY**
HISTORIC PRESERVATION MASTER PLAN

COMPLETED 03-14-2022

**SHAKER
HEIGHTS**

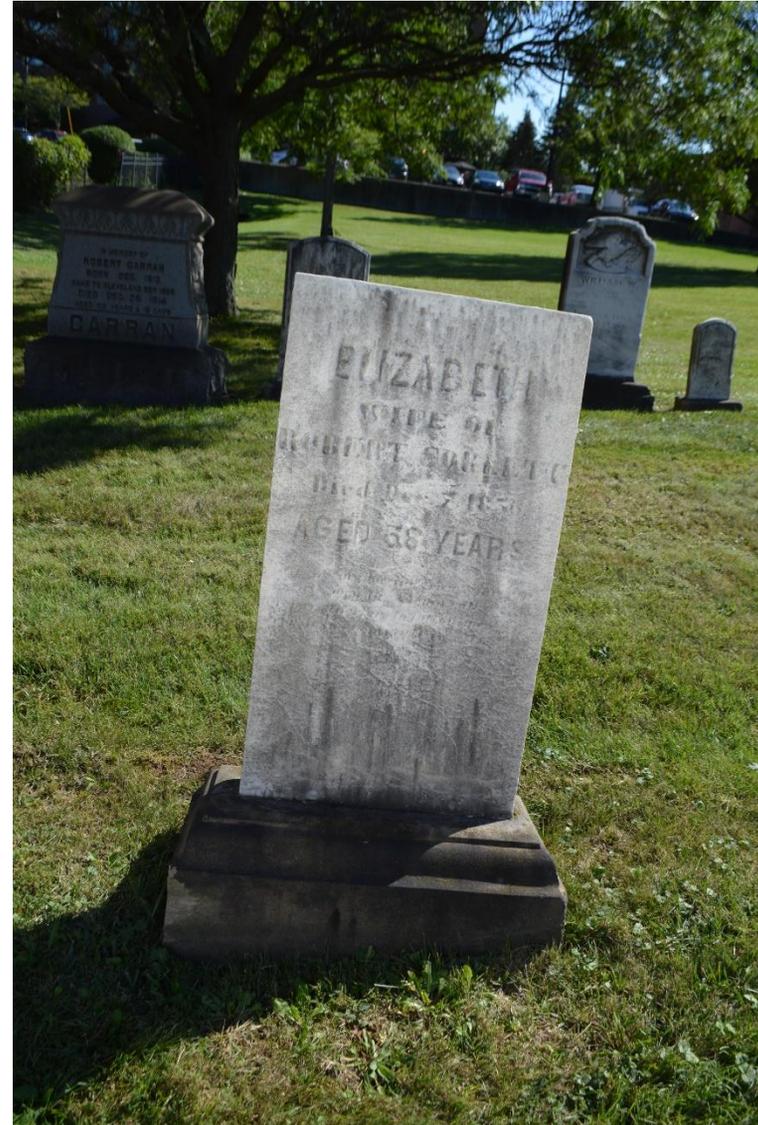
Cemetery	Warrensville West Cemetery
Location	Lee Rd., Shaker Heights, Ohio
GPS#	77
Lot #	75
Name	Corlett, Elizabeth
Date of Death	Dec. 7, 1836
Material	marble
Marker Type	tablet with base
Inscription	ELIZABETH/WIFE OF/ROBERT CORLETT/Died Dec. 7, 1836/AGED 58 YEARS
Stone Condition	Ambient dirt, biological growth, tilted, base corners chipped
Recommendations	Clean, treat biological growth, reset base & tablet plumb

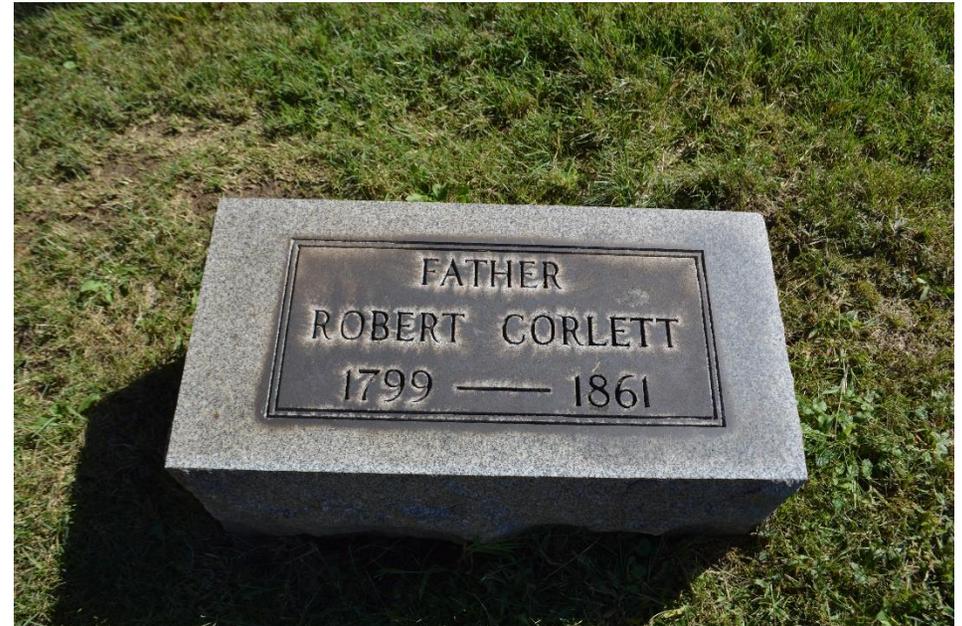
Cemetery	Warrensville West Cemetery
Location	Lee Rd., Shaker Heights, Ohio
GPS#	78
Lot #	74
Name	Corlett, Robert
Date of Death	1861
Material	granite
Marker Type	marker
Inscription	FATHER/ROBERT CORLETT/1799- 1861
Stone Condition	Ambient dirt, biological growth, good condition
Recommendations	Clean, treat biological growth

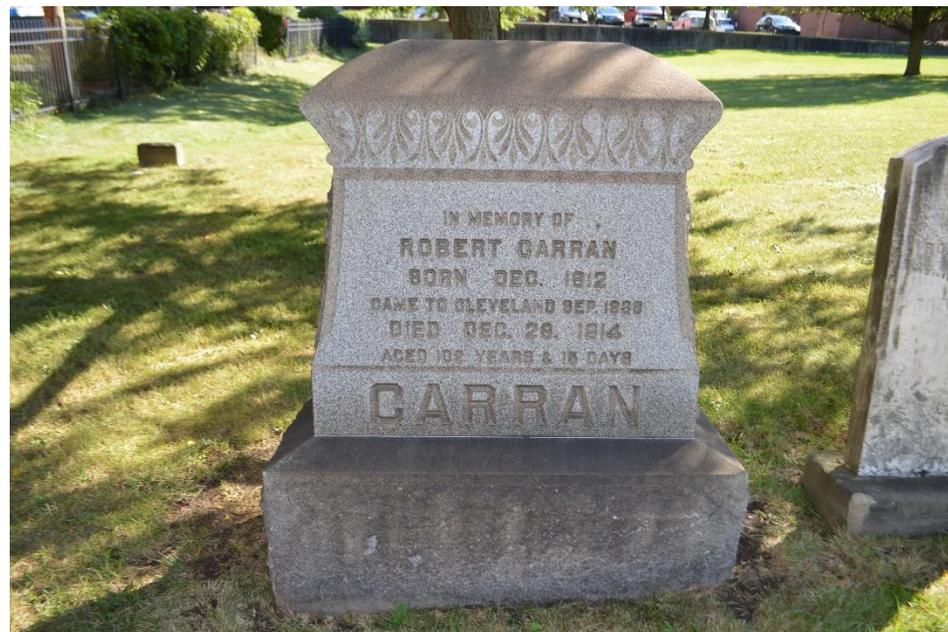
Cemetery	Warrensville West Cemetery
Location	Lee Rd., Shaker Heights, Ohio
GPS#	80
Lot #	99
Name	Carran, Robert
Date of Death	Dec. 26, 1914
Material	granite
Marker Type	die with base
Inscription	IN MEMORY OF/ROBERT CARRAN/BORN DEC. 1812/CAME TO CLEVELAND SEP.1836/DIED DEC. 26, 1914/AGED 102 YEARS & 15 DAYS/CARRAN
Stone Condition	Ambient dirt, biological growth, leaning, base sunken
Recommendations	Clean, treat biological growth, reset base plumb, reset die with lime mortar

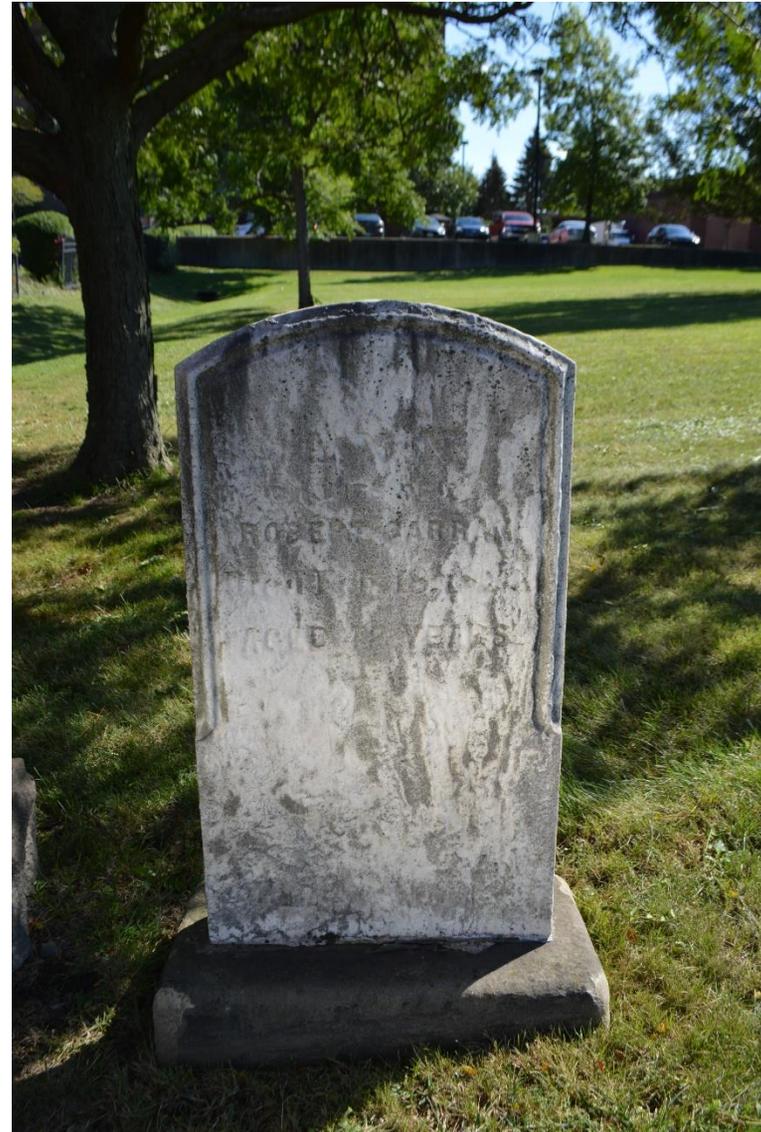
Cemetery	Warrensville West Cemetery
Location	Lee Rd., Shaker Heights, Ohio
GPS#	81
Lot #	100
Name	Carran, Ann
Date of Death	Feb. 8, 1872
Material	marble
Marker Type	tablet with base
Inscription	ANN/WIFE OF/ROBERT CARRAN/Died Feb. 8, 1872/AGED 42 YEARS
Stone Condition	Ambient dirt, biological growth, leaning, tilted, caulk, base corners chipped
Recommendations	Clean, treat biological growth, remove caulk, reset base plumb, reset tablet with lime mortar

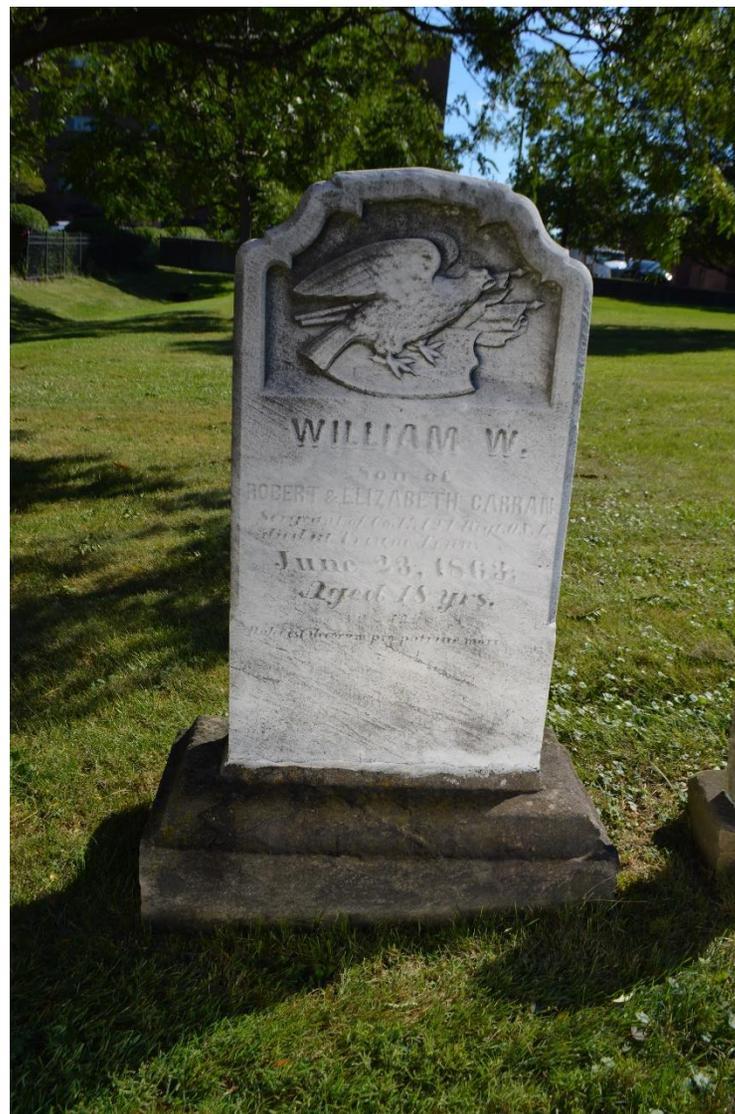
Cemetery	Warrensville West Cemetery
Location	Lee Rd., Shaker Heights, Ohio
GPS#	82
Lot #	101
Name	Carran, William W.
Date of Death	June 23, 1863
Material	marble
Marker Type	tablet with base
Inscription	WILLIAM W./Son of/ROBERT & ELIZABETH CARRAN/Sergeant of Co. E 121 Regt. OVI/died at Triune Tenn./June 23, 1863/Aged 18 Yrs./Dulce est decorum pro patriae mori
Stone Condition	Ambient dirt, biological growth, caulk, missing mortar
Recommendations	Clean, treat biological growth, remove caulk, reset base plumb, reset tablet with lime mortar

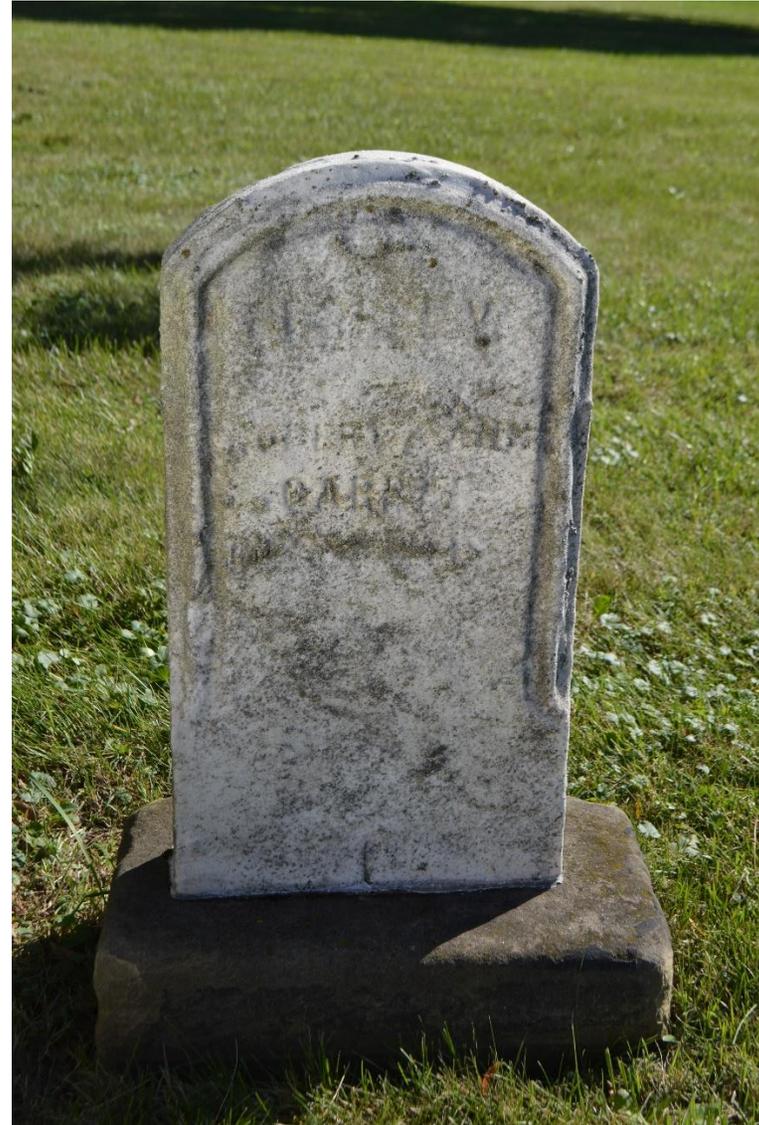
Cemetery	Warrensville West Cemetery
Location	Lee Rd., Shaker Heights, Ohio
GPS#	83
Lot #	102
Name	Carran, George W.
Date of Death	
Material	marble
Marker Type	die with base
Inscription	GEORGE W./Son of/ROBERT & ANN CARRAN//
Stone Condition	Ambient dirt, biological growth, caulk, missing mortar, base corners chipped
Recommendations	Clean, treat biological growth, remove caulk, reset base plumb, reset tablet with lime mortar

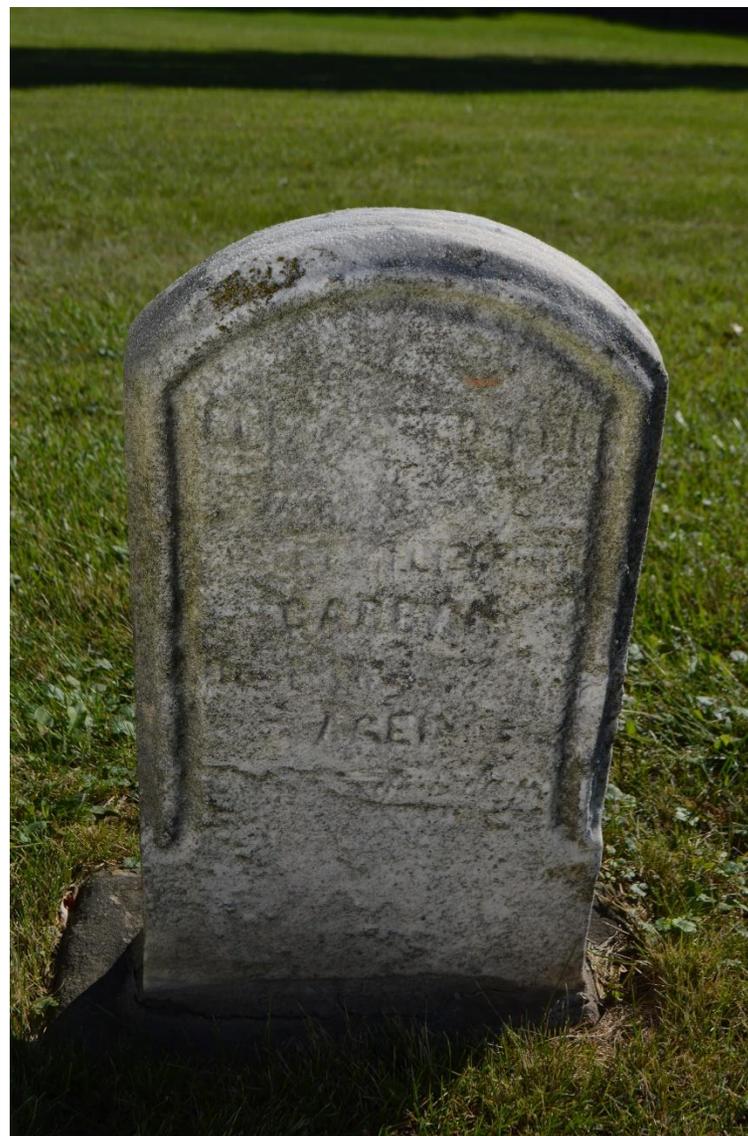
Cemetery	Warrensville West Cemetery
Location	Lee Rd., Shaker Heights, Ohio
GPS#	84
Lot #	103
Name	Carran, Elizabeth
Date of Death	Aug.
Material	marble
Marker Type	die with base
Inscription	ELIZABETH ANN/Daughter of/ROBERT & ELIZABETH/CARRAN/Died Aug.//AGED//
Stone Condition	Ambient dirt, biological growth, leaning, sunken base, concrete
Recommendations	Clean, treat biological growth, remove concrete, reset base plumb, reset tablet with lime mortar

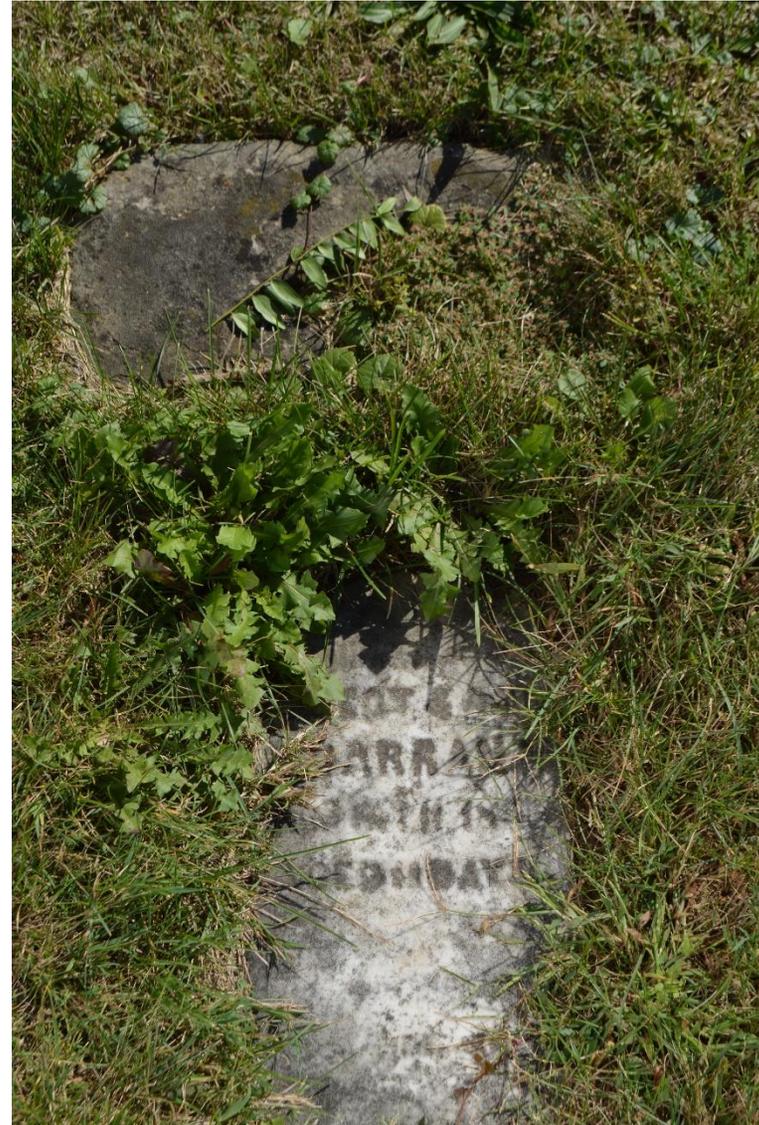
Cemetery	Warrensville West Cemetery
Location	Lee Rd., Shaker Heights, Ohio
GPS#	85
Lot #	104
Name	Carran, Mary
Date of Death	Oct. 11, 1853
Material	marble
Marker Type	tablet with base
Inscription	MARY/Daughter of/ROBERT & ANN/CARRAN/Died Oct. 11, 1853/AGED/2 Years -- months
Stone Condition	Ambient dirt, biological growth, fallen, base sunken
Recommendations	Clean, treat biological growth, reset base plumb, reset tablet with lime mortar

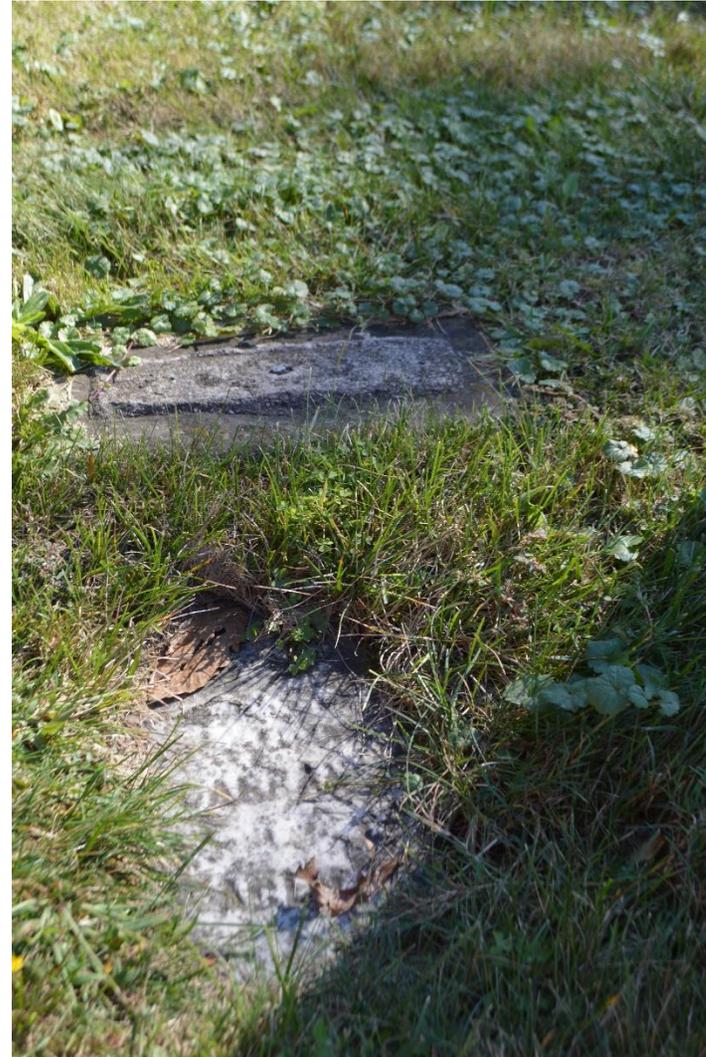
Cemetery	Warrensville West Cemetery
Location	Lee Rd., Shaker Heights, Ohio
GPS#	86
Lot #	105
Name	Carran, Ellen Jane
Date of Death	Sept. 23, 1852
Material	marble
Marker Type	tablet with base
Inscription	ELLEN JANE/Daughter of/ROBERT & ANN/CARRAN/Died Sept. 23, 1852/AGED/2 Years -- months
Stone Condition	Ambient dirt, biological growth, fallen, base sunken
Recommendations	Clean, treat biological growth, reset base plumb, reset tablet with lime mortar

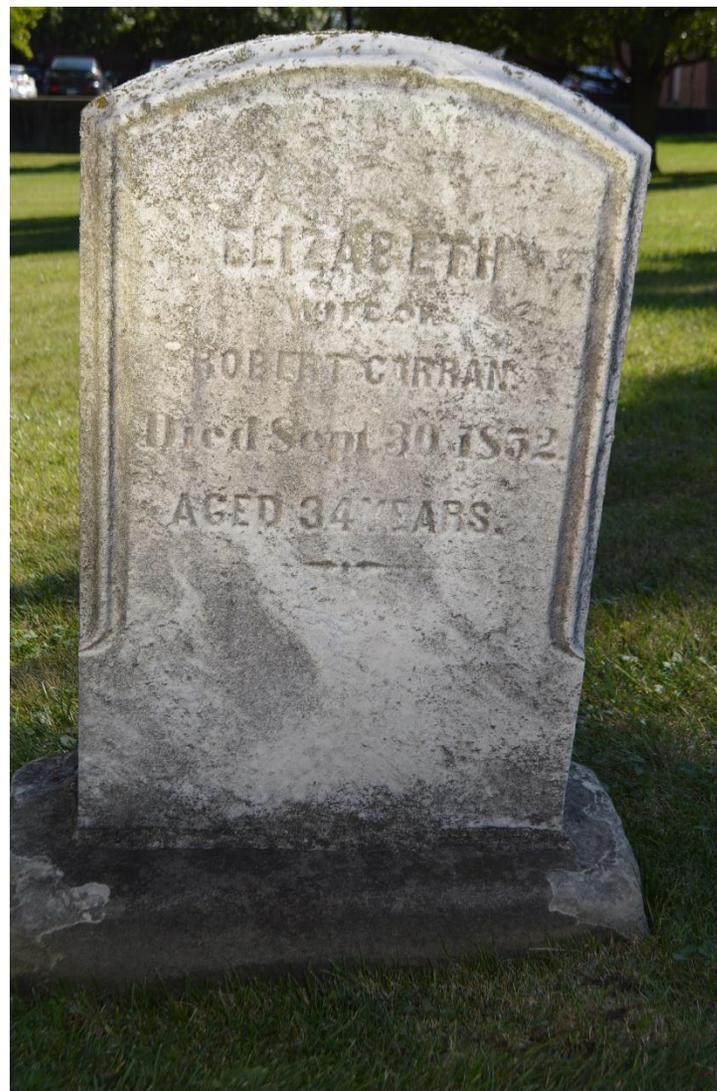
Cemetery Location	Warrensville West Cemetery Lee Rd., Shaker Heights, Ohio
GPS#	87
Lot #	106
Name	Carran, Mrs. Elizabeth
Date of Death	Sept. 30, 1852
Material	marble
Marker Type	tablet with base
Inscription	ELIZABETH/WIFE OF/ROBERT CARRAN/Died Sept. 30, 1852/AGED 34 YEARS
Stone Condition	Ambient dirt, biological growth, leaning, sunken base
Recommendations	Clean, treat biological growth, reset base plumb, reset tablet with lime mortar

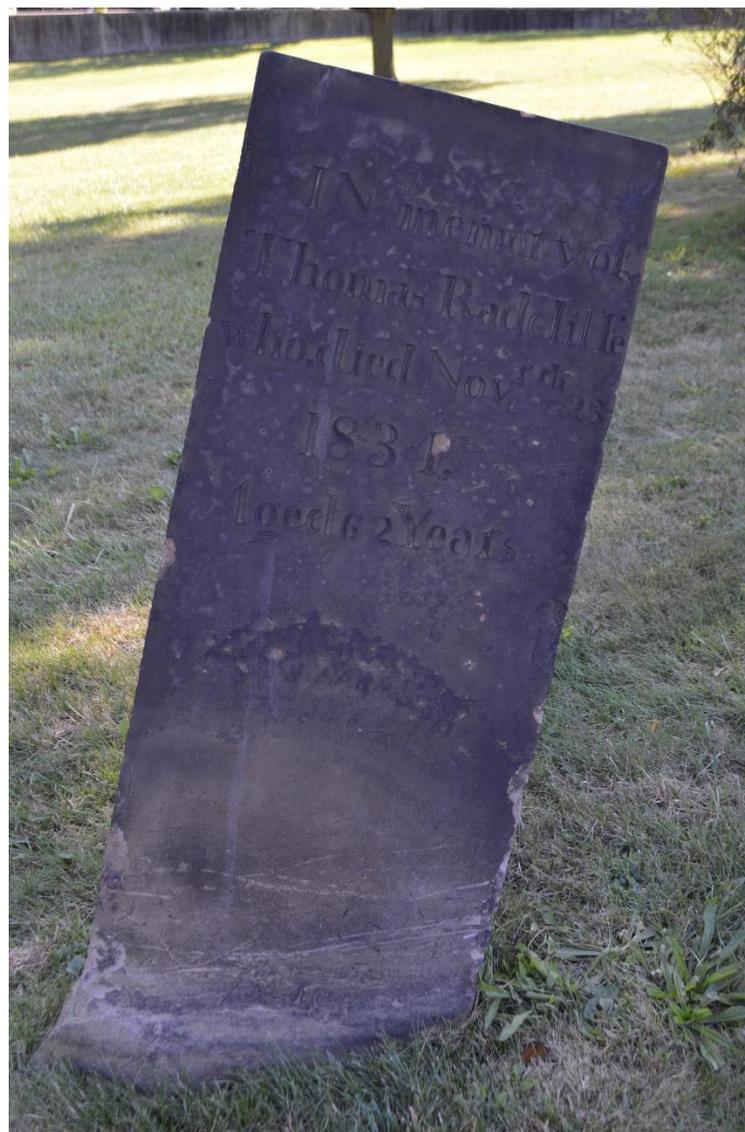
Cemetery	Warrensville West Cemetery
Location	Lee Rd., Shaker Heights, Ohio
GPS#	88
Lot #	107
Name	Radcliffe, Thomas
Date of Death	Nov. 23, 1834
Material	siltstone
Marker Type	tablet
Inscription	In memory of/Thomas Radcliffe/who died Nov. 23,/1834/Aged 62 Years//J.C.
Stone Condition	Ambient dirt, biological growth, tilted, leaning, set too high, chipped edges
Recommendations	Clean, treat biological growth, reset plumb at correct height

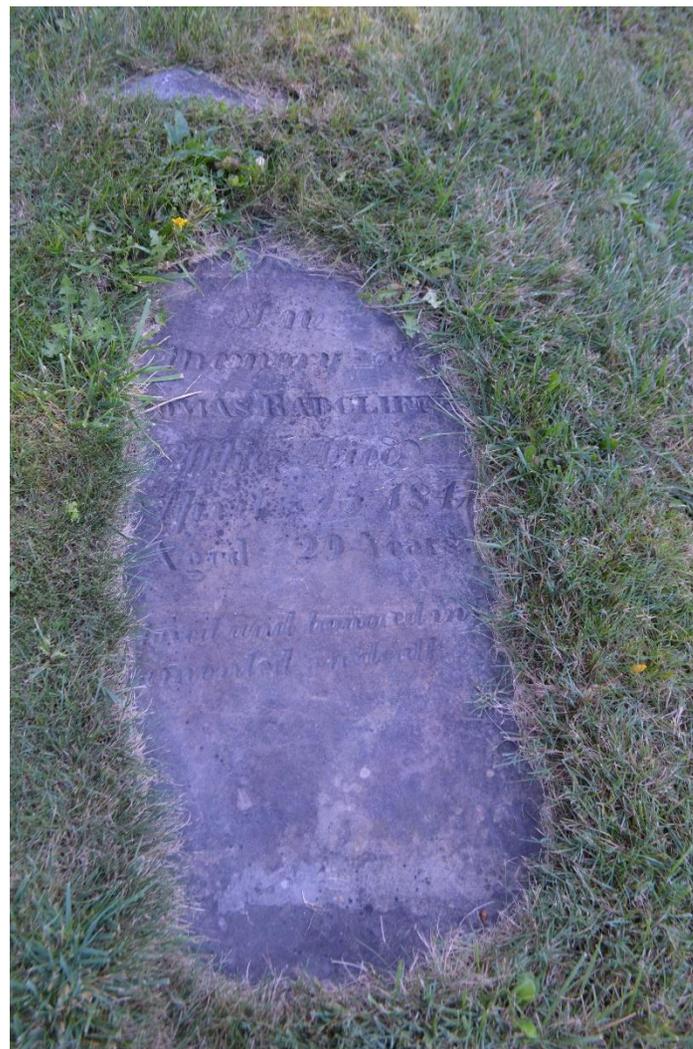
Ambient dirt, biological growth, fallen,
sunken, missing base

Clean, treat biological growth, locate
base, reset tablet with lime mortar

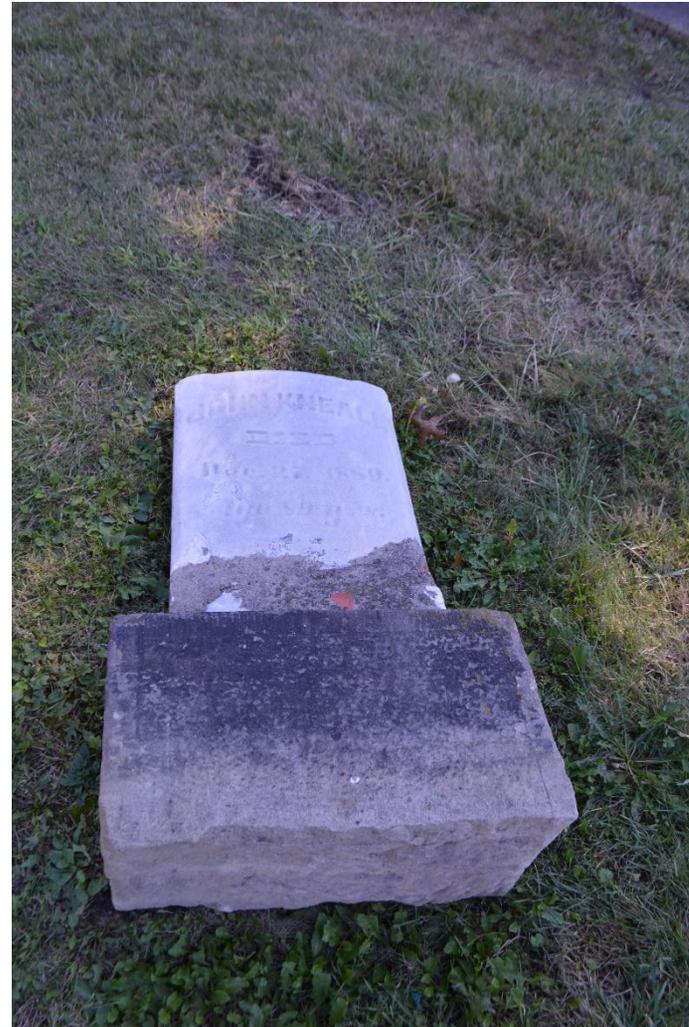
Cemetery	Warrensville West Cemetery
Location	Lee Rd., Shaker Heights, Ohio
GPS#	90
Lot #	109
Name	Kneale, John
Date of Death	Dec. 27, 1880
Material	marble
Marker Type	die with base
Inscription	JOHN KNEALE/DIED/Dec. 27, 1880/Age 89 Yrs.
Stone Condition	Ambient dirt, biological growth, fallen, concrete
Recommendations	Clean, treat biological growth, remove concrete, reset plumb at correct height

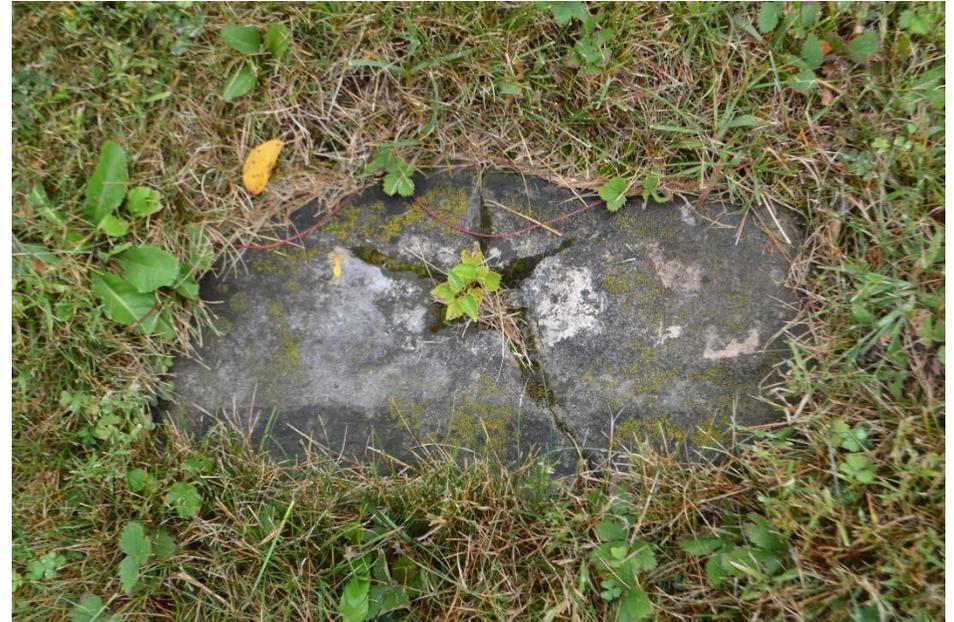
Cemetery	Warrensville West Cemetery
Location	Lee Rd., Shaker Heights, Ohio
GPS#	91
Lot #	91
Name	Unknown
Date of Death	
Material	
Marker Type	die with base
Inscription	
Stone Condition	Ambient dirt, biological growth, base cracked, missing stone
Recommendations	Locate stone

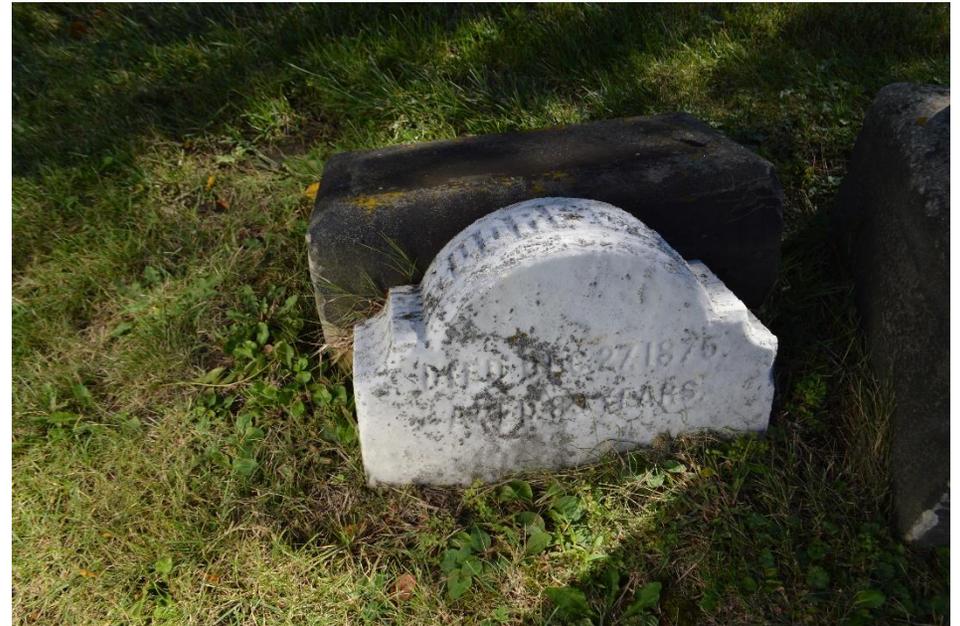
Cemetery	Warrensville West Cemetery
Location	Lee Rd., Shaker Heights, Ohio
GPS#	92
Lot #	92
Name	Bell, Moore
Date of Death	Dec. 27, 1875
Material	marble
Marker Type	die with base
Inscription	MOORE BELL/DIED DEC. 27, 1875/AGED 83 YEARS
Stone Condition	Ambient dirt, biological growth, fallen, sunken base
Recommendations	Clean, treat biological growth, reset base plumb, reset die with lime mortar

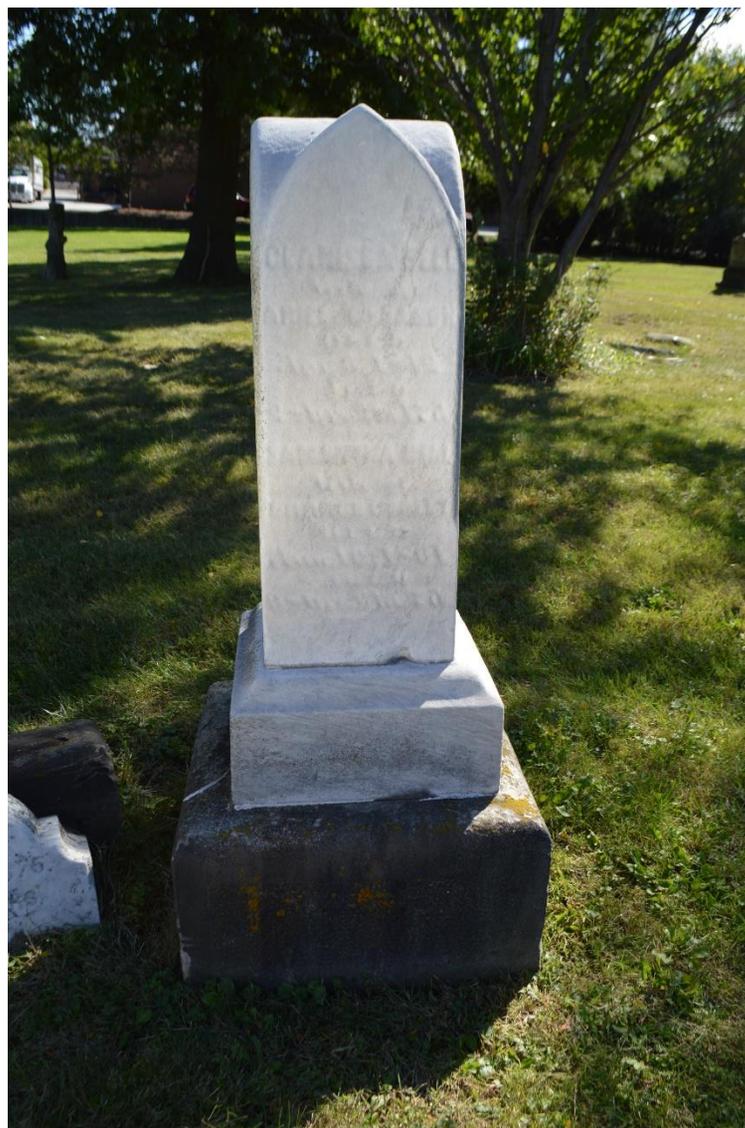
Cemetery	Warrensville West Cemetery
Location	Lee Rd., Shaker Heights, Ohio
GPS#	93
Lot #	93
Name	Bell, Moor & Annis
Date of Death	Dec. 27, 1875
Material	marble
Marker Type	pedestal
Inscription	CLARRISSA BELL//SAMANTHA BELL//MOOR BELL/Born Mar. 5, 1786/DIED/Dec. 27, 1874/AGED 88 yrs. 9 Ms. 21 D./ANNIS BELL/Born Mar. 26, 1790/DIED/Sept. 20, 1881/AGED 90 yrs. 5 M. 24 D.

Ambient dirt, biological growth, leaning, tilted, caulk, missing mortar

Clean, treat biological growth, remove caulk, reset base plumb, reassemble with lime mortar

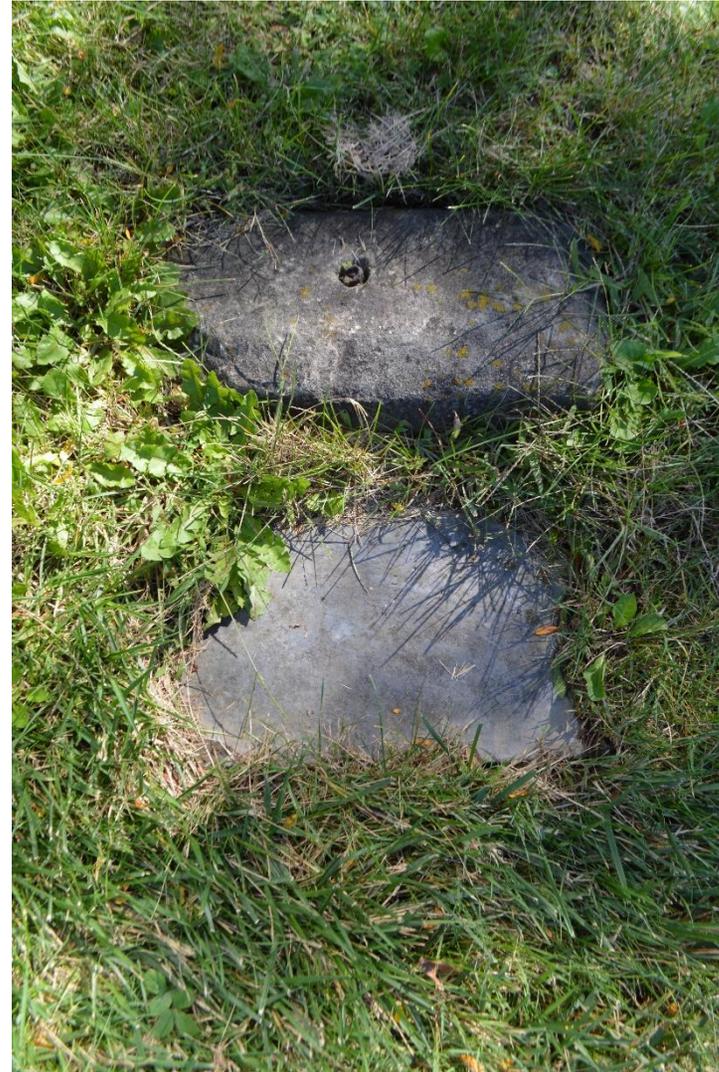
Stone Condition
Ambient dirt, biological growth, fallen,
sunken base

Recommendations
Clean, treat biological growth, reset base
plumb, reset tablet with lime mortar

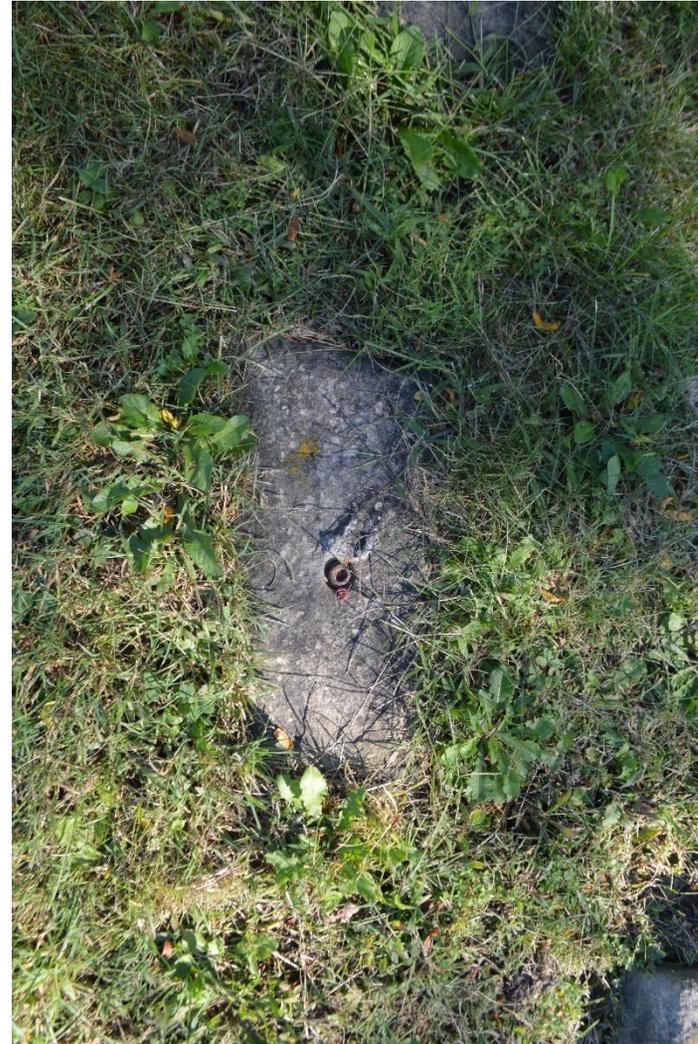
Cemetery	Warrensville West Cemetery
Location	Lee Rd., Shaker Heights, Ohio
GPS#	95
Lot #	95
Name	Unknown
Date of Death	
Material	
Marker Type	die with base
Inscription	
Stone Condition	Ambient dirt, biological growth, sunken base, missing stone
Recommendations	Locate stone

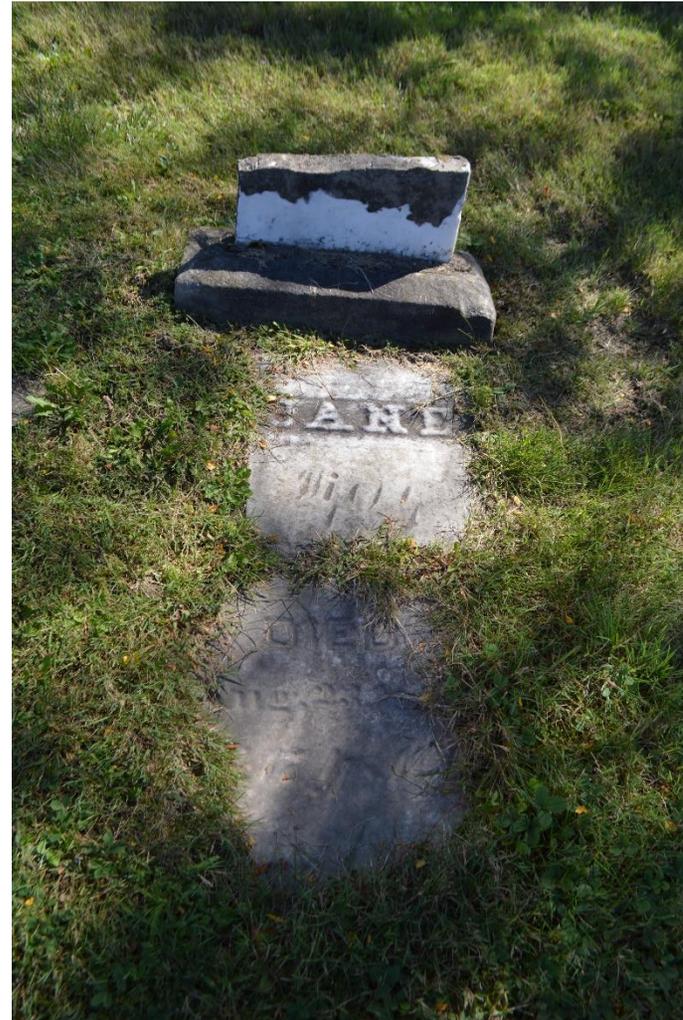
Ambient dirt, biological growth, fallen, broken, 3 fragments, sunken & leaning base, failed concrete repair

Clean, treat biological growth, remove concrete, reset base plumb, reset tablet with lime mortar, reattach fragments

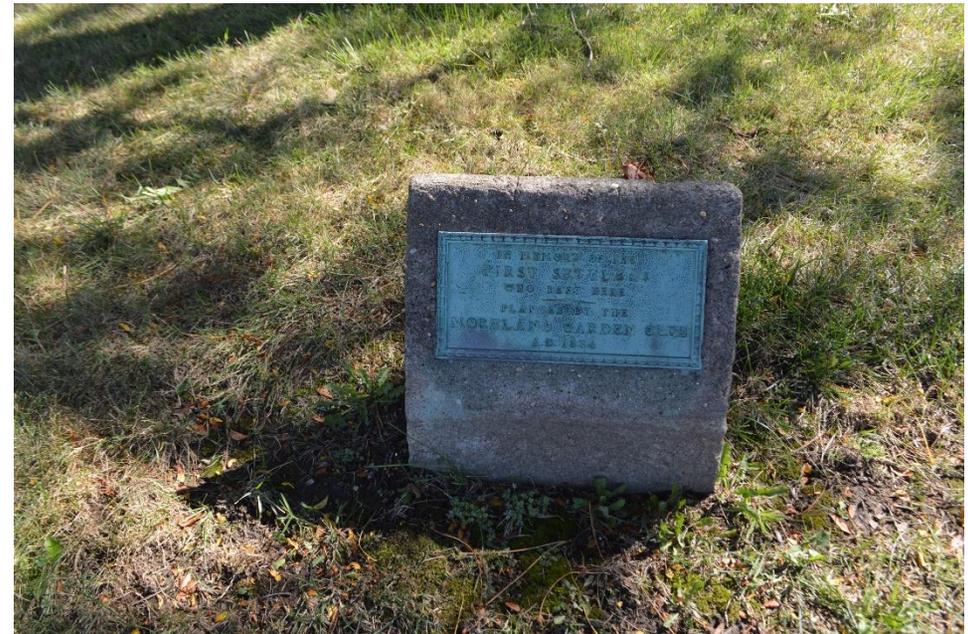
Cemetery	Warrensville West Cemetery
Location	Lee Rd., Shaker Heights, Ohio
GPS#	97
Lot #	
Name	First Settlers Stone
Date of Death	
Material	
Marker Type	concrete with bronze plaque
Inscription	IN MEMORY OF THE/FIRST SETTLERS/WHO REST HERE//PLANTED BY THE/MORELAND GARDEN CLUB/AD 1934
Stone Condition	Ambient dirt, biological growth, good condition, small crack in concrete base
Recommendations	Clean, treat biological growth

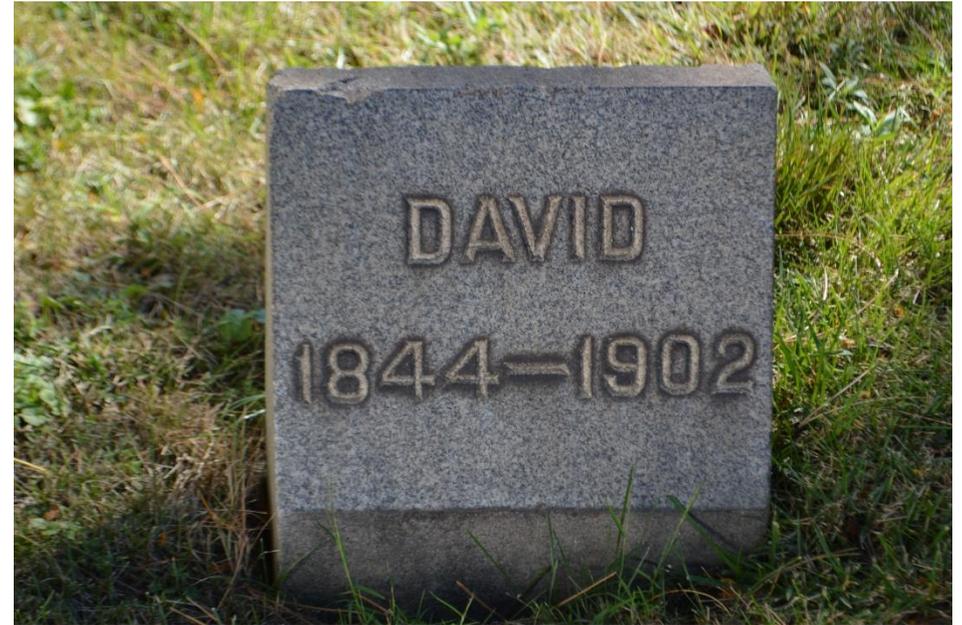
Cemetery	Warrensville West Cemetery
Location	Lee Rd., Shaker Heights, Ohio
GPS#	98A
Lot #	111
Name	Wade, David
Date of Death	
Material	granite
Marker Type	marker
Inscription	DAVID/1844-1902
Stone Condition	Ambient dirt, biological growth, tilted, sunken
Recommendations	Clean, treat biological growth, reset plumb at correct height

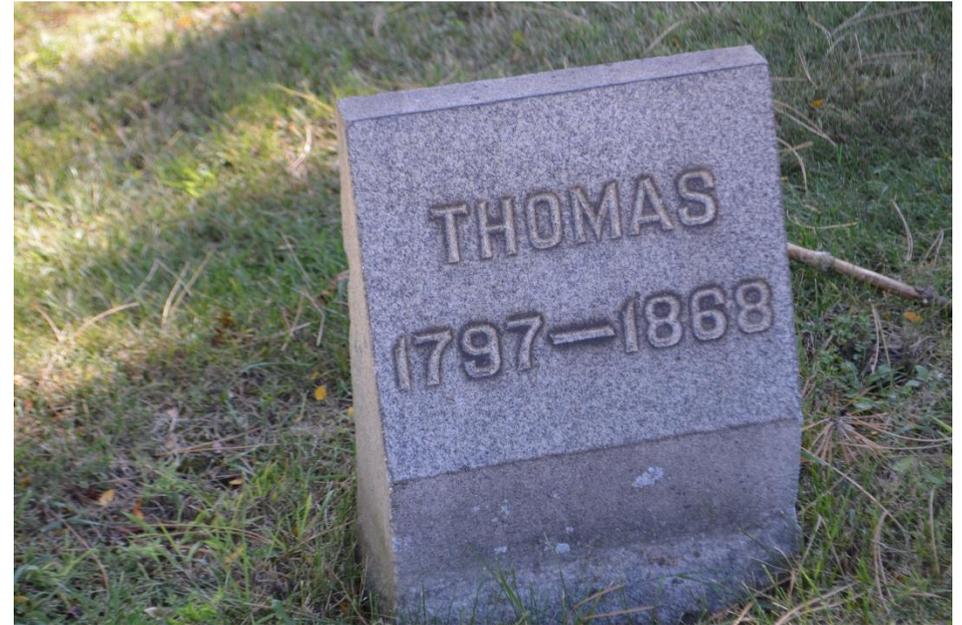
Cemetery	Warrensville West Cemetery
Location	Lee Rd., Shaker Heights, Ohio
GPS#	98B
Lot #	112
Name	Wade, Thomas
Date of Death	1868
Material	granite
Marker Type	marker
Inscription	THOMAS/1797 - 1868
Stone Condition	Ambient dirt, biological growth, tilted, set too high
Recommendations	Clean, treat biological growth, reset plumb at correct height

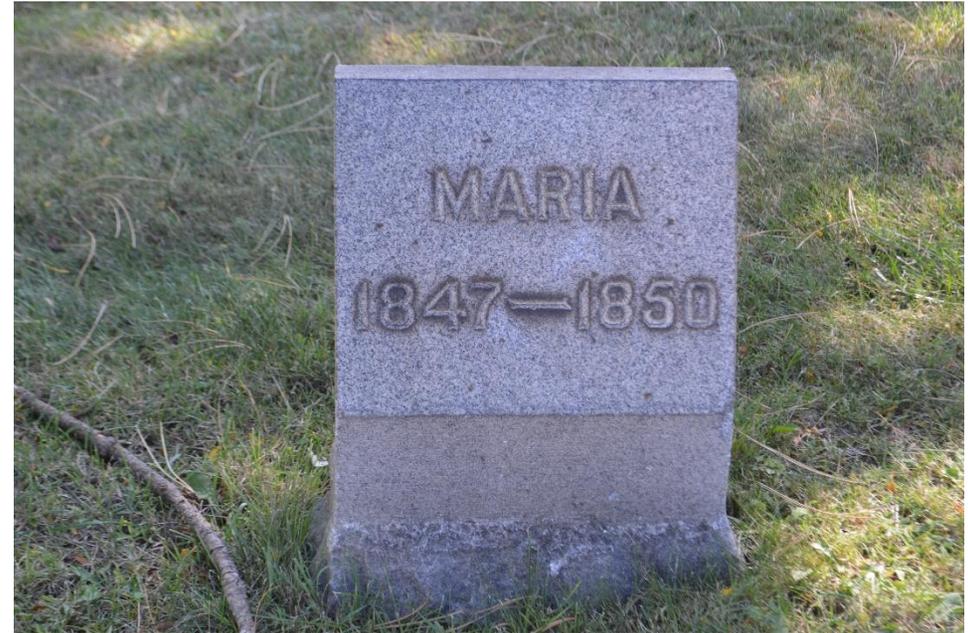
Cemetery	Warrensville West Cemetery
Location	Lee Rd., Shaker Heights, Ohio
GPS#	98C
Lot #	113
Name	Wade, Maria
Date of Death	1850
Material	granite
Marker Type	marker
Inscription	MARIA/1847 - 1850
Stone Condition	Ambient dirt, biological growth, tilted, set too high
Recommendations	Clean, treat biological growth, reset plumb at correct height

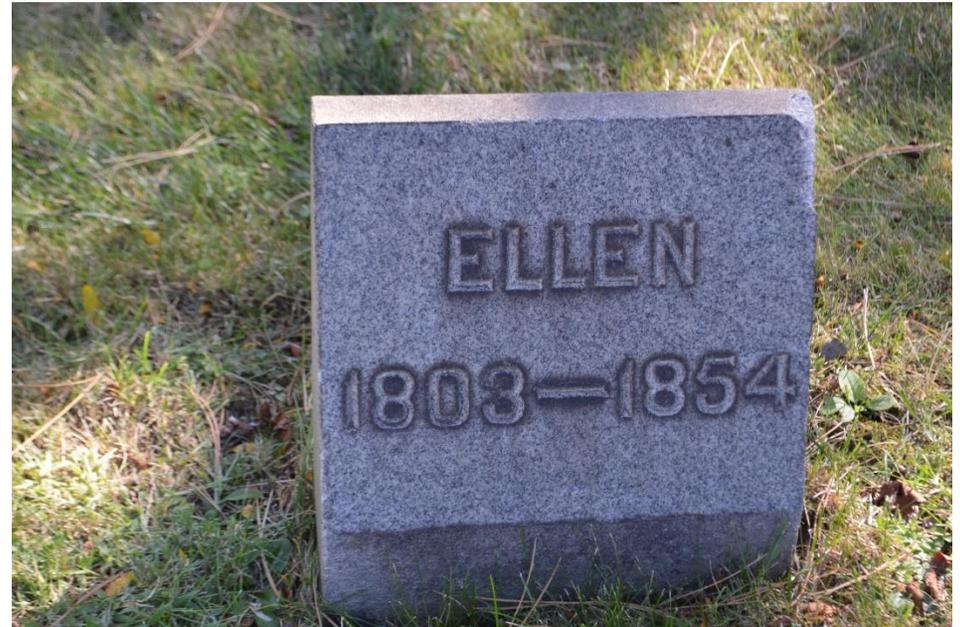
Cemetery	Warrensville West Cemetery
Location	Lee Rd., Shaker Heights, Ohio
GPS#	98D
Lot #	114
Name	Wade, Ellen
Date of Death	1854
Material	granite
Marker Type	marker
Inscription	ELLEN/1803 - 1854
Stone Condition	Ambient dirt, biological growth, leaning
Recommendations	Clean, treat biological growth, reset plumb at correct height

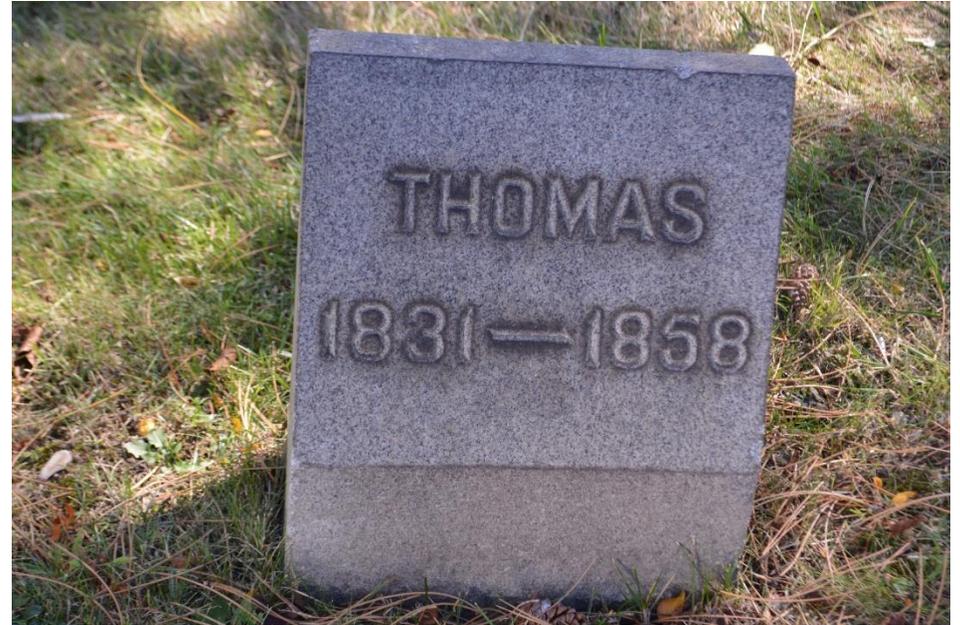
Cemetery	Warrensville West Cemetery
Location	Lee Rd., Shaker Heights, Ohio
GPS#	98E
Lot #	115
Name	Wade, Thomas
Date of Death	1858
Material	granite
Marker Type	marker
Inscription	THOMAS/1831 - 1858
Stone Condition	Ambient dirt, biological growth, leaning, tilted
Recommendations	Clean, treat biological growth, reset plumb at correct height

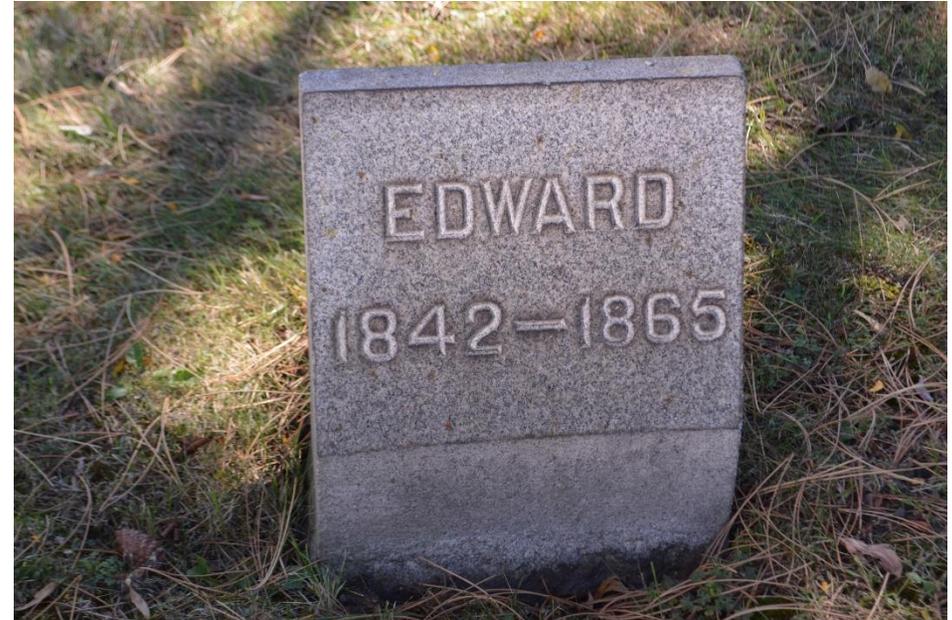
Cemetery	Warrensville West Cemetery
Location	Lee Rd., Shaker Heights, Ohio
GPS#	98F
Lot #	116
Name	Wade, Edward
Date of Death	1865
Material	granite
Marker Type	marker
Inscription	EDWARD/1842 - 1865
Stone Condition	Ambient dirt, biological growth, leaning, tilted
Recommendations	Clean, treat biological growth, reset plumb at correct height

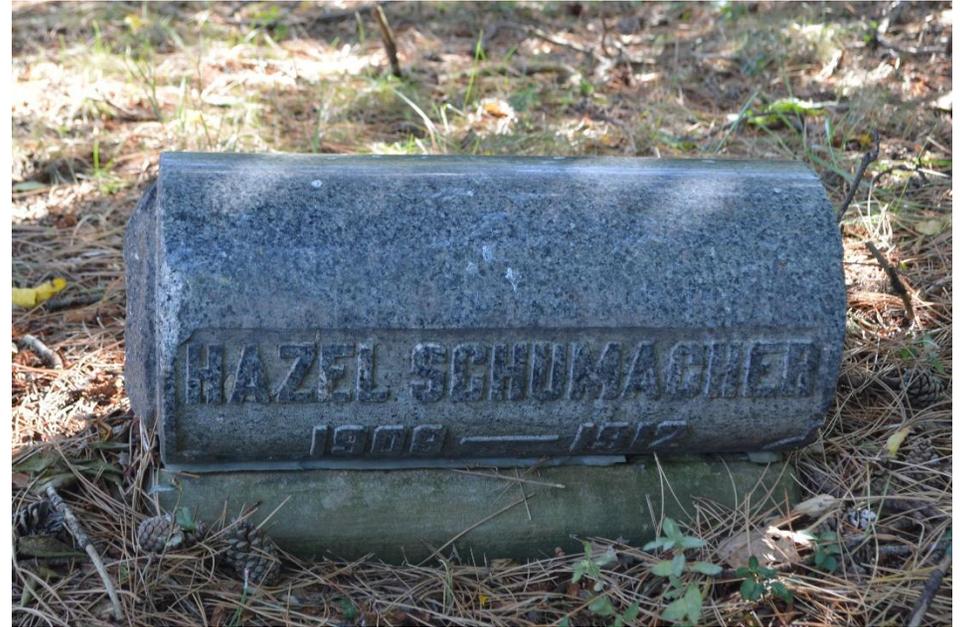
Cemetery	Warrensville West Cemetery
Location	Lee Rd., Shaker Heights, Ohio
GPS#	99
Lot #	118
Name	Schumacher, Hazel
Date of Death	1912
Material	granite
Marker Type	cylinder
Inscription	HAZEL SCHUMACHER/1908- 1912/TRUMAN E. BULL/1877-1941
Stone Condition	Ambient dirt, biological growth, leaning, sunken base, caulk, chipped edges
Recommendations	Clean, treat biological growth, remove caulk, reset base plumb, reset die with lime mortar

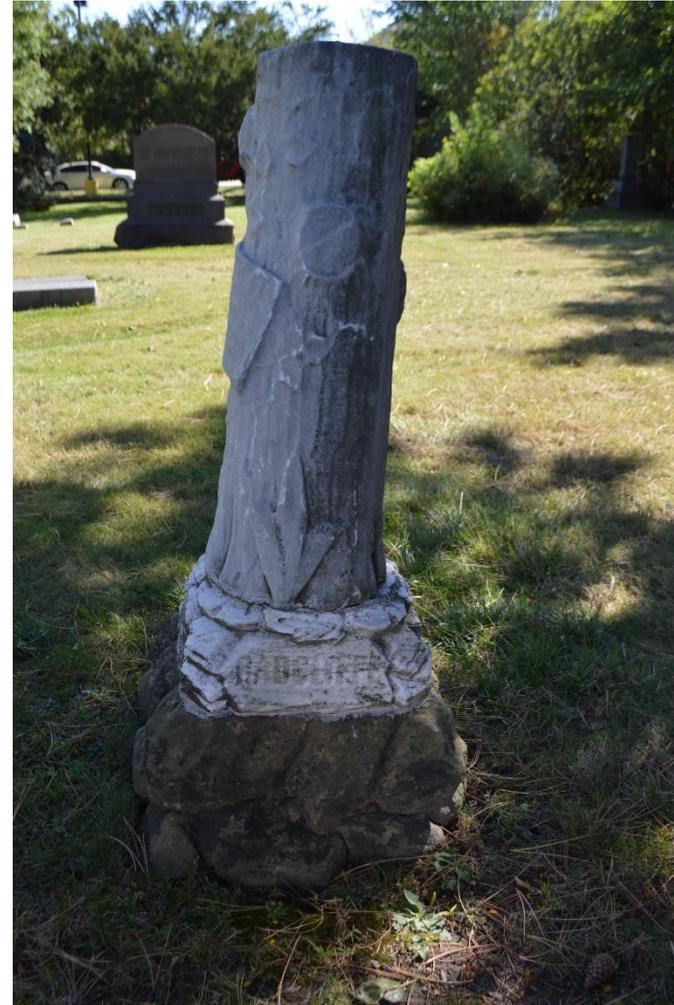
Cemetery	Warrensville West Cemetery
Location	Lee Rd., Shaker Heights, Ohio
GPS#	100
Lot #	122
Name	Radcliffe, John
Date of Death	
Material	marble
Marker Type	Tree
Inscription	JOHN RADCLIFFE//
Stone Condition	Ambient dirt, biological growth, leaning, moved off center, caulk, sunken base
Recommendations	Clean, treat biological growth, remove caulk, reset base plumb, reassemble with lime mortar
