final report
**WARRENSVILLE WEST
CEMETERY**
HISTORIC PRESERVATION MASTER PLAN

COMPLETED 03-14-2022

**SHAKER
HEIGHTS**

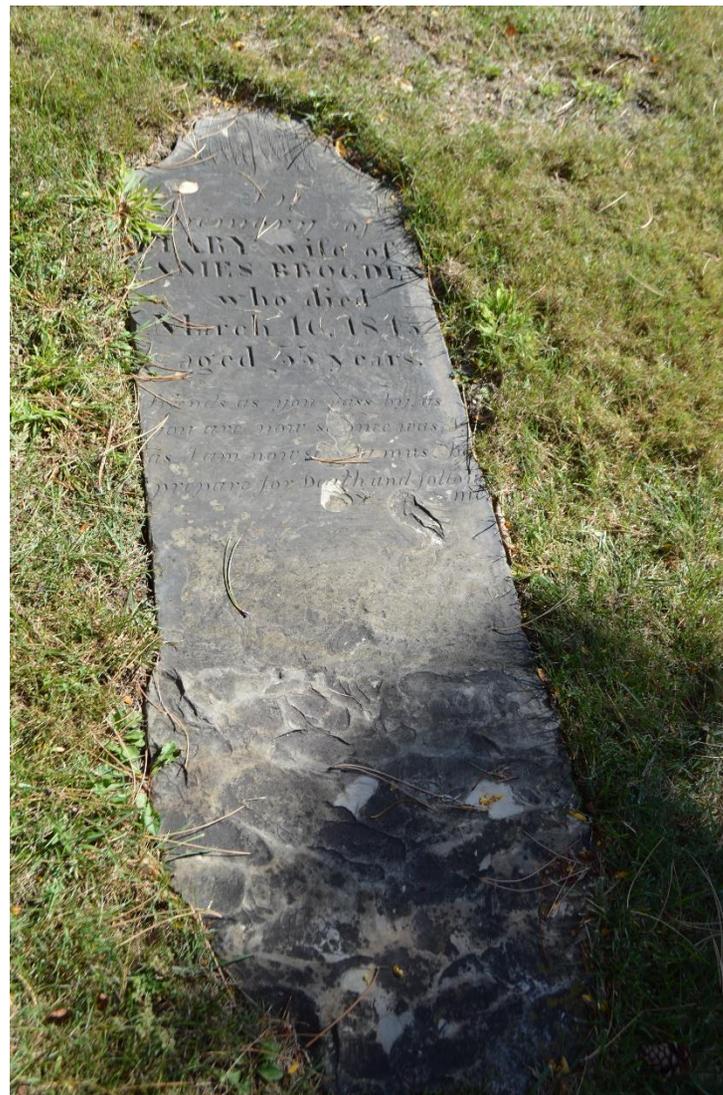
Cemetery	Warrensville West Cemetery
Location	Lee Rd., Shaker Heights, Ohio
GPS#	101
Lot #	121
Name	Brogden, Mary
Date of Death	March 16, 1843
Material	siltstone
Marker Type	tablet
Inscription	<p>In/memory of/MARY wife of/JAMES BROGDEN/who died/March 16, 1843/aged 55 Years/friends as you pass by, as/you are now so once was I/as I am now so you must be/prepare for Death and follow me</p>
Stone Condition	Ambient dirt, biological growth, fallen, delaminating on face
Recommendations	Clean, treat biological growth, reset plumb at correct height

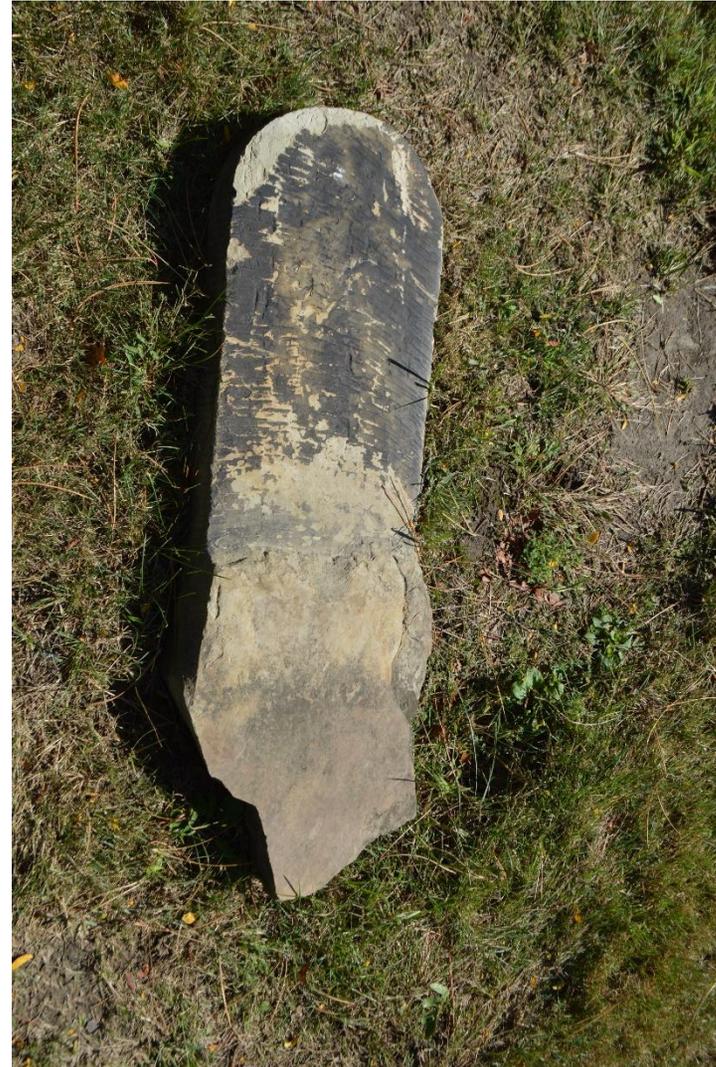
Stone Condition Ambient dirt, biological growth, fallen

Recommendations Clean, treat biological growth, reset
plumb at correct height

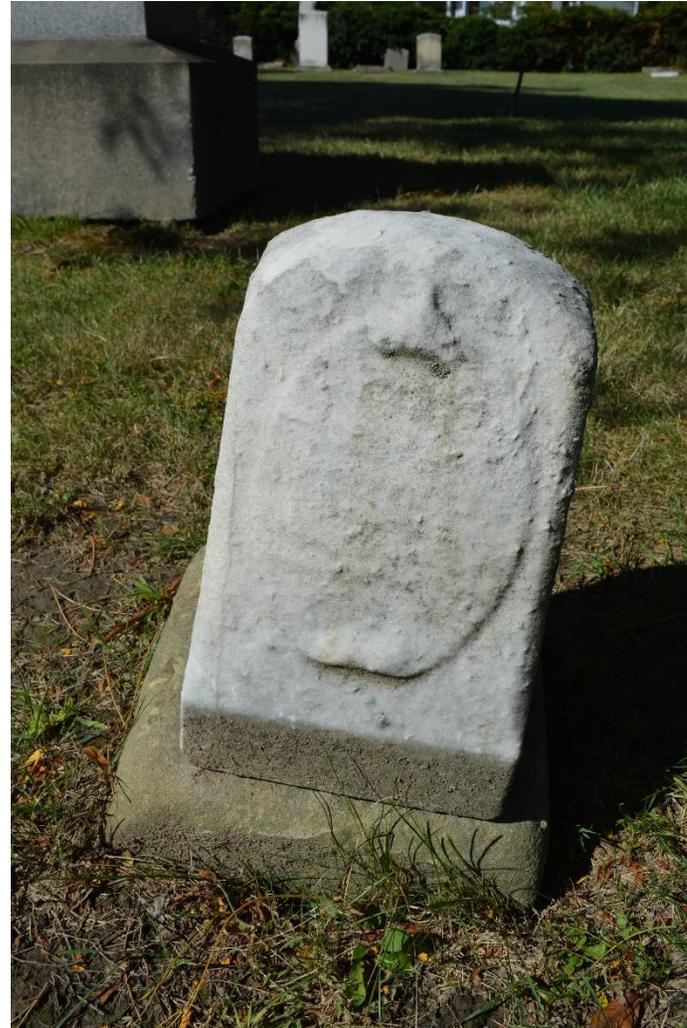
Cemetery	Warrensville West Cemetery
Location	Lee Rd., Shaker Heights, Ohio
GPS#	102
Lot #	120
Name	Unknown
Date of Death	
Material	marble
Marker Type	die with base
Inscription	Unreadable
Stone Condition	Ambient dirt, biological growth, leaning, sunken base
Recommendations	Clean, treat biological growth, reset base plumb, reset die with lime mortar

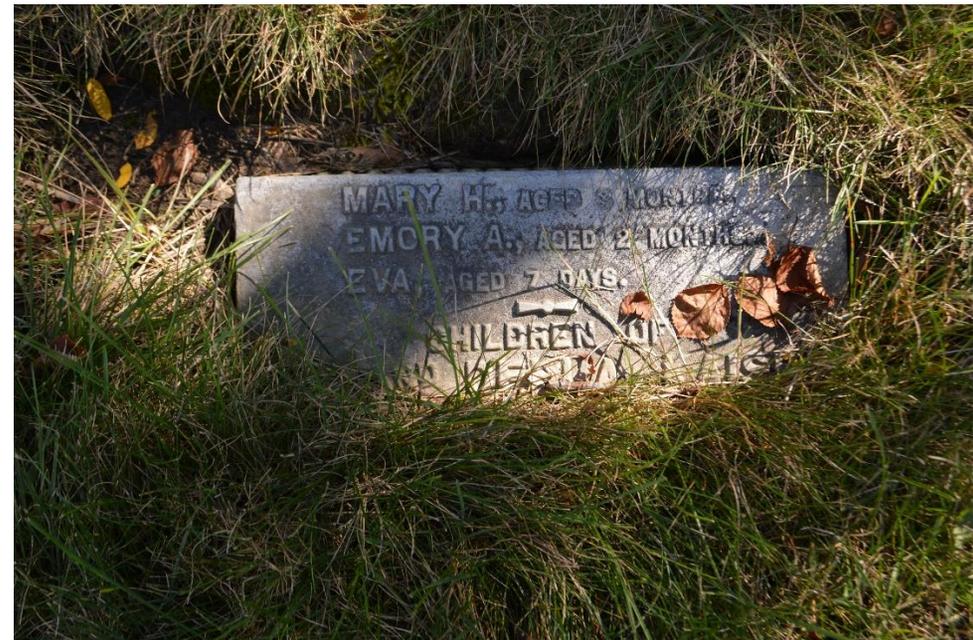
Cemetery	Warrensville West Cemetery
Location	Lee Rd., Shaker Heights, Ohio
GPS#	103
Lot #	119
Name	Kaise, Mary, Emory, Eva
Date of Death	
Material	zinc
Marker Type	marker
Inscription	MARY H. AGED 3 MONTHS/EMORY A. AGED 2 MONTHS/EVA AGED 7 DAYS/CHILDREN OF/A.C. AND DELLA KAISER
Stone Condition	Ambient dirt, biological growth, sunken, overgrown
Recommendations	Clean, treat biological growth, reset plumb at correct height

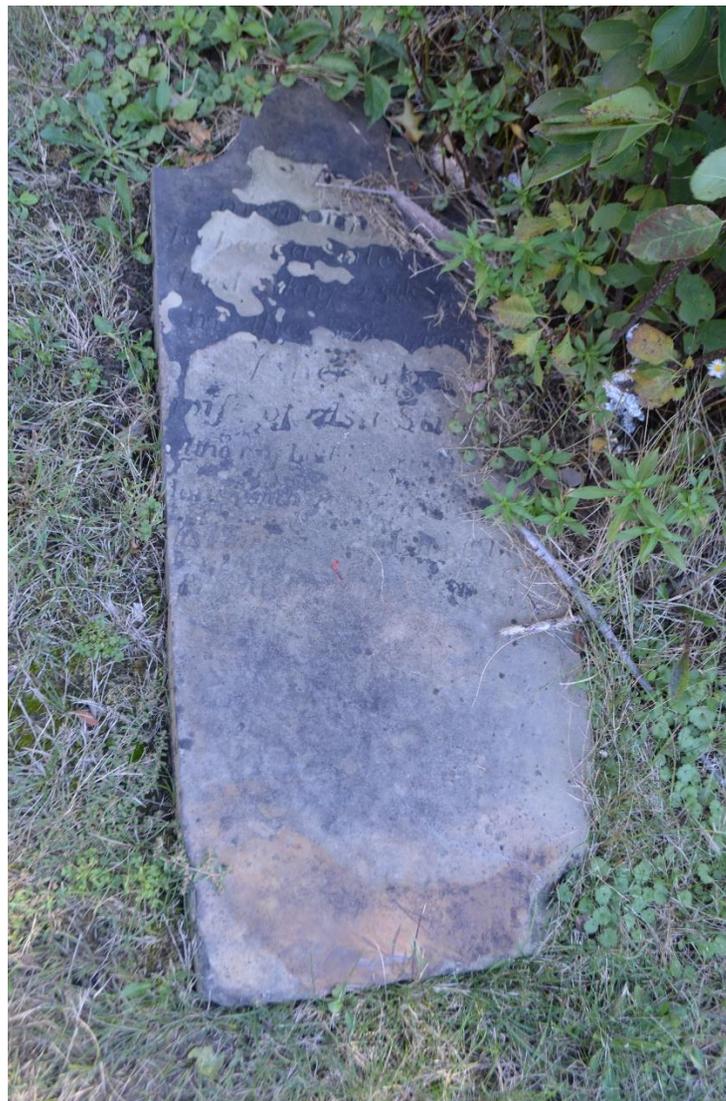
Ambient dirt, biological growth, fallen,
missing base, impacted by bush/tree

Clean, treat biological growth, trim or
remove bushes, locate base,reset tablet
with lime mortar

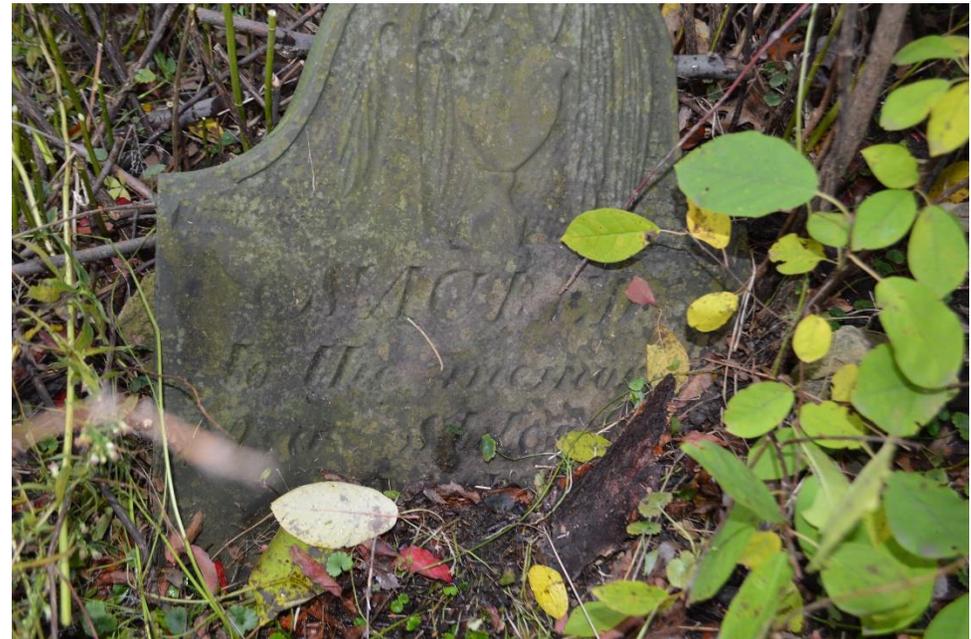
Ambient dirt, biological growth, fallen,
missing base, impacted by bush/tree

Clean, treat biological growth, trim or
remove bushes, locate base, reset tablet
with lime mortar

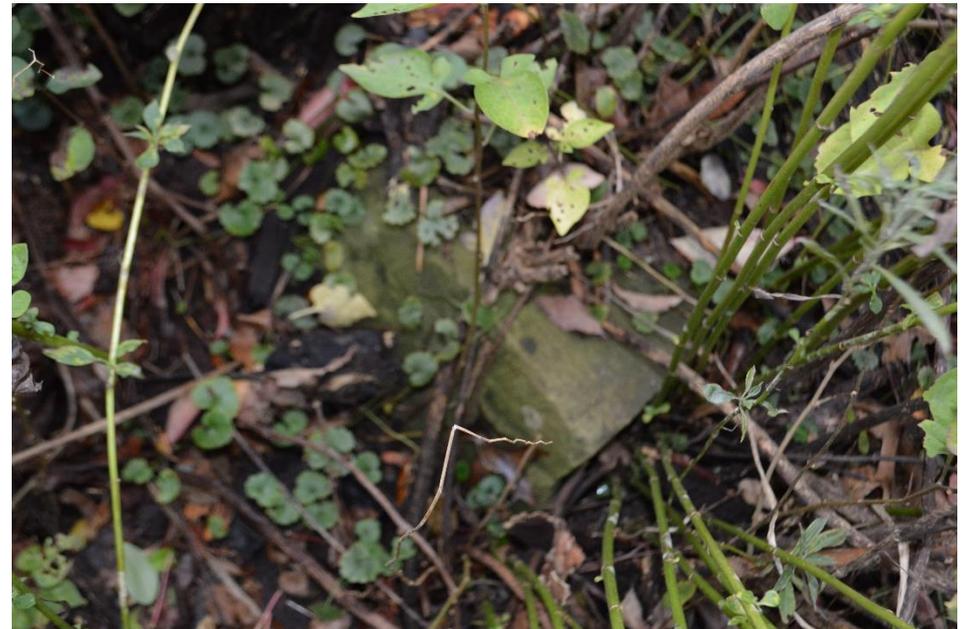
Ambient dirt, biological growth, sunken, impacted by bush/tree, missing stone, may be associated with #104A

Clean, treat biological growth, trim or remove bushes, locate stone, reset tablet with lime mortar

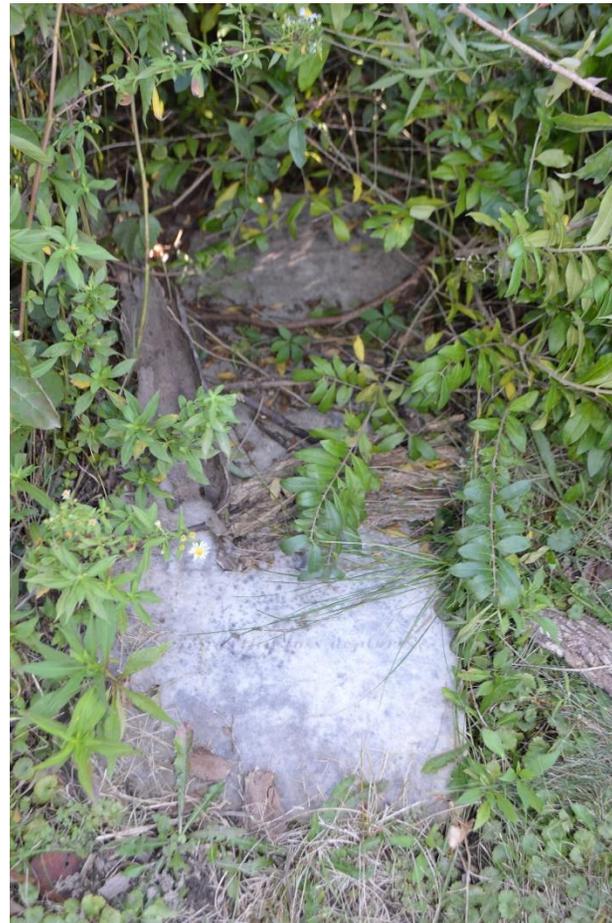
Ambient dirt, biological growth, fallen, missing base, impacted by bush/tree

Clean, treat biological growth, trim or remove bushes, locate base, reset tablet with lime mortar

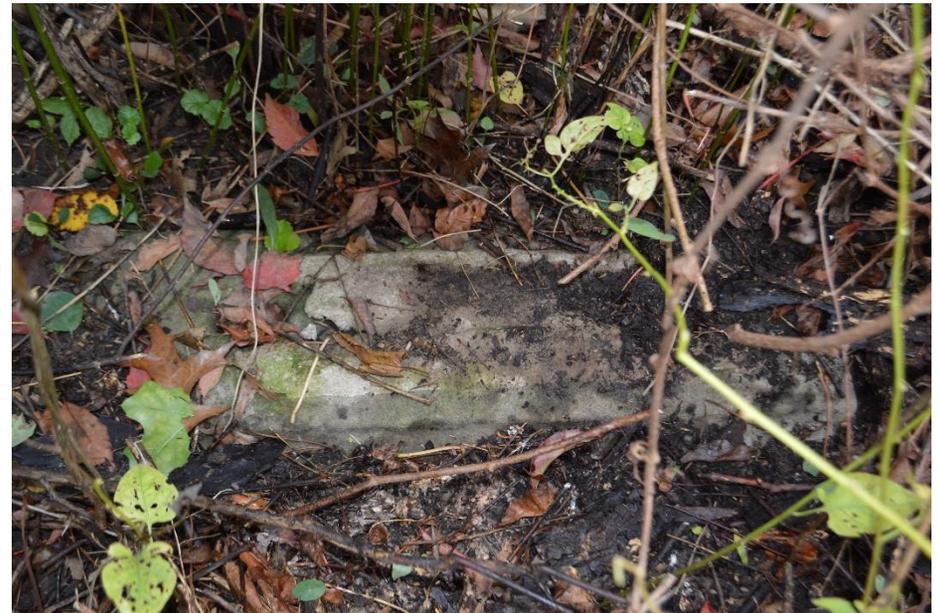
Ambient dirt, biological growth, sunken, impacted by bush/tree, missing stone, may be associated with #105

Clean, treat biological growth, trim or remove bushes, locate stone, reset tablet with lime mortar

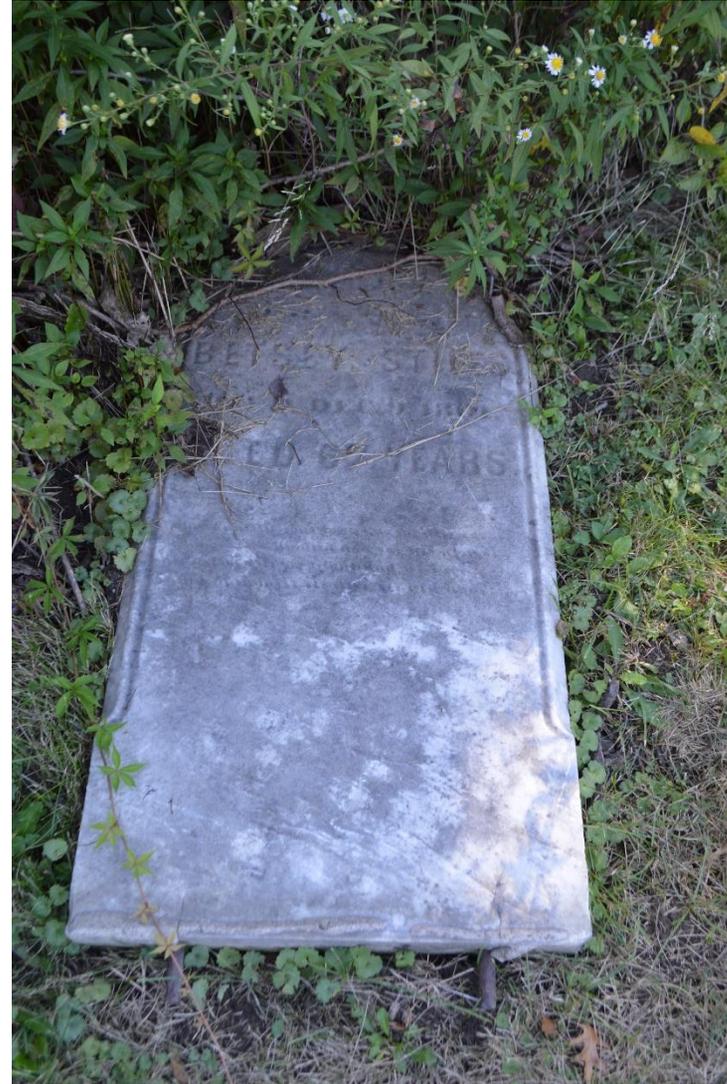
Ambient dirt, biological growth, fallen,
missing base, impacted by bush/tree

Clean, treat biological growth, trim or
remove bushes, locate base,reset tablet
with lime mortar

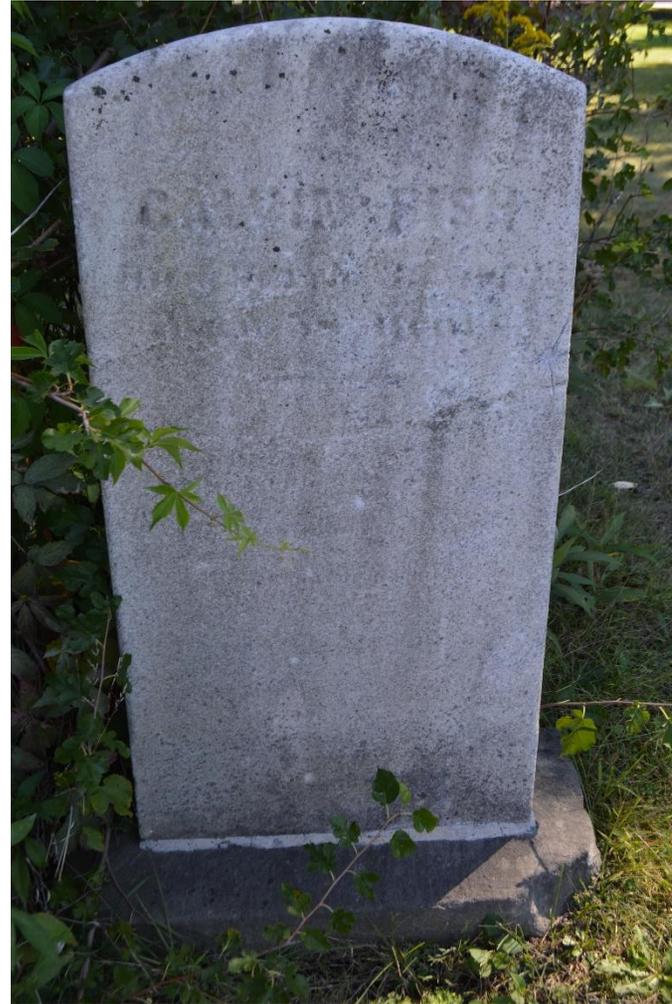
Cemetery	Warrensville West Cemetery
Location	Lee Rd., Shaker Heights, Ohio
GPS#	107
Lot #	127
Name	Fish, Calvin
Date of Death	March 31, 1873
Material	marble
Marker Type	tablet with base
Inscription	In memory of my husband/CALVIN FISH/Died March 31, 1873/Aged 58 Years
Stone Condition	Ambient dirt, biological growth, leaning, impacted by bush/tree
Recommendations	Clean, treat biological growth, trim or remove bushes, reset plumb at correct height

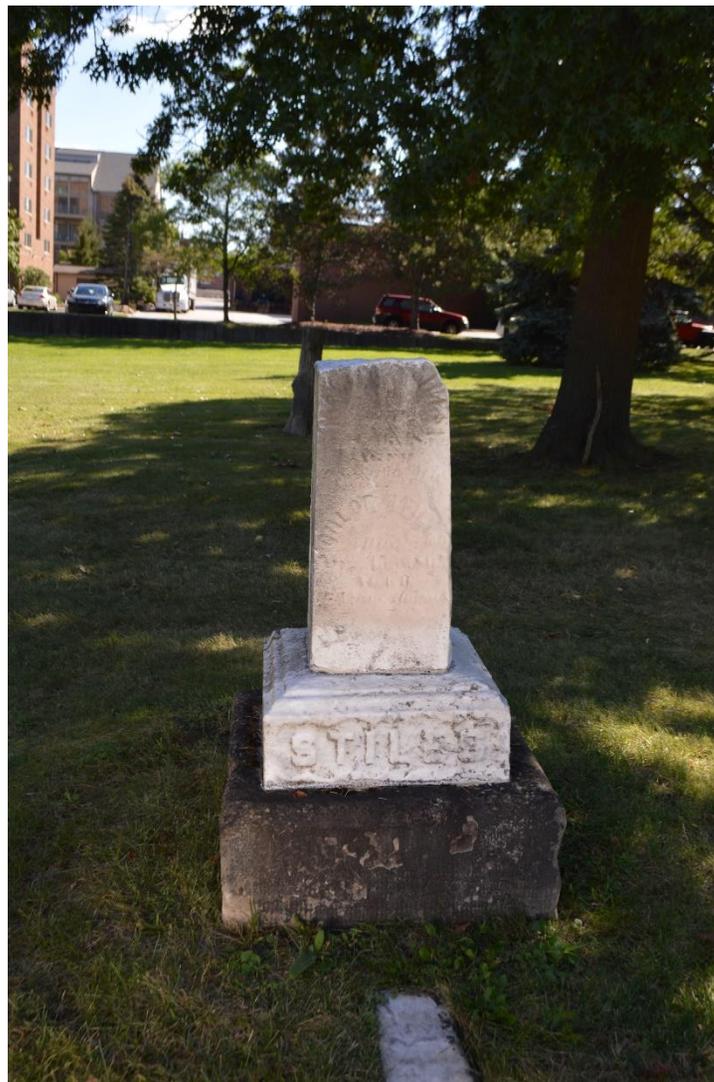
Cemetery	Warrensville West Cemetery
Location	Lee Rd., Shaker Heights, Ohio
GPS#	108
Lot #	128
Name	Stiles, Hiram & Martha
Date of Death	May 29, 1865 & July 16, 1855
Material	marble
Marker Type	obelisk
Inscription	HIRAM STILES/DIED/May 29, 1865/AGED//MARTHA STILES/Died/July 16, 1855/AGED/19Yrs. 11 Ms. 21 Ds./CHLOE STILES/Died/Aug 15, 1865/AGED/16 Yrs. 16 Ds/MANDANA STILES
Stone Condition	Ambient dirt, biological growth, broken, 2 fragments, leaning, missing mortar
Recommendations	Clean, treat biological growth, reset base plumb, reassemble with lime mortar, reattach fragments

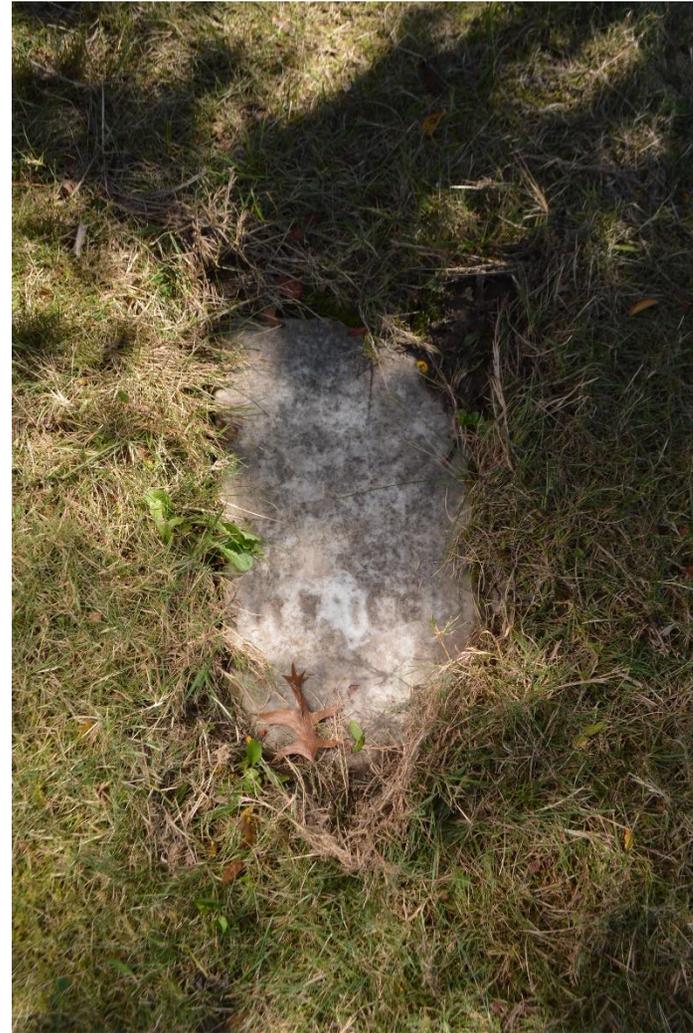
Stone Condition
Ambient dirt, biological growth, fallen,
sunken

Recommendations
Clean, treat biological growth, reset
plumb at correct height

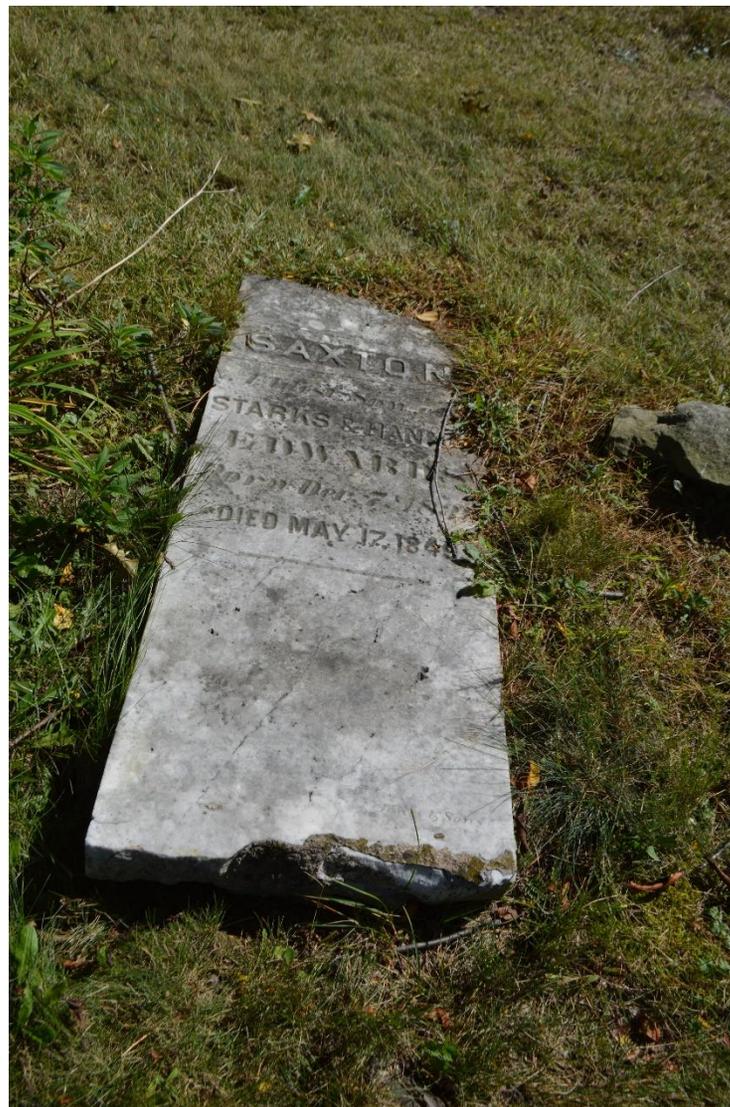
Cemetery	Warrensville West Cemetery
Location	Lee Rd., Shaker Heights, Ohio
GPS#	110
Lot #	131
Name	Edwards, Saxton
Date of Death	Dec. 7, 1830
Material	marble
Marker Type	tablet with base
Inscription	SAXTON/Eldest Son of/STARKS & HANNAH/EDWARDS/Born Dec. 7, 1830/Died May 17,1849
Stone Condition	Ambient dirt, biological growth, fallen, missing base
Recommendations	Clean, treat biological growth, locate base, reset tablet with lime mortar

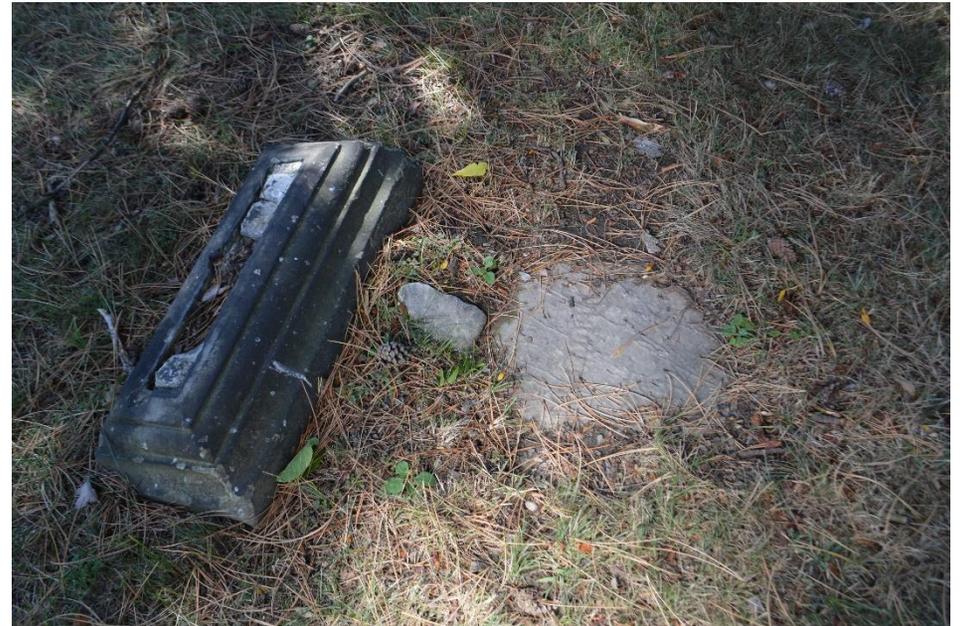
Cemetery	Warrensville West Cemetery
Location	Lee Rd., Shaker Heights, Ohio
GPS#	111
Lot #	133
Name	Unknown
Date of Death	
Material	marble
Marker Type	die with base
Inscription	
Stone Condition	Ambient dirt, biological growth, broken, many fragments
Recommendations	Clean, treat biological growth, reset plumb at correct height, reattach fragments

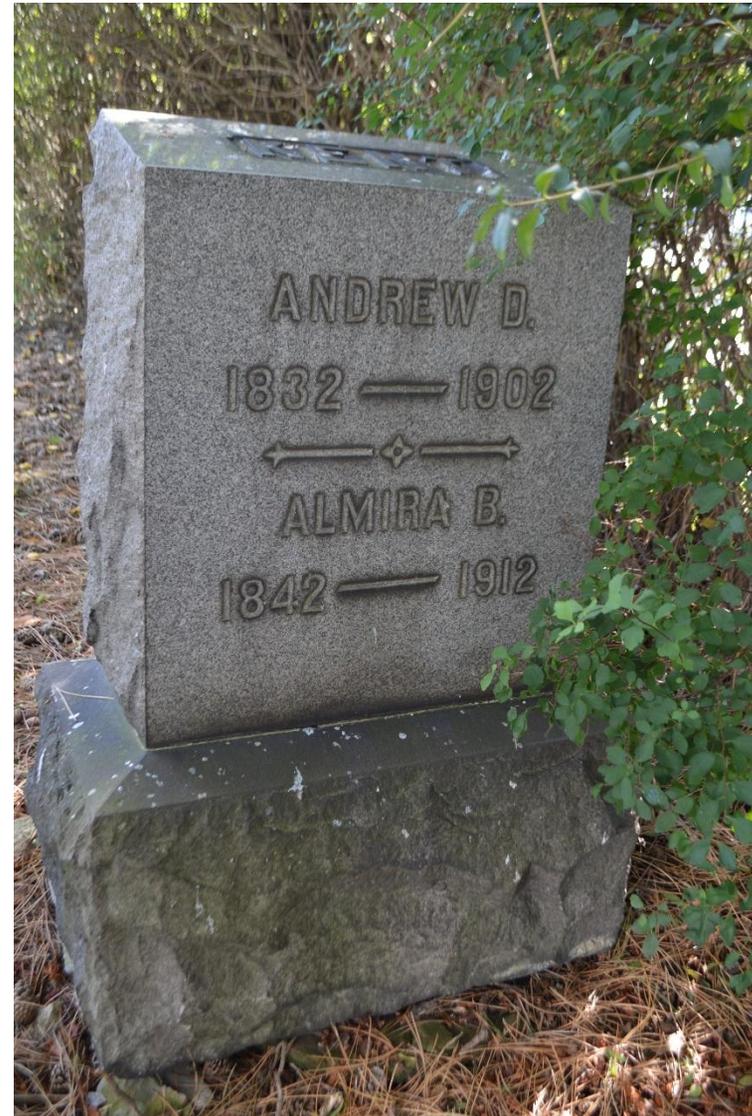
Cemetery	Warrensville West Cemetery
Location	Lee Rd., Shaker Heights, Ohio
GPS#	112
Lot #	134
Name	Kent, Andrew & Almira
Date of Death	1902 & 1912
Material	granite
Marker Type	die with base
Inscription	KENT/ANDREW D./1832- 1902/ALMIRA B./1842-1912
Stone Condition	Ambient dirt, biological growth, tilted, leaning, impacted by bushes
Recommendations	Clean, treat biological growth, trim or remove bushes, reset base plumb, reassemble with lime mortar

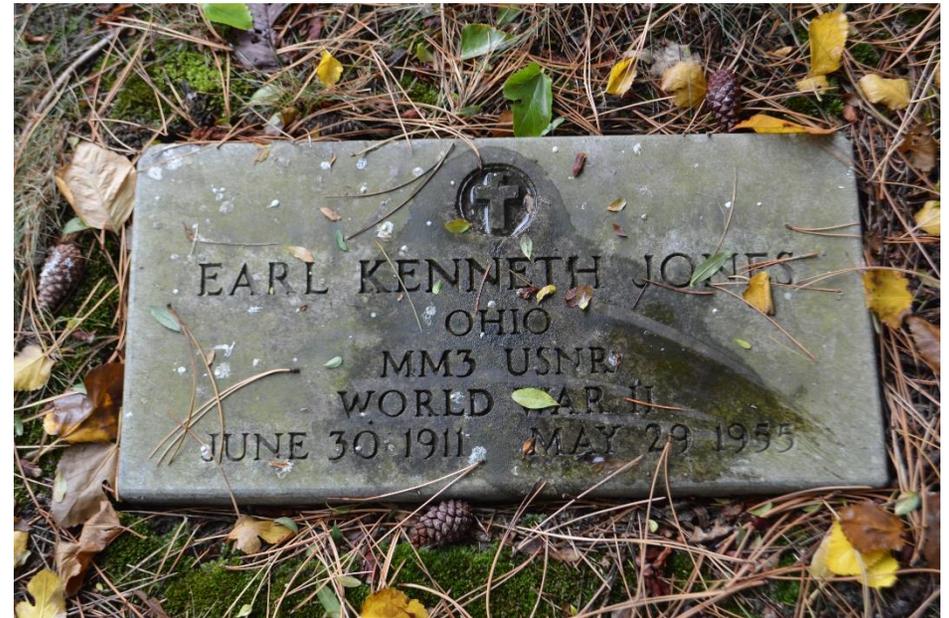
Cemetery	Warrensville West Cemetery
Location	Lee Rd., Shaker Heights, Ohio
GPS#	113
Lot #	140
Name	Jones, Earl Kenneth
Date of Death	May 29, 1955
Material	granite
Marker Type	marker
Inscription	EARL KENNETH JONES/OHIO/MM3 USNR/WORLD WAR II/JUNE 30 1911 MAY 29 1955
Stone Condition	Ambient dirt, biological growth, good condition
Recommendations	Clean, treat biological growth

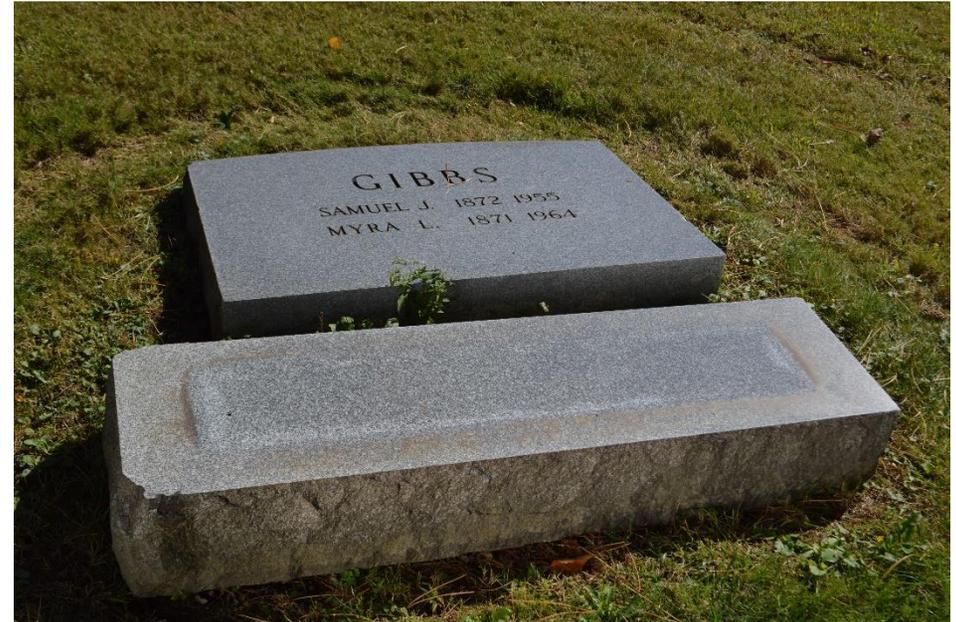
Cemetery	Warrensville West Cemetery
Location	Lee Rd., Shaker Heights, Ohio
GPS#	114
Lot #	139
Name	Gibbs, Samuel & Myra
Date of Death	1955 & 1964
Material	granite
Marker Type	die with base
Inscription	GIBBS/SAMUEL J. 1872 1955/MYRA L. 1871 1964
Stone Condition	Ambient dirt, biological growth, fallen, chipped corners
Recommendations	Clean, treat biological growth, reset base plumb, reset die with lime mortar

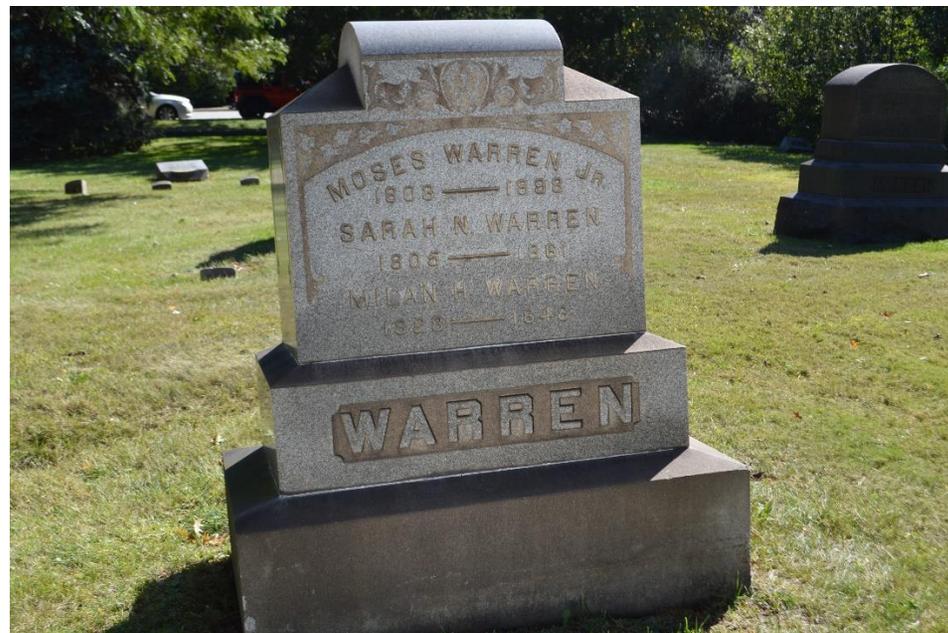
Stone Condition
Ambient dirt, biological growth, fallen,
chipped corners

Recommendations
Clean, treat biological growth, reset base
plumb, reset die with lime mortar

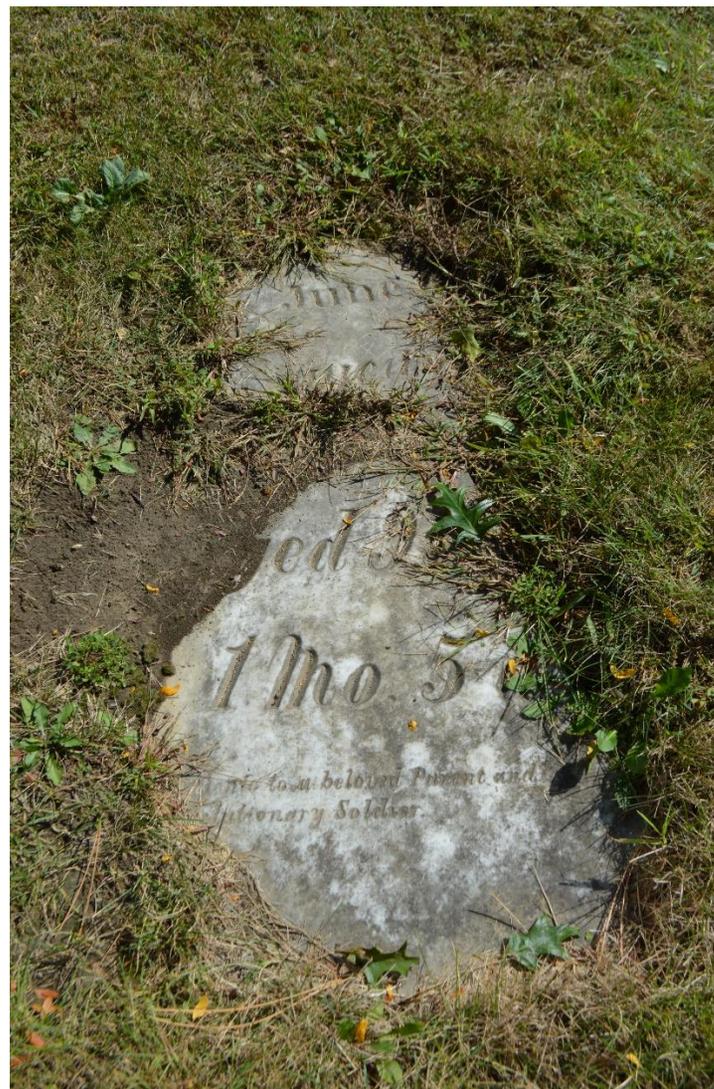
Cemetery	Warrensville West Cemetery
Location	Lee Rd., Shaker Heights, Ohio
GPS#	116
Lot #	137
Name	Unknown
Date of Death	
Material	marble
Marker Type	tablet with base
Inscription	<p>//AGED 91 Yrs. 1 Mo. 5 D/Memento to a beloved Parent and/Revolutionary Soldier</p>
Stone Condition	Ambient dirt, biological growth, fallen, broken, many fragments, missing material
Recommendations	Clean, treat biological growth, locate fragments, create base, reassemble with restoration mortar

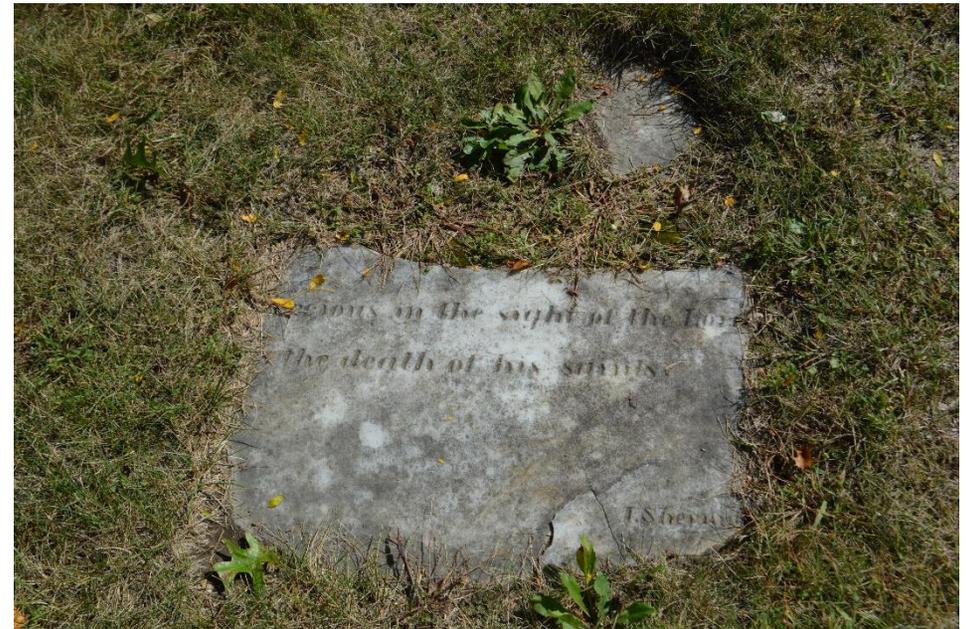
Cemetery	Warrensville West Cemetery
Location	Lee Rd., Shaker Heights, Ohio
GPS#	117
Lot #	136
Name	Unknown
Date of Death	
Material	marble
Marker Type	tablet with base
Inscription	//Precious in the sight of the Lord/is the death of his saints//I. Sherman
Stone Condition	Ambient dirt, biological growth, fallen, broken, many fragments, missing material
Recommendations	Clean, treat biological growth, locate fragments, create base, reassemble with restoration mortar

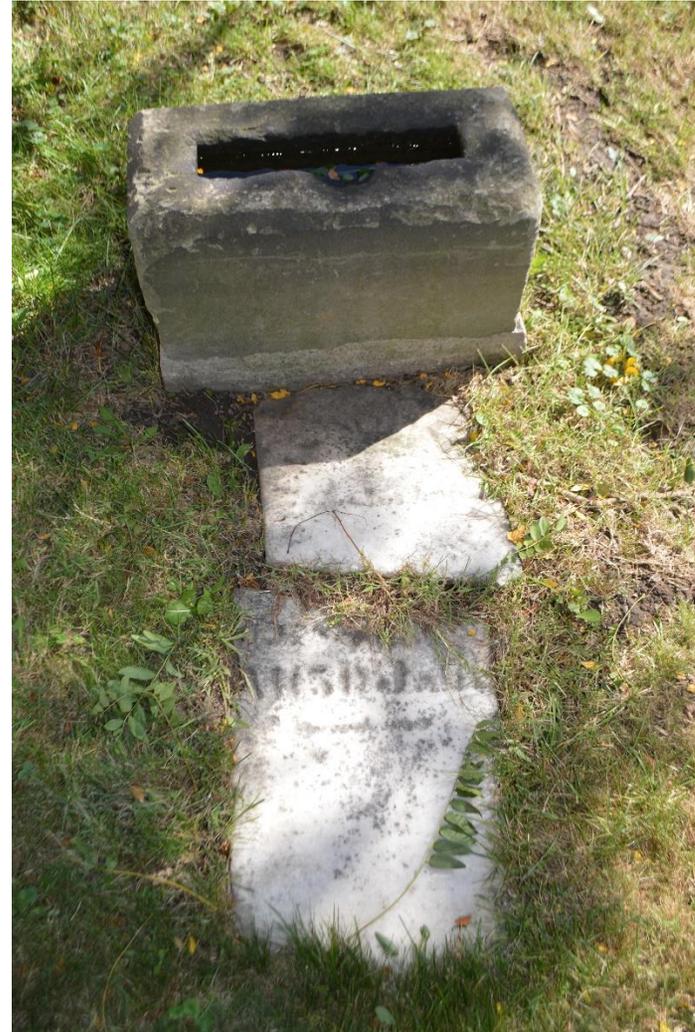
Stone Condition
Ambient dirt, biological growth, fallen,
broken, 2 fragments, missing material

Recommendations
Clean, treat biological growth, reset base
plumb, reset tablet with lime mortar,
reattach fragments

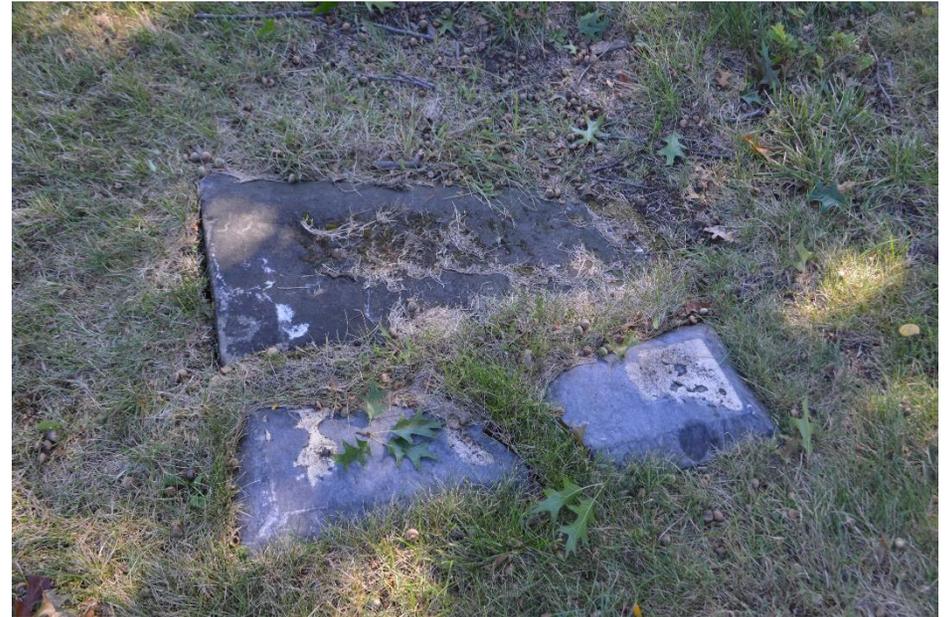
Cemetery	Warrensville West Cemetery
Location	Lee Rd., Shaker Heights, Ohio
GPS#	119
Lot #	
Name	Unknown
Date of Death	
Material	marble
Marker Type	die with base
Inscription	
Stone Condition	Ambient dirt, biological growth, sunken foundation stone, broken plinth, missing die
Recommendations	Clean, treat biological growth, locate die, reset base plumb, reassemble plinth with restoration mortar, reset die with lime mortar

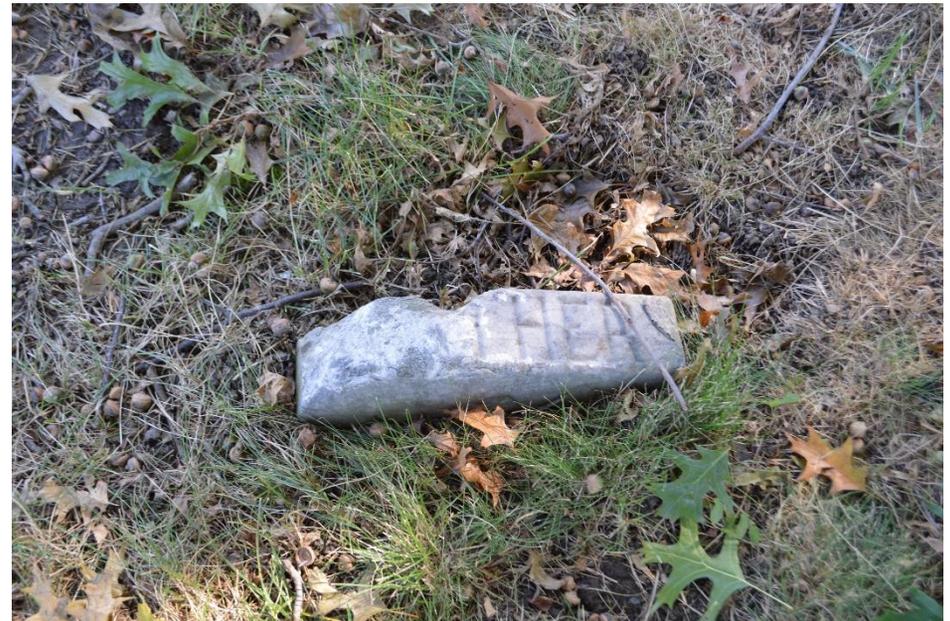
Cemetery	Warrensville West Cemetery
Location	Lee Rd., Shaker Heights, Ohio
GPS#	120
Lot #	
Name	Unknown
Date of Death	
Material	marble
Marker Type	die with base
Inscription	--THER
Stone Condition	Ambient dirt, biological growth, sunken, corner broken, missing material, impacted by tree
Recommendations	Clean, treat biological growth, remove from roots, reset plumb

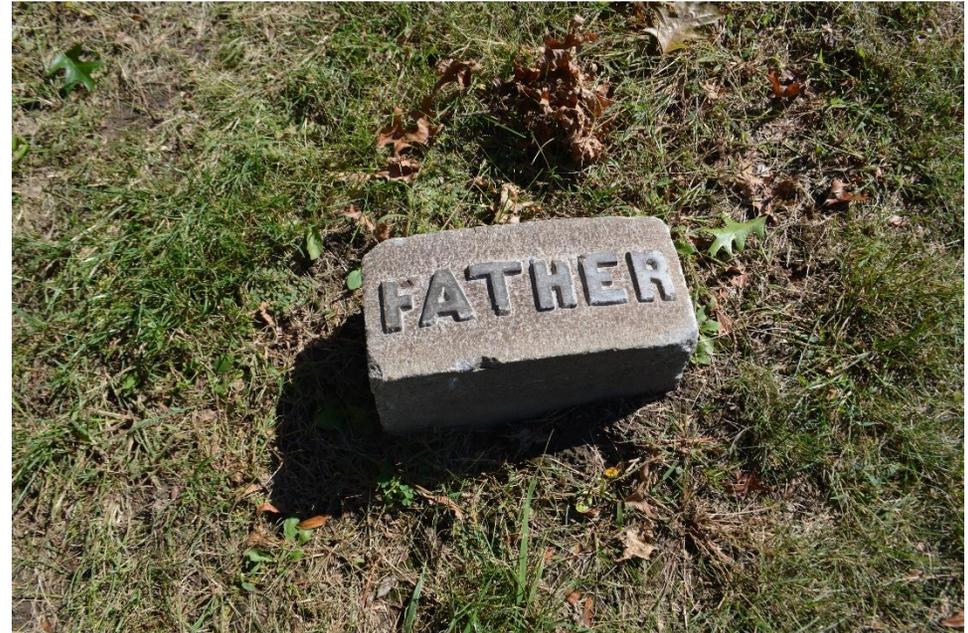
Cemetery	Warrensville West Cemetery
Location	Lee Rd., Shaker Heights, Ohio
GPS#	121A
Lot #	142
Name	Adams, Father
Date of Death	
Material	granite
Marker Type	marker
Inscription	FATHER
Stone Condition	Ambient dirt, biological growth, leaning, chipped edges
Recommendations	Clean, treat biological growth, reset plumb at correct height

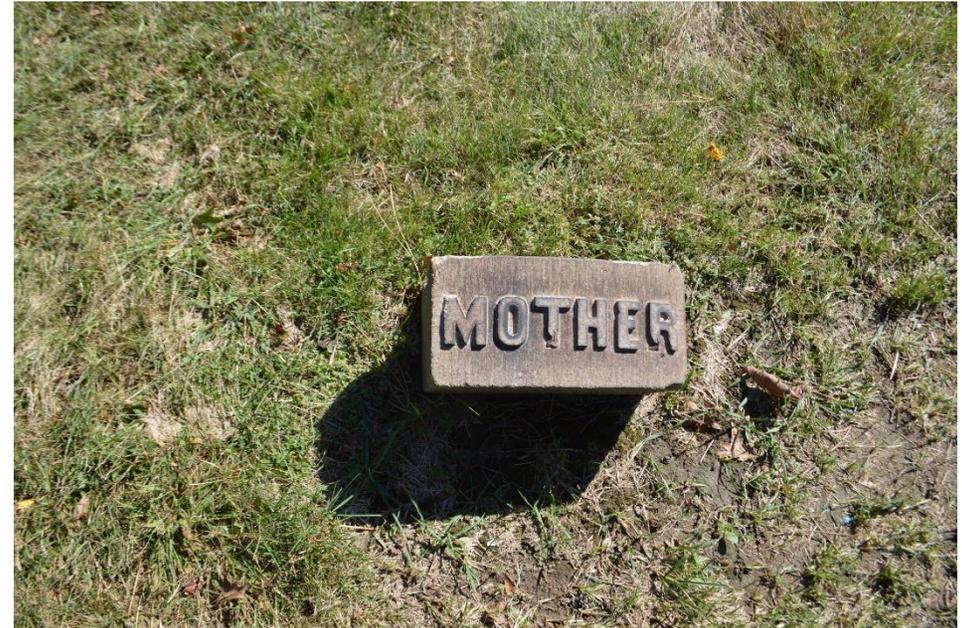
Cemetery	Warrensville West Cemetery
Location	Lee Rd., Shaker Heights, Ohio
GPS#	121B
Lot #	143
Name	Adams, Father
Date of Death	
Material	granite
Marker Type	marker
Inscription	MOTHER
Stone Condition	Ambient dirt, biological growth, leaning, chipped edges, missing material
Recommendations	Clean, treat biological growth, reset plumb at correct height

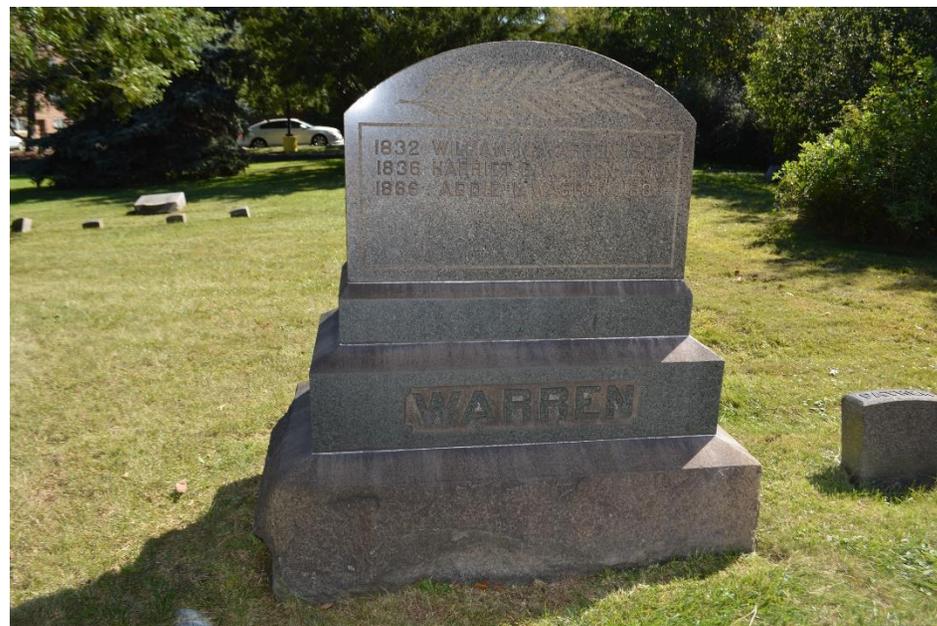
Cemetery	Warrensville West Cemetery
Location	Lee Rd., Shaker Heights, Ohio
GPS#	122
Lot #	144
Name	Warren, Wm & Woodward, George
Date of Death	1902 & 1907
Material	granite
Marker Type	die with base
Inscription	1832 WILLIAM M. WARREN 1902/1836 HARRIET B. WARREN 1919/1866 ADDIE L. WARREN 1883// 1823 GEORGE WOODWARD 1907/ 1830 LEORA H. WOODWARD / 1865 ARLETTA L. WOODWARD 1866/1873 LAURENCE L. WOODWARD 1874
Stone Condition	Ambient dirt, biological growth, good condition
Recommendations	Clean, treat biological growth

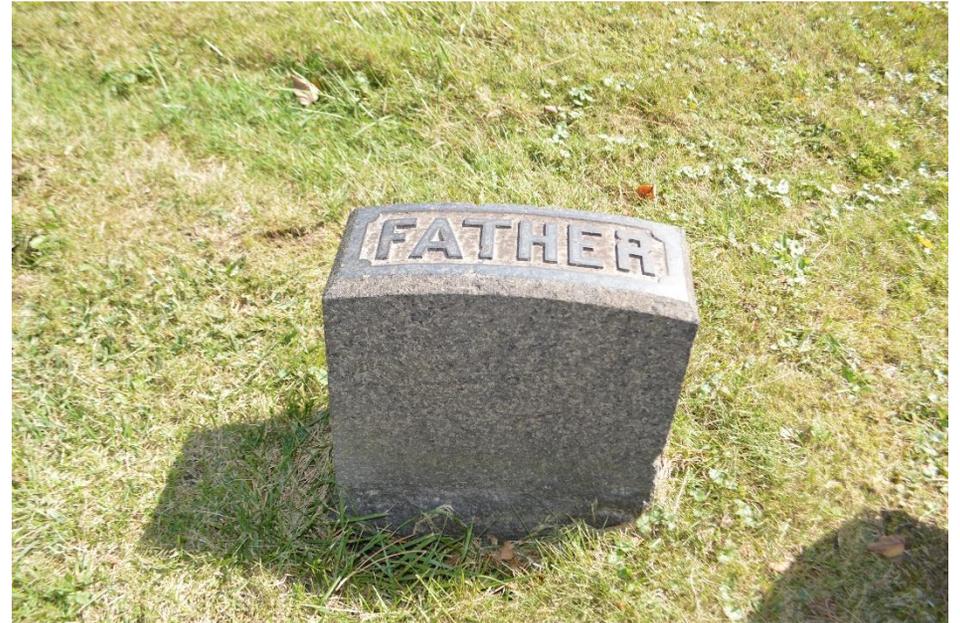
Cemetery	Warrensville West Cemetery
Location	Lee Rd., Shaker Heights, Ohio
GPS#	122A
Lot #	145
Name	Warren, Father
Date of Death	
Material	granite
Marker Type	marker
Inscription	FATHER
Stone Condition	Ambient dirt, biological growth, tilted, set too high
Recommendations	Clean, treat biological growth, reset plumb at correct height

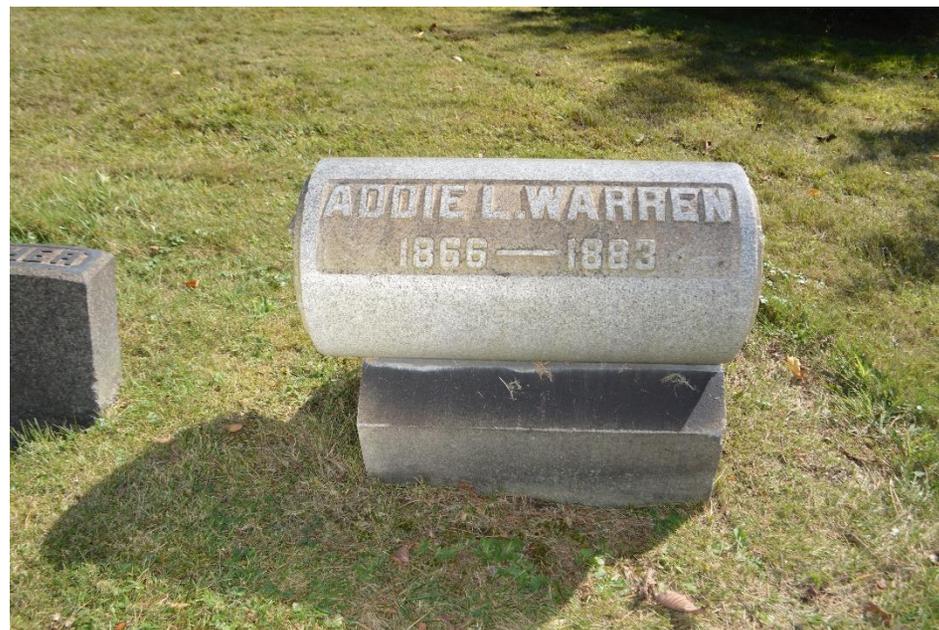
Stone Condition

Clean, treat biological growth, remove caulk, reset base plumb, reset die with lime mortar

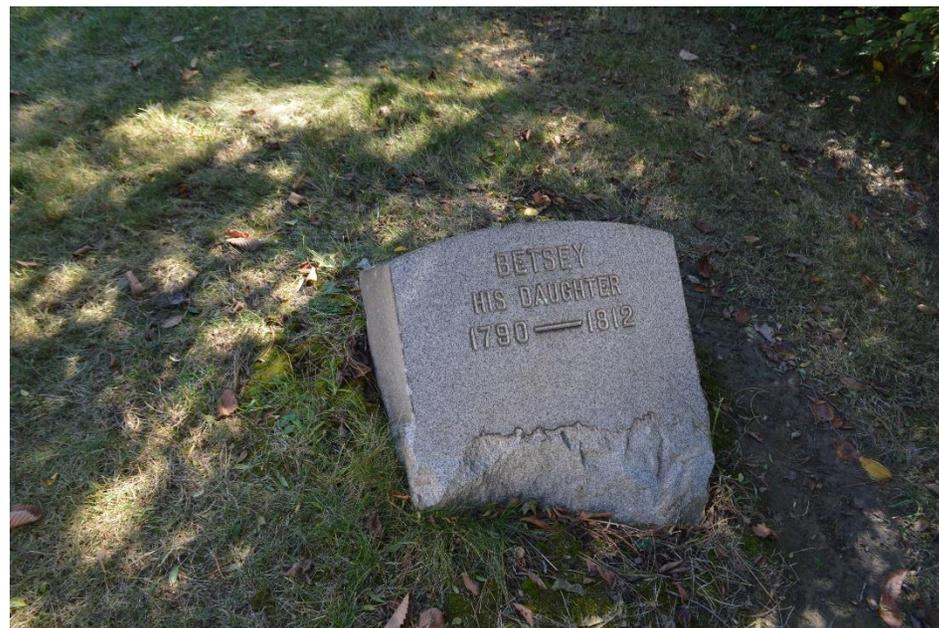
Cemetery	Warrensville West Cemetery
Location	Lee Rd., Shaker Heights, Ohio
GPS#	124
Lot #	147
Name	Prentiss, James & Betsey
Date of Death	1817 & 1812
Material	granite
Marker Type	marker
Inscription	JAMES PRENTISS/1755 – 1817/"A REVOLUTIONARY SOLDIER"/BETSEY/HIS DAUGHTER/1790 - 1812
Stone Condition	Ambient dirt, biological growth, leaning more than 45°, chipped edges
Recommendations	Clean, treat biological growth, reset plumb at correct height
