final report
**WARRENSVILLE WEST
CEMETERY**
HISTORIC PRESERVATION MASTER PLAN

COMPLETED 03-14-2022

**SHAKER
HEIGHTS**

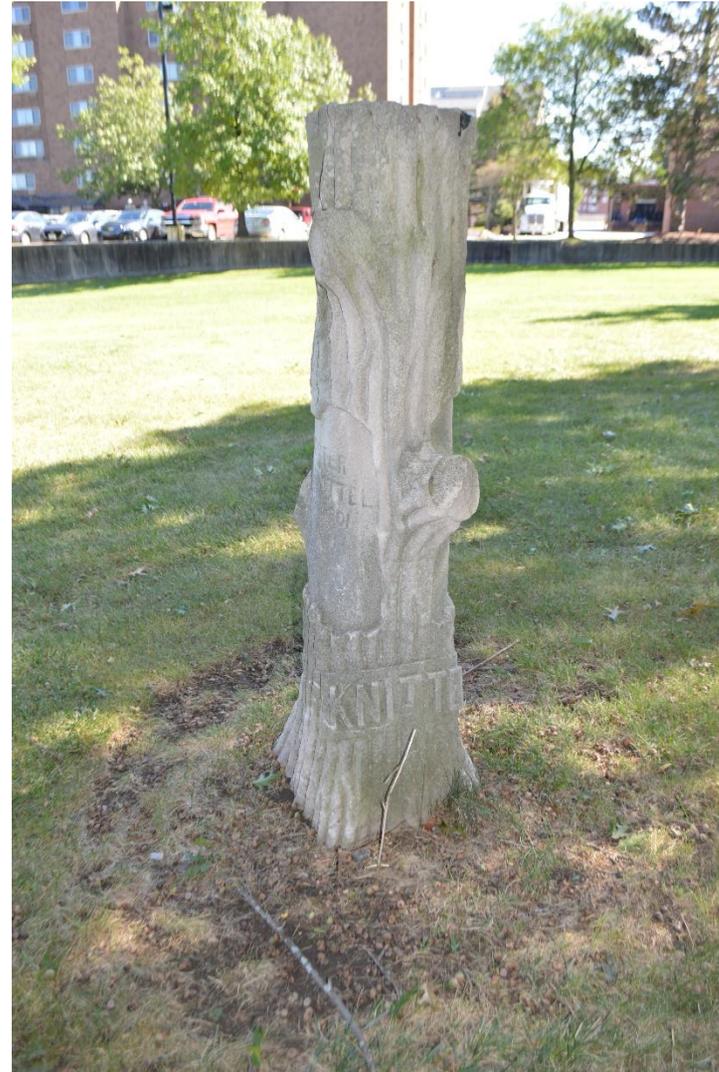
Cemetery	Warrensville West Cemetery
Location	Lee Rd., Shaker Heights, Ohio
GPS#	125
Lot #	149
Name	Knittel, Sylvester & Katharina
Date of Death	1901
Material	limestone
Marker Type	tree
Inscription	SYLVESTER/KNITTEL/1824 – 1901/KATHARINA/WIFE OF/SYLVESTER KNITTEL/1822 – 1885/ KNITTEL
Stone Condition	Ambient dirt, biological growth, leaning, chipped around bottom edge
Recommendations	Clean, treat biological growth, reset plumb at correct height

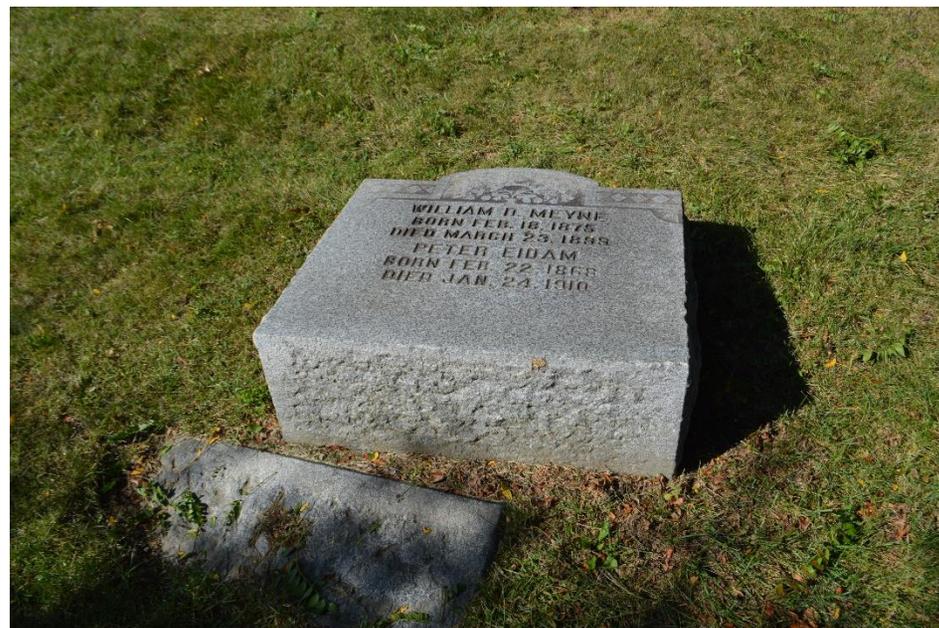
Stone Condition

Clean, treat biological growth, reset base
plumb at correct height, reset die with
lime mortar

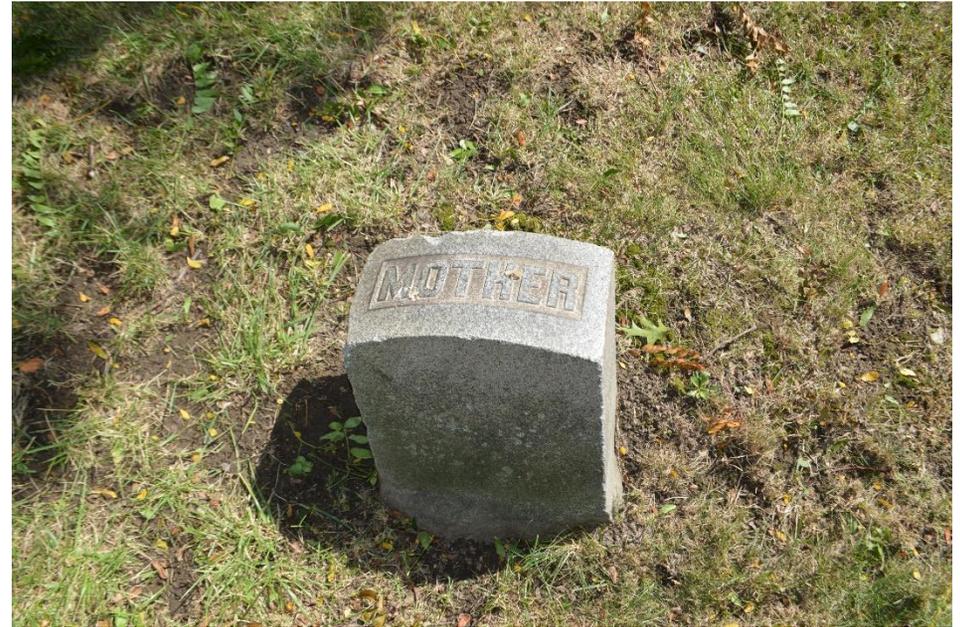
Cemetery	Warrensville West Cemetery
Location	Lee Rd., Shaker Heights, Ohio
GPS#	126A
Lot #	151
Name	Eidam, Mother
Date of Death	
Material	granite
Marker Type	marker
Inscription	MOTHER
Stone Condition	Ambient dirt, biological growth, tilted, set too high
Recommendations	Clean, treat biological growth, reset plumb at correct height

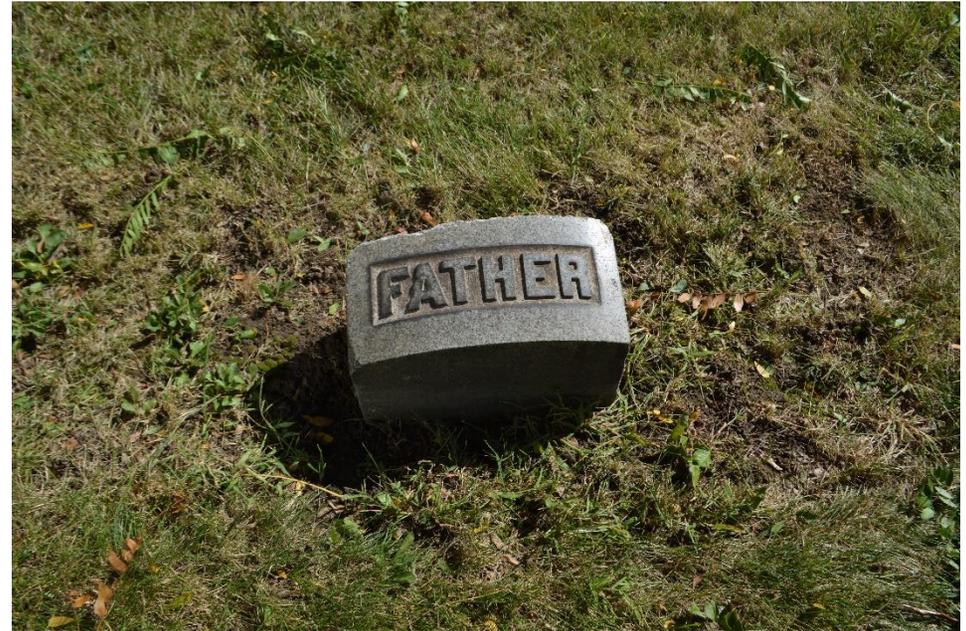
Cemetery	Warrensville West Cemetery
Location	Lee Rd., Shaker Heights, Ohio
GPS#	126B
Lot #	152
Name	Eidam, Father
Date of Death	
Material	granite
Marker Type	marker
Inscription	FATHER
Stone Condition	Ambient dirt, biological growth, sunken, leaning
Recommendations	Clean, treat biological growth, reset plumb at correct height

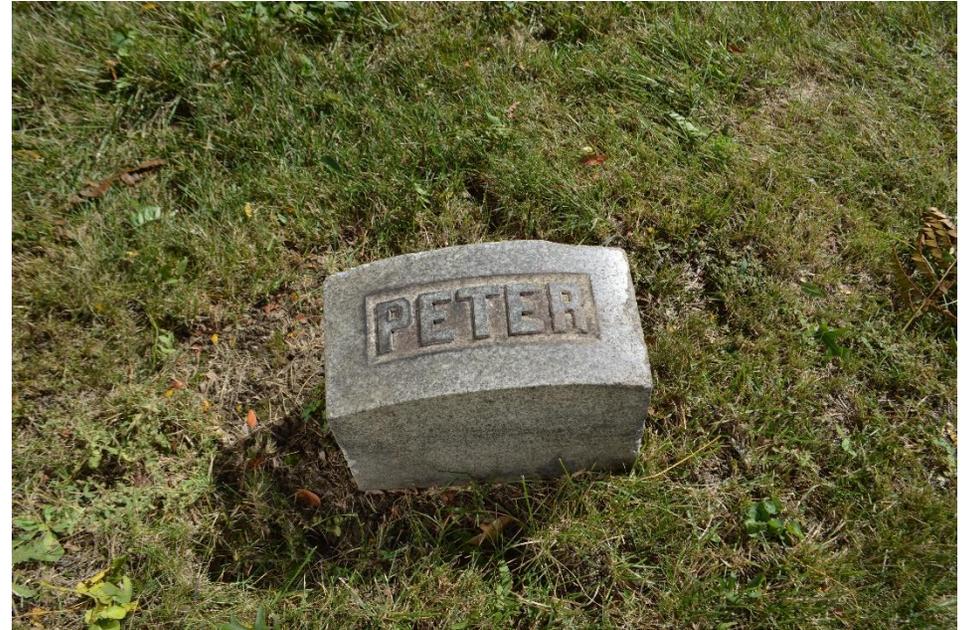
Cemetery	Warrensville West Cemetery
Location	Lee Rd., Shaker Heights, Ohio
GPS#	126C
Lot #	153
Name	Eidam, Peter
Date of Death	
Material	granite
Marker Type	marker
Inscription	PETER
Stone Condition	Ambient dirt, biological growth, leaning, chipped corners
Recommendations	Clean, treat biological growth, reset plumb at correct height

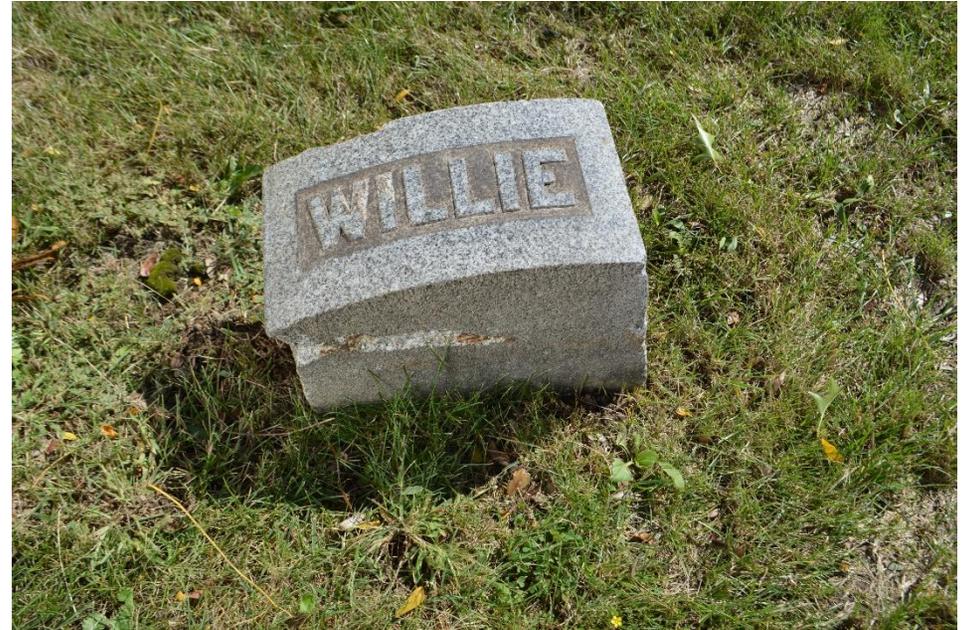
Cemetery	Warrensville West Cemetery
Location	Lee Rd., Shaker Heights, Ohio
GPS#	126D
Lot #	154
Name	Meyne, Willie
Date of Death	
Material	granite
Marker Type	marker
Inscription	WILLIE
Stone Condition	Ambient dirt, biological growth, leaning, chipped corners, missing material
Recommendations	Clean, treat biological growth, reset plumb at correct height

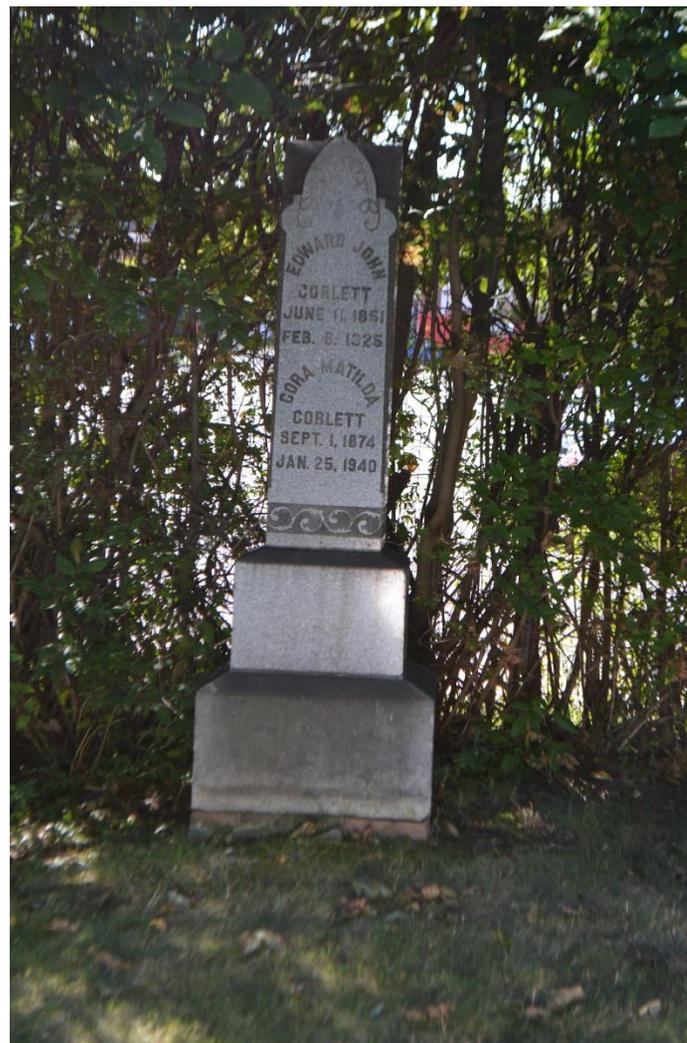
Cemetery	Warrensville West Cemetery
Location	Lee Rd., Shaker Heights, Ohio
GPS#	127
Lot #	150
Name	Corlett, Edward & Mary
Date of Death	March 12, 1903 & Aug 4, 1900
Material	granite
Marker Type	obelisk
Inscription	EDWARD CORLETT/NOV 24, 1824/MAR 12, 1903/MARY A. COWLEY/HIS WIFE/NOV 20, 1826/AUG 4, 1900/NATIVES OF THE/ISLES OF MAN//EDWARD JOHN/CORLETT/JUNE 11, 1851/FEB 6, 1925/CORA MATILDA/CORLETT/SEPT 1, 1874/JAN 25, 1940//MARY ANN/FEB 28, 1848/FEB 10, 1864/ELLEN JANE/
Stone Condition	Ambient dirt, biological growth, leaning, set on rubble, impacted by bushes
Recommendations	Clean, treat biological growth, remove rubble & bushes, reset base plumb,reassemble with lime mortar

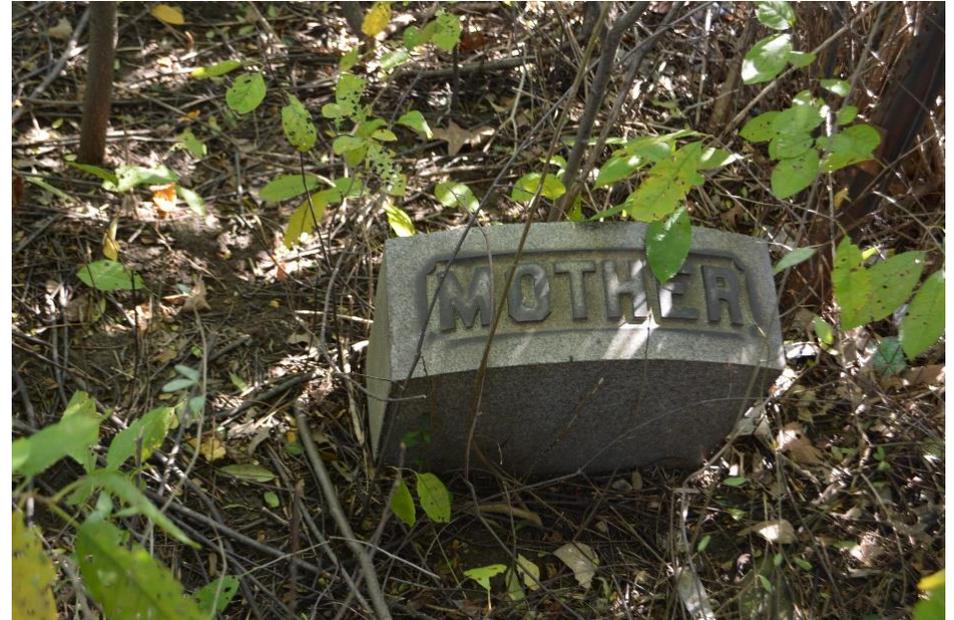
Cemetery	Warrensville West Cemetery
Location	Lee Rd., Shaker Heights, Ohio
GPS#	127A
Lot #	159
Name	Corlett, Mother
Date of Death	
Material	granite
Marker Type	marker
Inscription	MOTHER
Stone Condition	Ambient dirt, biological growth, leaning, impacted by bushes
Recommendations	Clean, treat biological growth, remove bushes, reset plumb at correct height

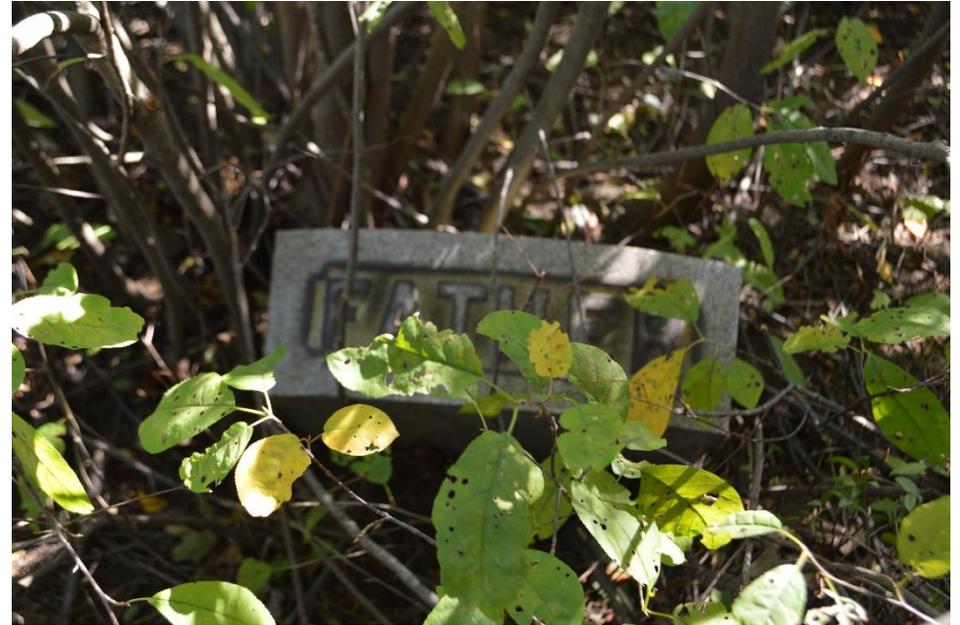
Cemetery	Warrensville West Cemetery
Location	Lee Rd., Shaker Heights, Ohio
GPS#	127B
Lot #	158
Name	Corlett, Father
Date of Death	
Material	granite
Marker Type	marker
Inscription	FATHER
Stone Condition	Ambient dirt, biological growth, leaning, impacted by bushes
Recommendations	Clean, treat biological growth, remove bushes, reset plumb at correct height

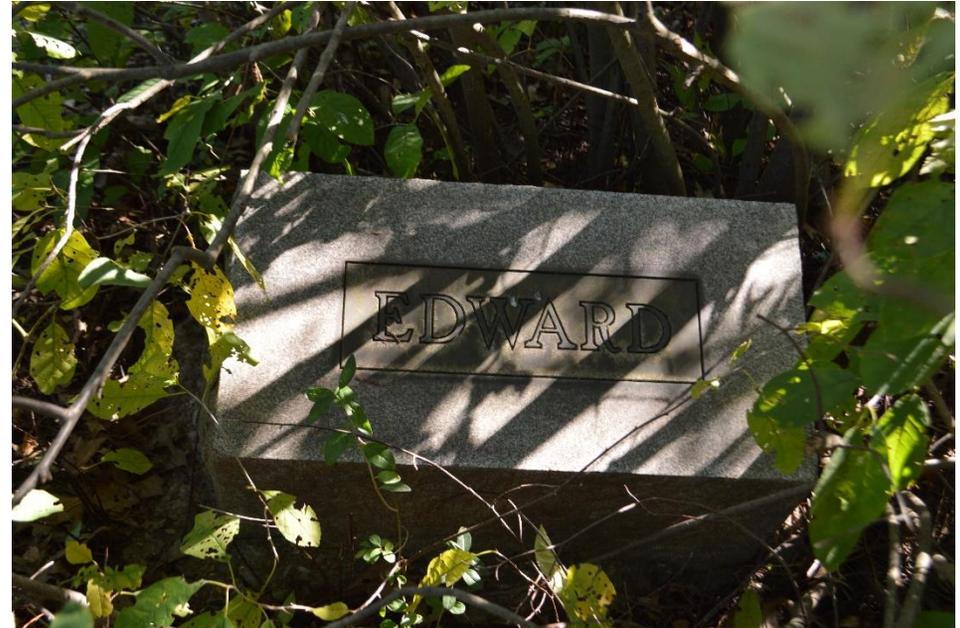
Cemetery	Warrensville West Cemetery
Location	Lee Rd., Shaker Heights, Ohio
GPS#	127C
Lot #	157
Name	Corlett, Edward
Date of Death	
Material	granite
Marker Type	marker
Inscription	EDWARD
Stone Condition	Ambient dirt, biological growth, leaning, impacted by bushes
Recommendations	Clean, treat biological growth, remove bushes, reset plumb at correct height

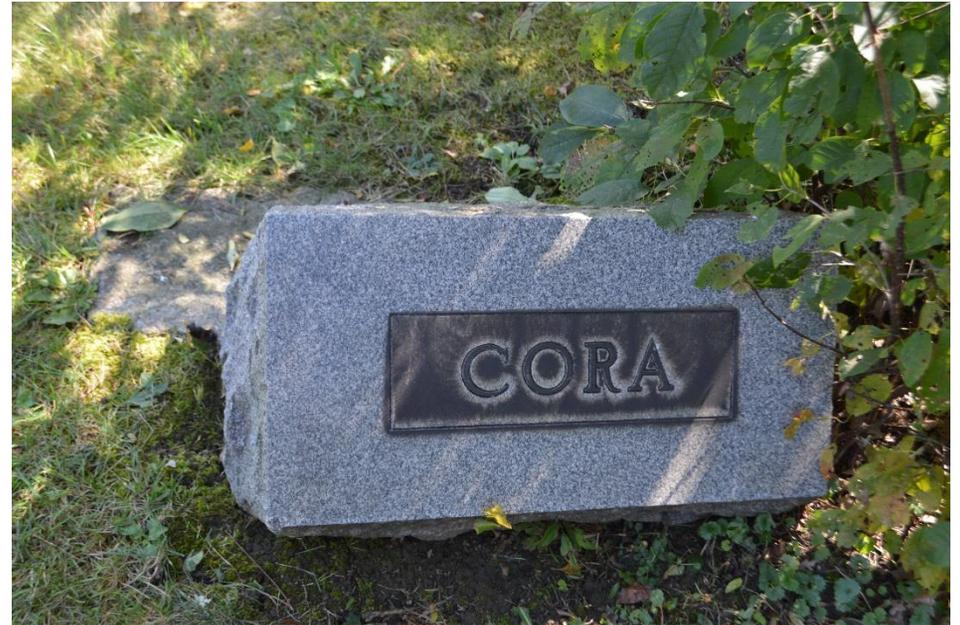
Cemetery	Warrensville West Cemetery
Location	Lee Rd., Shaker Heights, Ohio
GPS#	127D
Lot #	156
Name	Corlett, Cora
Date of Death	
Material	granite
Marker Type	marker
Inscription	CORA
Stone Condition	Ambient dirt, biological growth, fallen off concrete foundation, impacted by bushes
Recommendations	Clean, treat biological growth, remove bushes and concrete, reset plumb at correct height

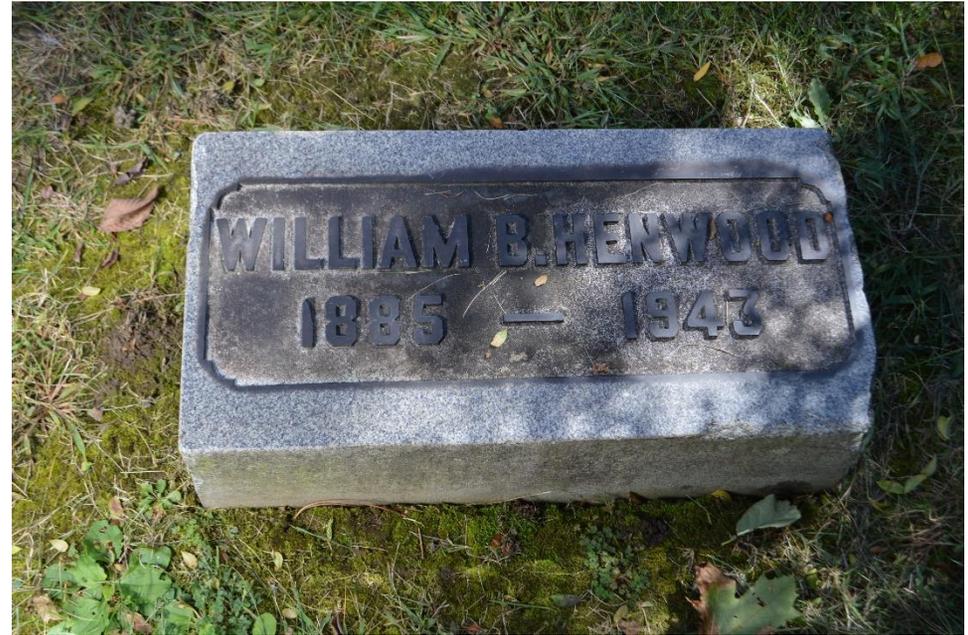
Cemetery	Warrensville West Cemetery
Location	Lee Rd., Shaker Heights, Ohio
GPS#	128
Lot #	160
Name	Henwood, William B.
Date of Death	1943
Material	granite
Marker Type	marker
Inscription	WILLIAM B. HENWOOD/1885 - 1943
Stone Condition	Ambient dirt, biological growth, good condition
Recommendations	Clean, treat biological growth

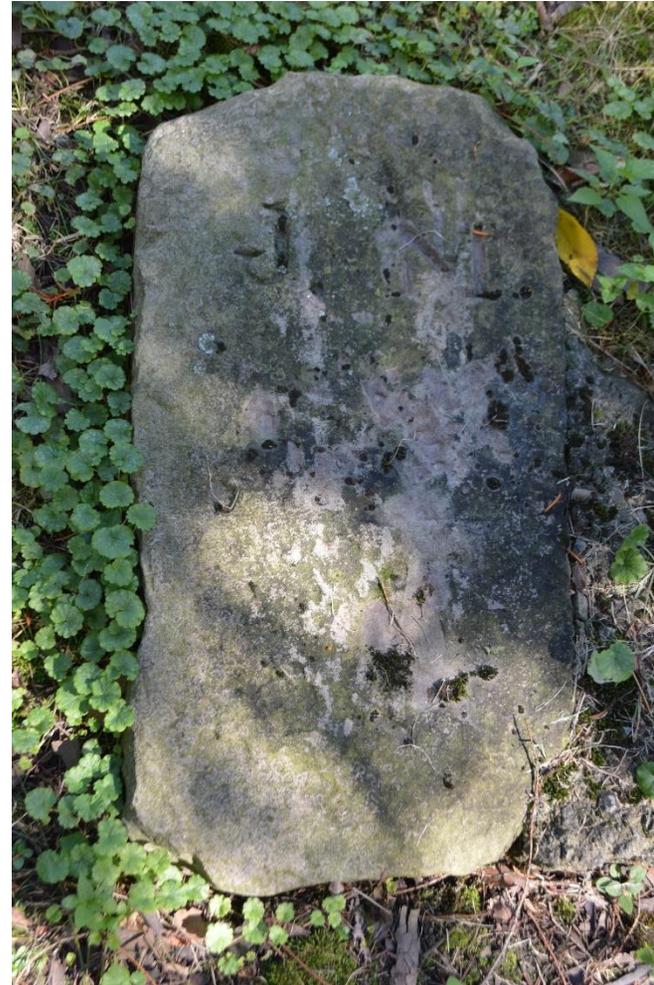
Cemetery	Warrensville West Cemetery
Location	Lee Rd., Shaker Heights, Ohio
GPS#	130
Lot #	163
Name	M., J.
Date of Death	
Material	siltstone
Marker Type	tablet
Inscription	J. M.
Stone Condition	Ambient dirt, biological growth, set flat in concrete
Recommendations	Clean, treat biological growth, remove concrete, reset plumb at correct height

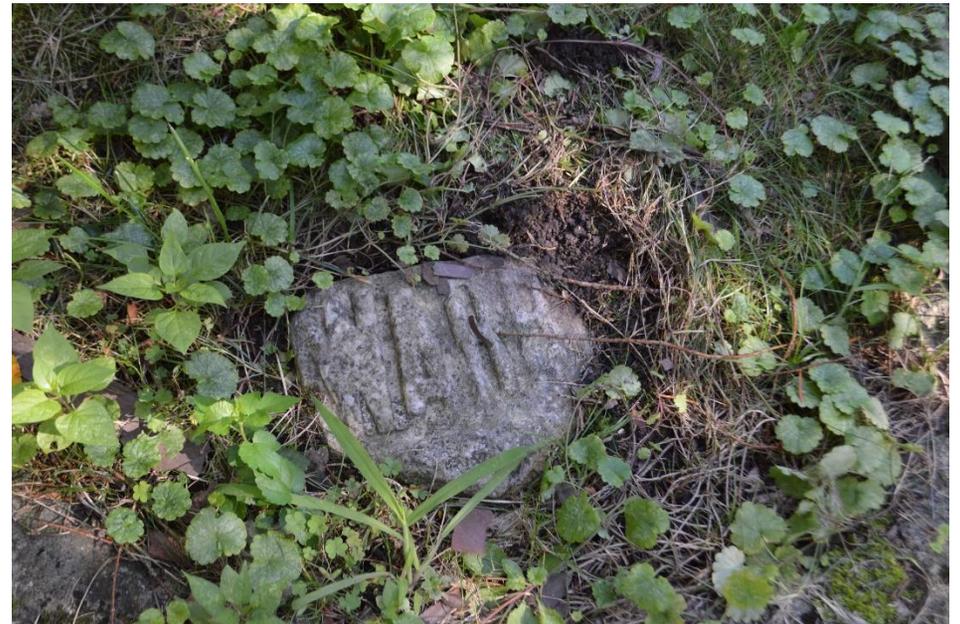
Cemetery	Warrensville West Cemetery
Location	Lee Rd., Shaker Heights, Ohio
GPS#	131
Lot #	163
Name	Warr
Date of Death	
Material	marble
Marker Type	marker
Inscription	WARR
Stone Condition	Ambient dirt, biological growth, sunken, chipped
Recommendations	Clean, treat biological growth, reset plumb at correct height

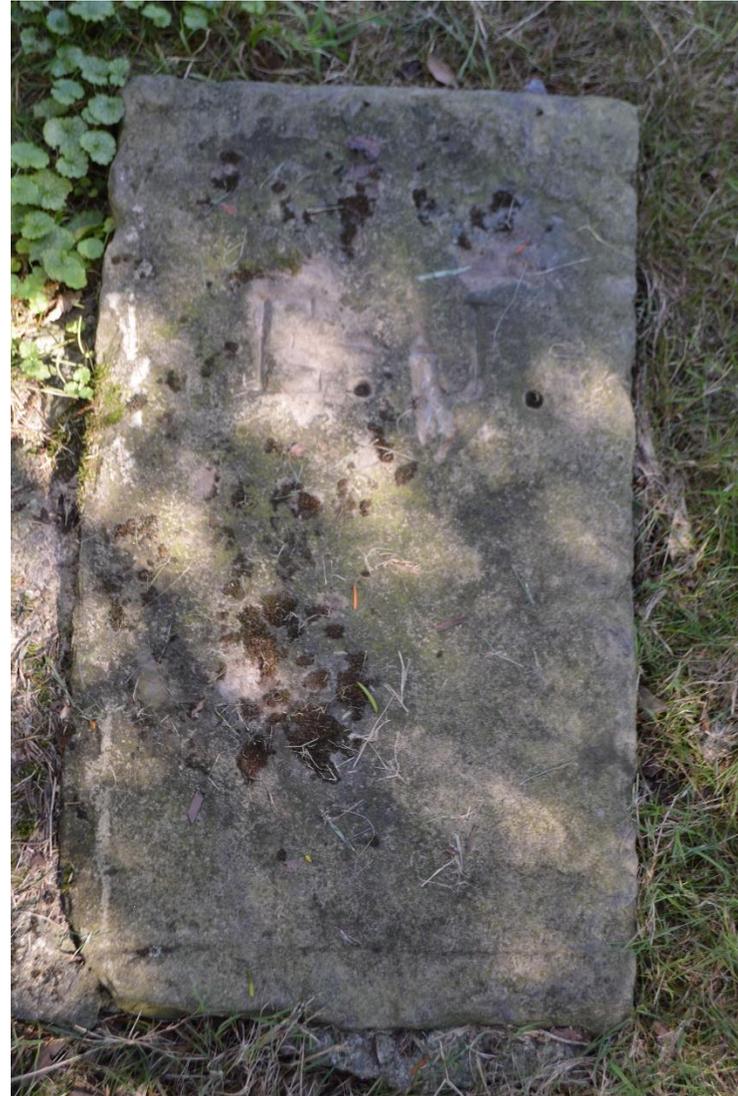
Cemetery	Warrensville West Cemetery
Location	Lee Rd., Shaker Heights, Ohio
GPS#	132
Lot #	163
Name	J., E.
Date of Death	
Material	siltstone
Marker Type	tablet
Inscription	E. J.
Stone Condition	Ambient dirt, biological growth, set flat in concrete
Recommendations	Clean, treat biological growth, remove concrete, reset plumb at correct height

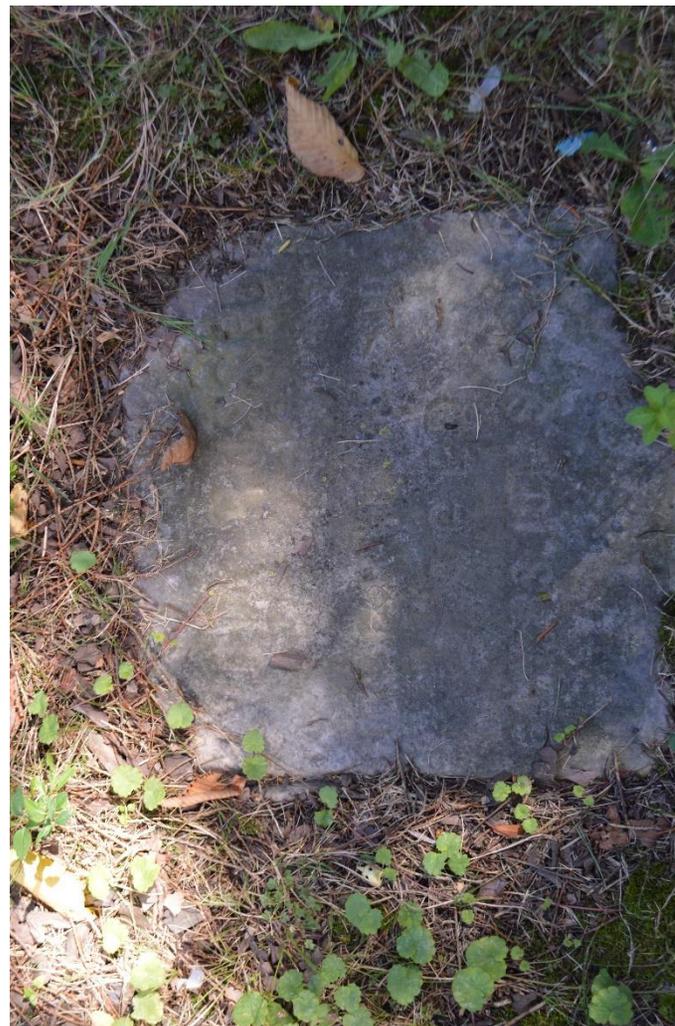
Cemetery	Warrensville West Cemetery
Location	Lee Rd., Shaker Heights, Ohio
GPS#	133
Lot #	163
Name	Russell, Lydia
Date of Death	June 29, 1839
Material	marble
Marker Type	tablet
Inscription	OUR MOTHER/LYDIA RUSSELL/CONSORT OF..RUSSELL/DIED JUNE 29, 1839/AGED/63 YRS. 10 MS. 28 DS.
Stone Condition	Ambient dirt, biological growth, set flat in concrete
Recommendations	Clean, treat biological growth, remove concrete, reset plumb at correct height

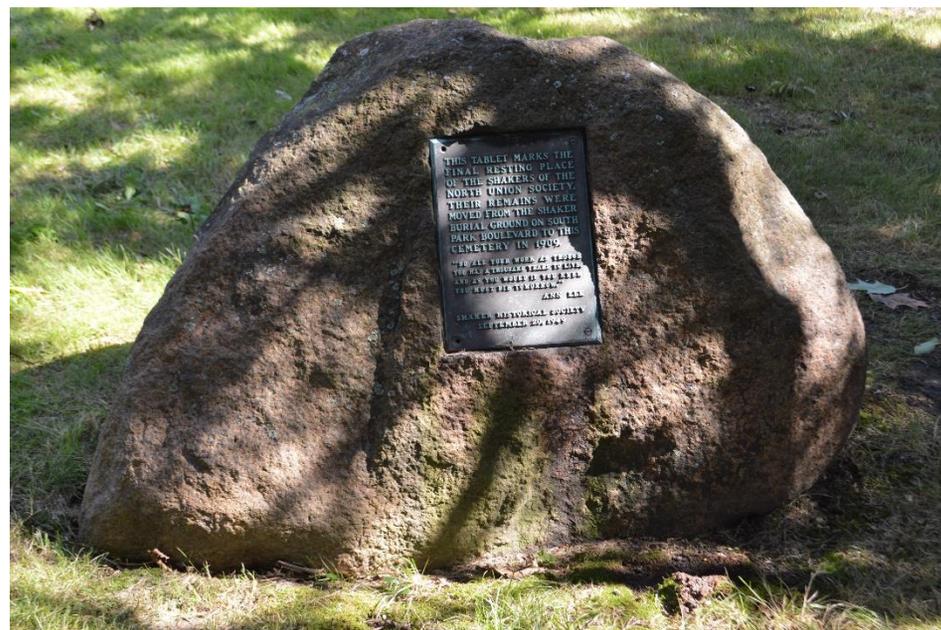
Stone Condition
Ambient dirt, biological growth, good
condition, plaque is missing two screws

Recommendations
Clean, treat biological growth, replace
missing screws

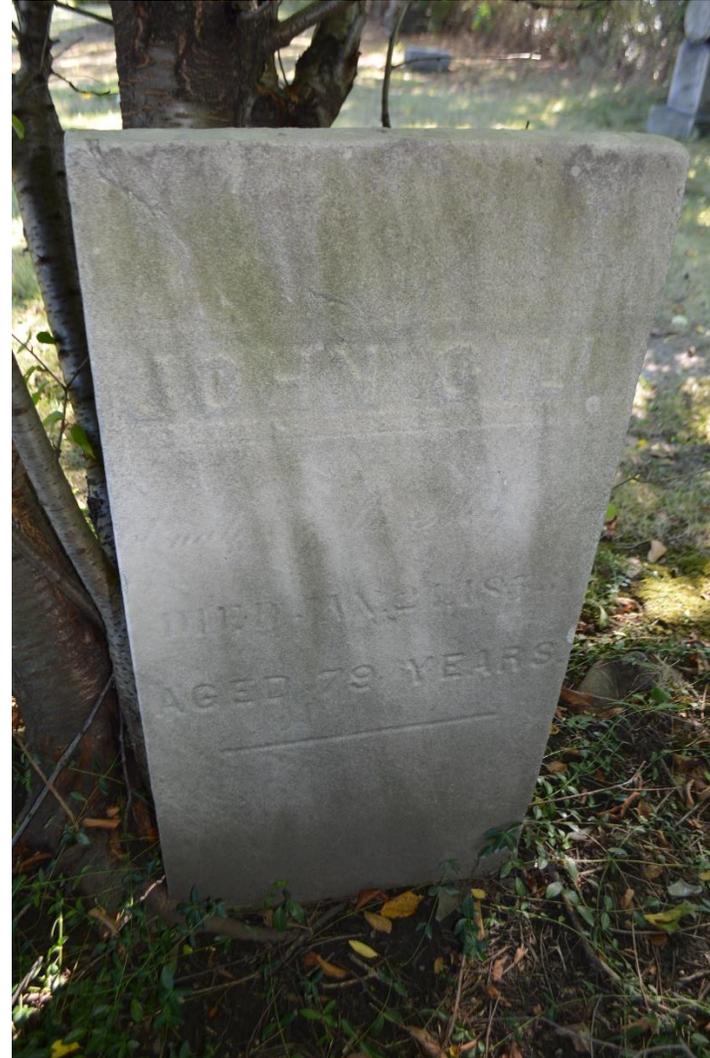
Cemetery	Warrensville West Cemetery
Location	Lee Rd., Shaker Heights, Ohio
GPS#	135
Lot #	61
Name	Gill, John
Date of Death	Jan. 24, 185-
Material	marble
Marker Type	tablet
Inscription	JOHN GILL//died Jan. 24, 185-/AGED 79 YEARS
Stone Condition	Ambient dirt, biological growth, leaning, impacted by trees
Recommendations	Clean, treat biological growth, remove or trim trees, reset tablet plumb at correct height

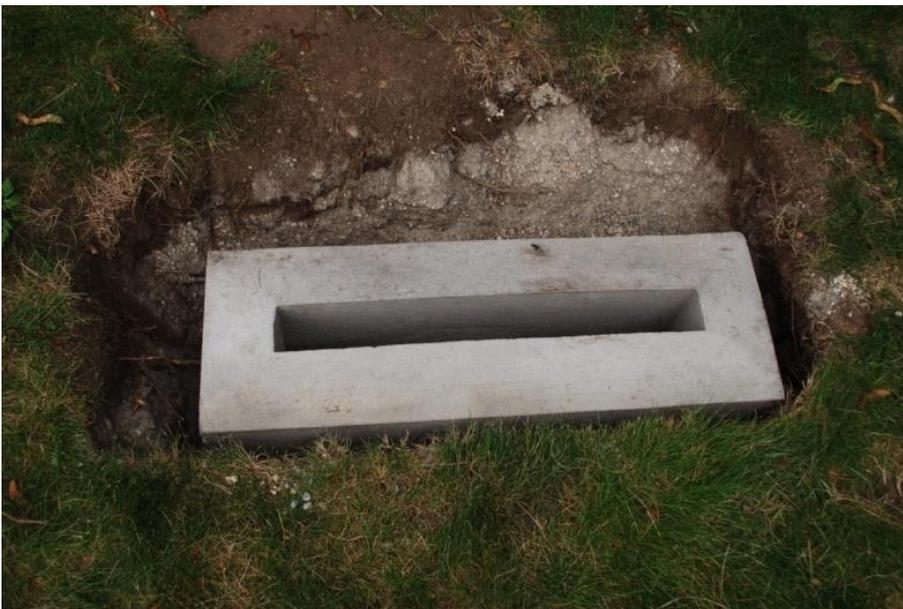
Traditional cast concrete bases are typically made with a slot that is ½" wider and thicker than the stone and is recessed 3"-4". Depending on the size of the stone the base is usually 8"-12" deep, 8"-12" greater thickness and 6"-8" wider than the stone. This method is fine when resetting stones with a square bottom although the low moisture permeability of concrete will have a long term affect on the mortar joint. This is due to the slot not being continuous and moisture that collects cannot escape. A slot through the base where moisture can propagate out solves this problem.

Some conservation specifications recommend squaring the bottom of the stone by cutting the stone with a saw. This is not recommended as the use of power tools on old stones can cause damage to the stone. In addition valuable history including inscriptions may be lost. If the bottom of the stone is not square a base with the same

dimensions as above should be made but the slot should go completely through the base. This allows the excess stone to extend under the base level if needed and provides for better support.

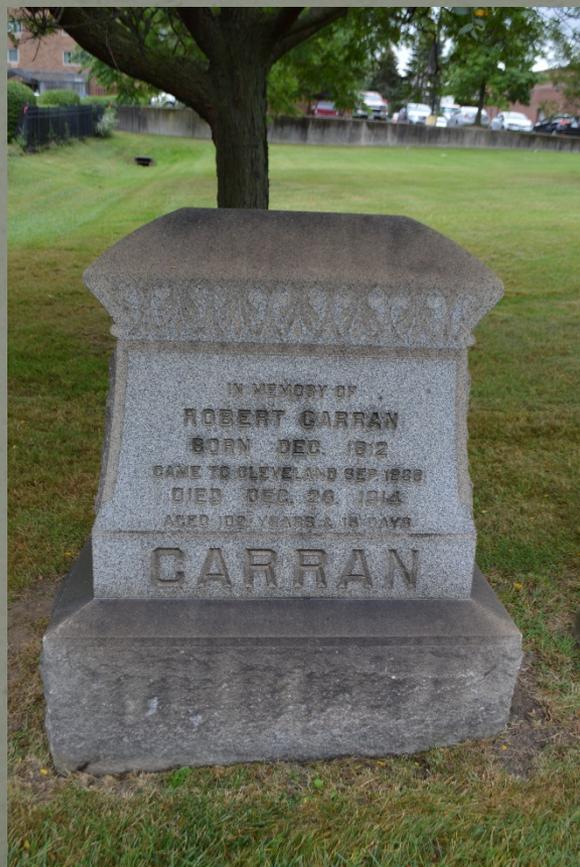
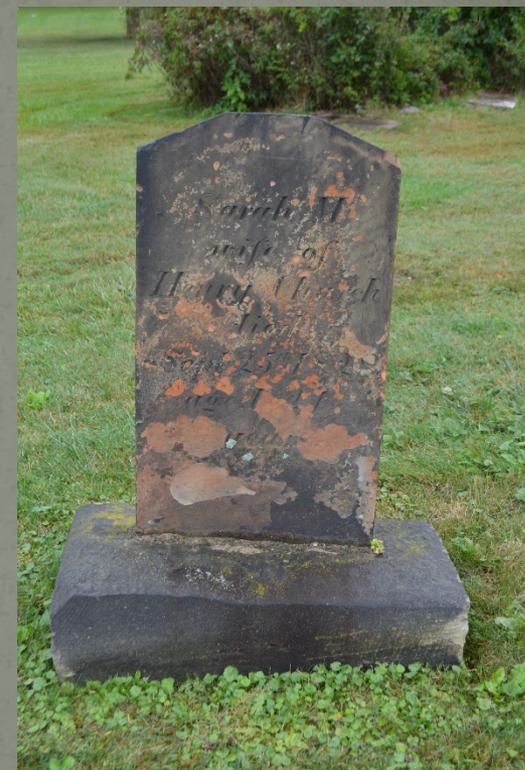
Tablet with base

Die with base

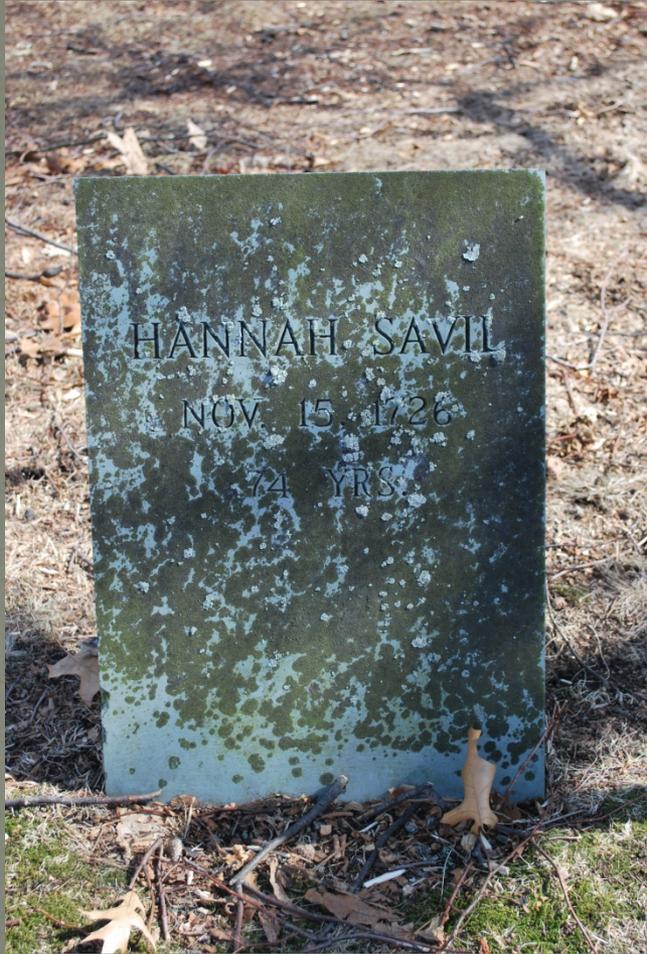
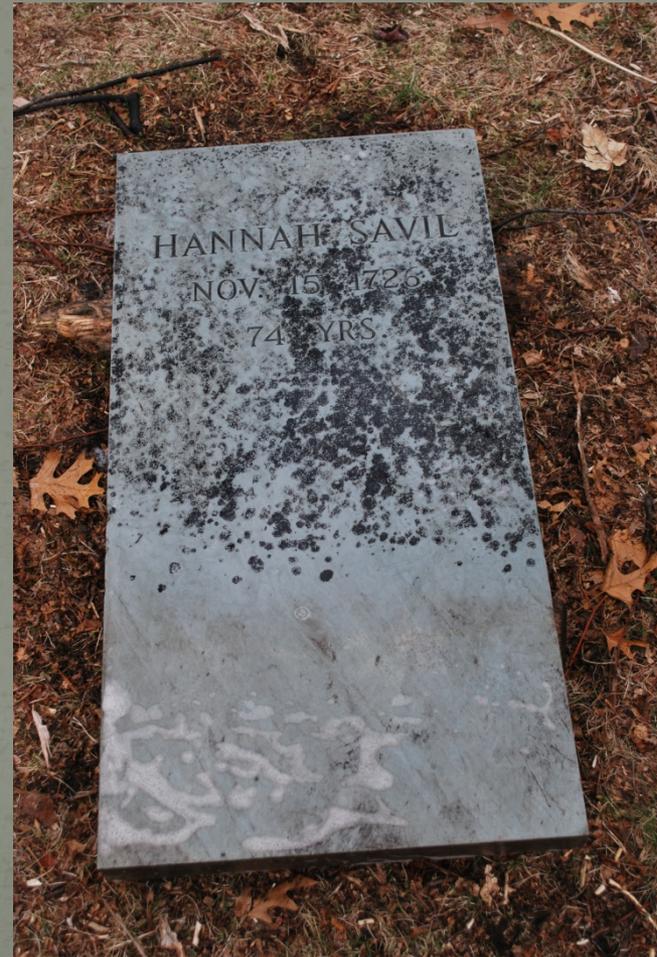
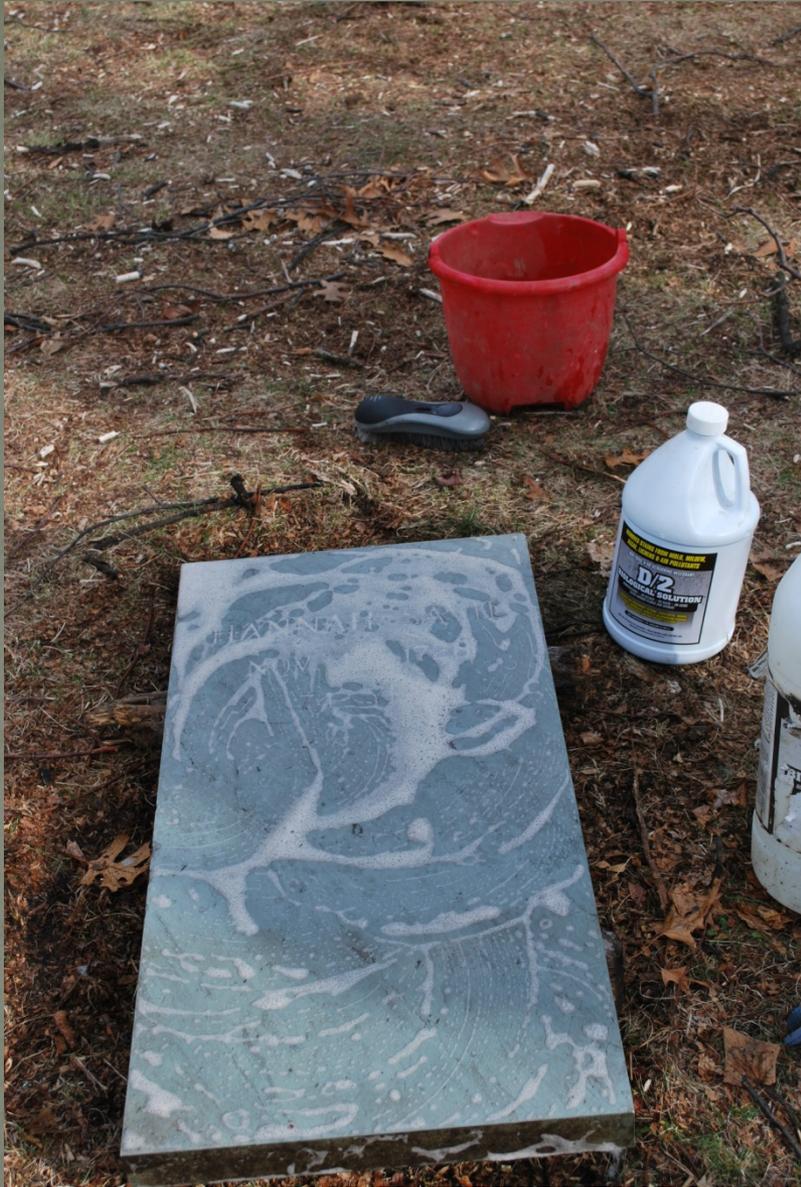
Cleaning the stone

- The stone is treated for biological growths with D₂
- Kills lichens and moss
- Environmentally safe
- Continues to fight biological growths

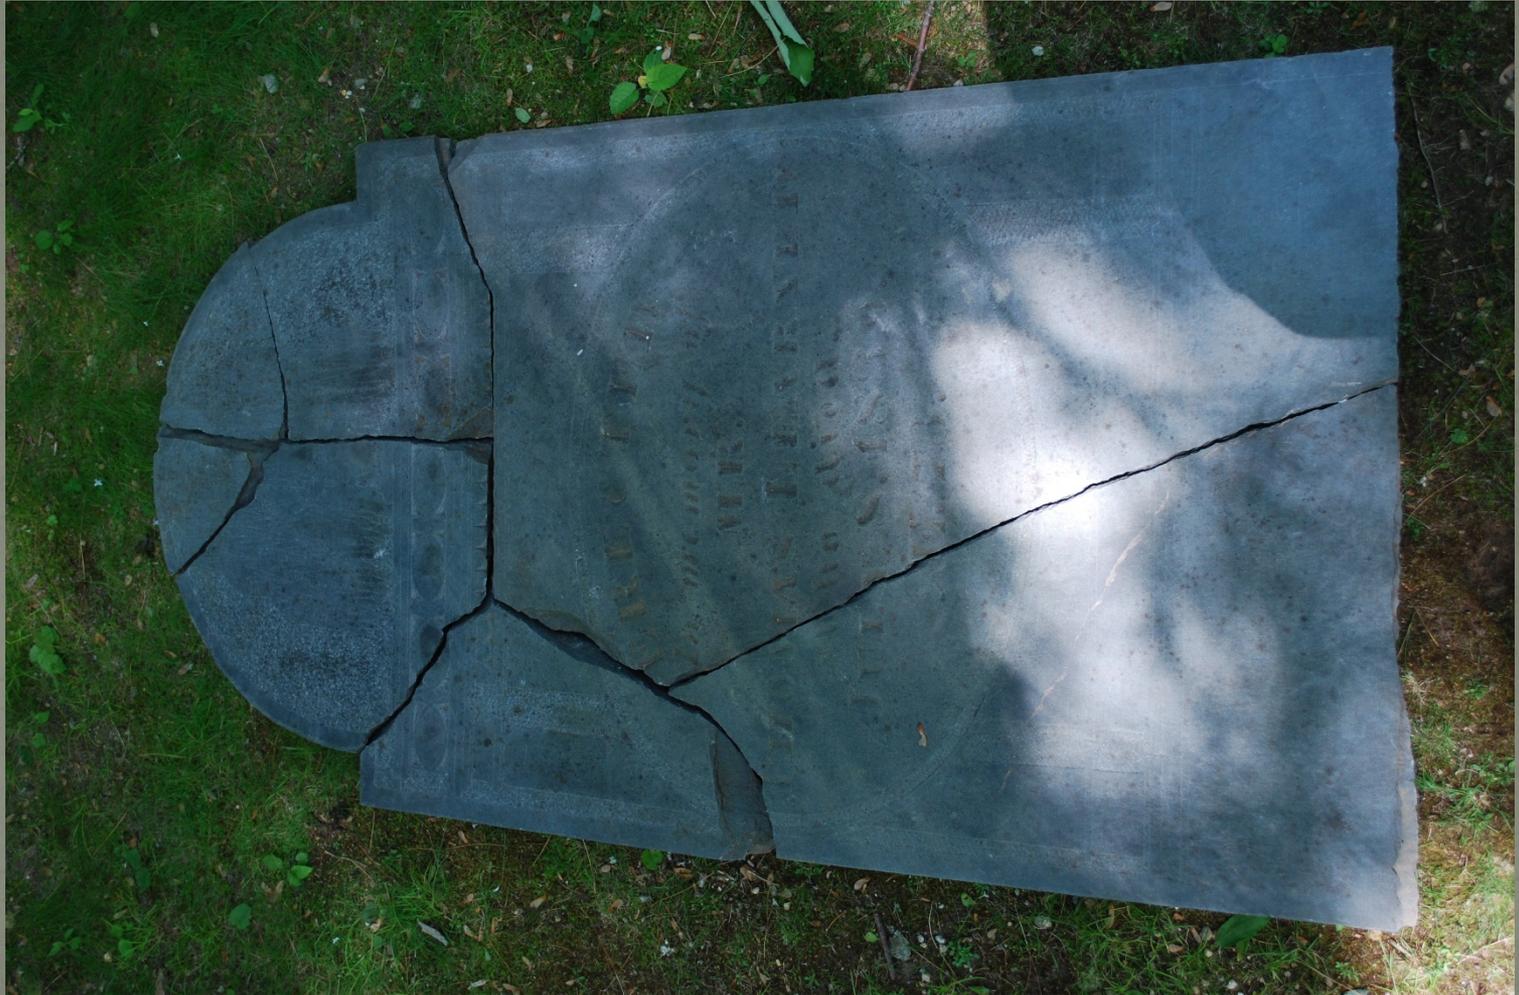
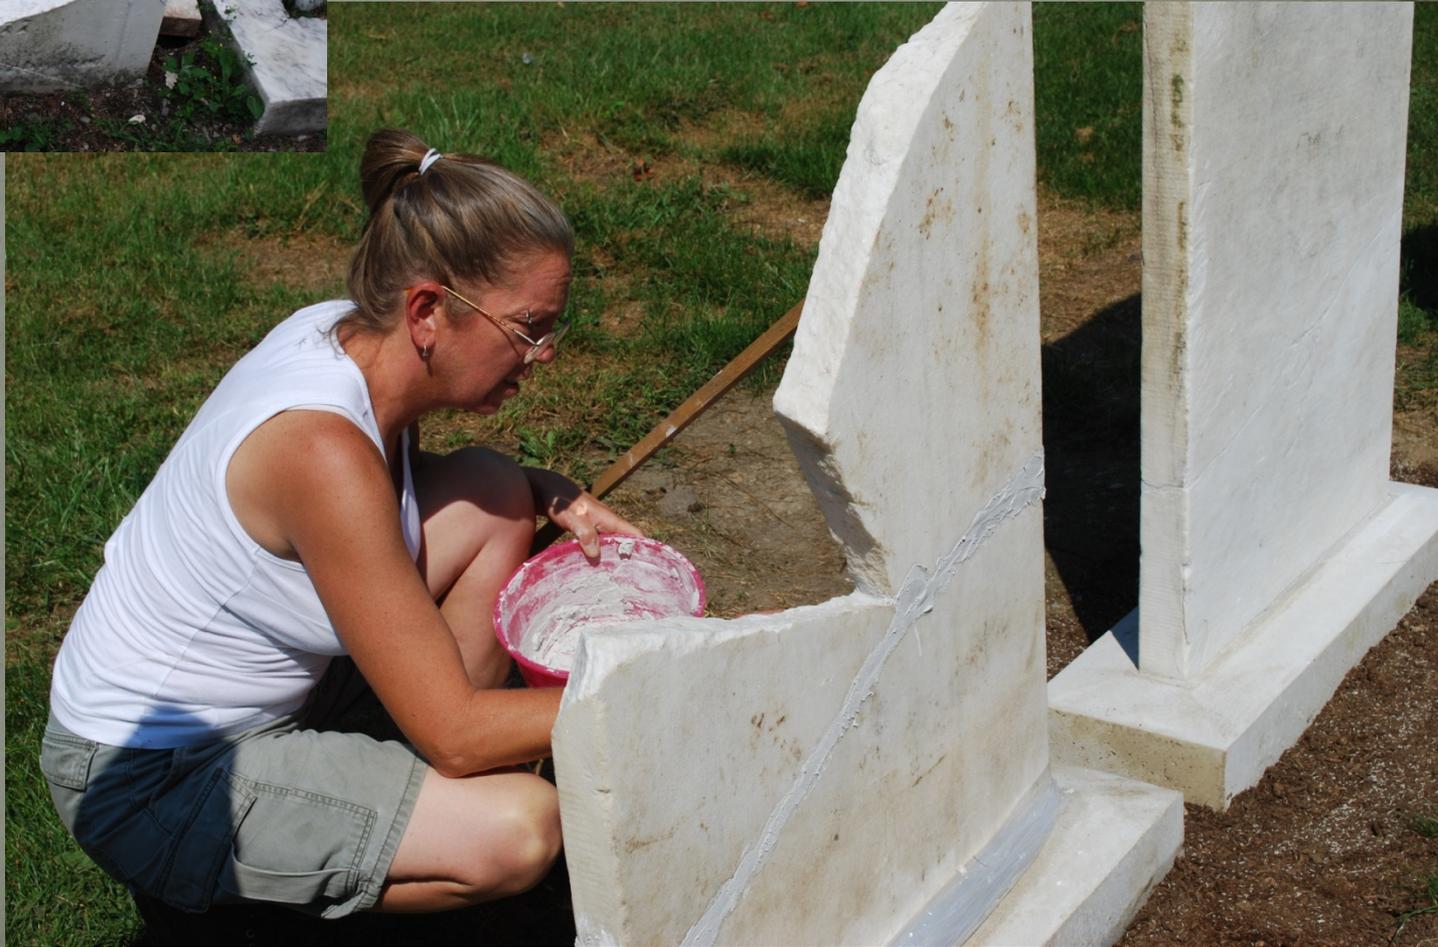
Broken Stones

- Reassembled with Jahn restoration Mortar
